SUBJECT: Black Ink Cartridge Seal

FROM: Copier Technical Support Section

VT3500  
Ges 5375/Rex 1280  
NSA CP375

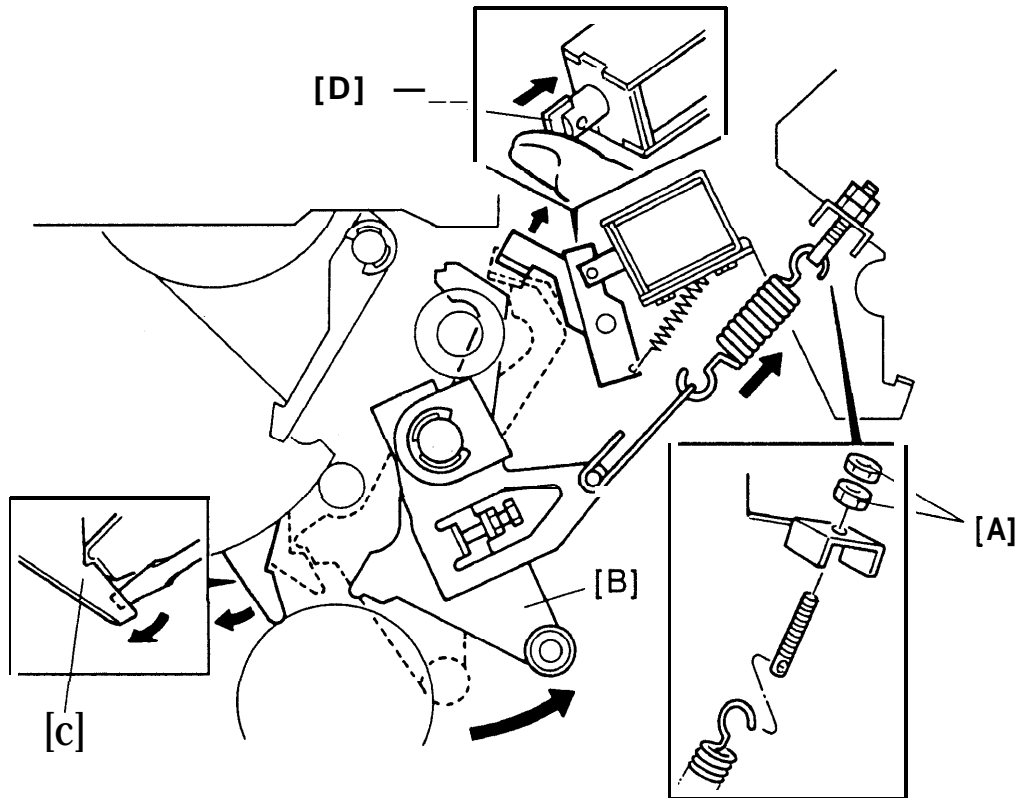
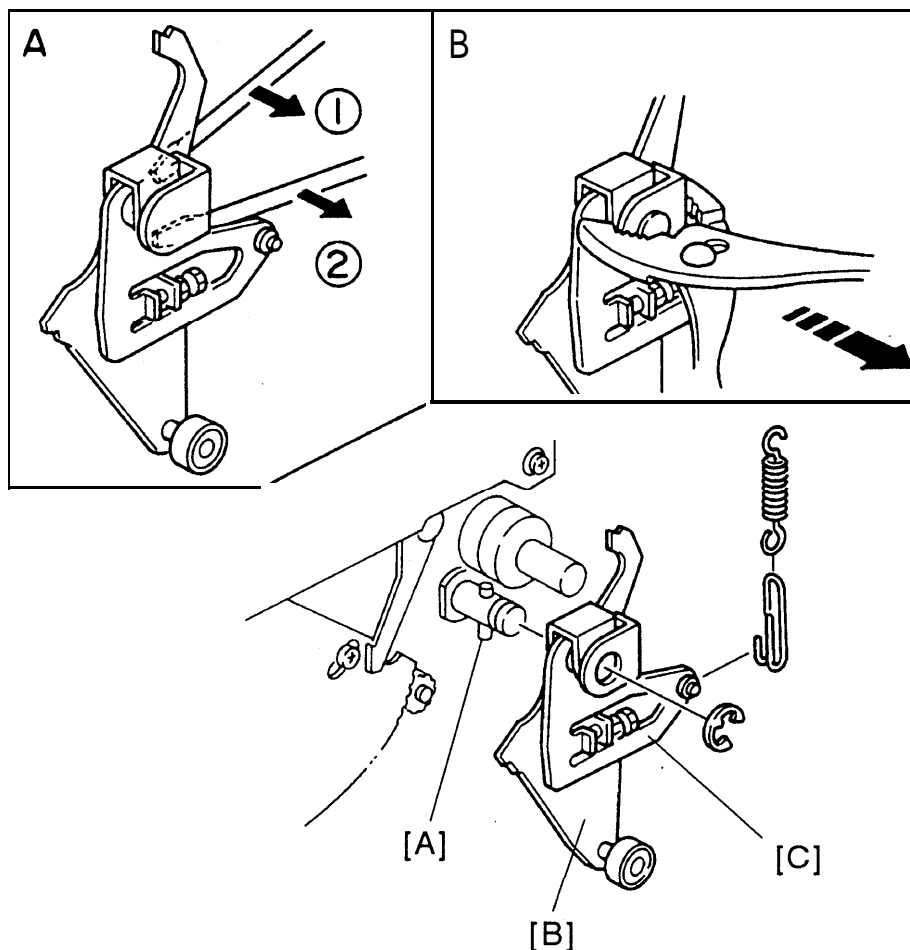
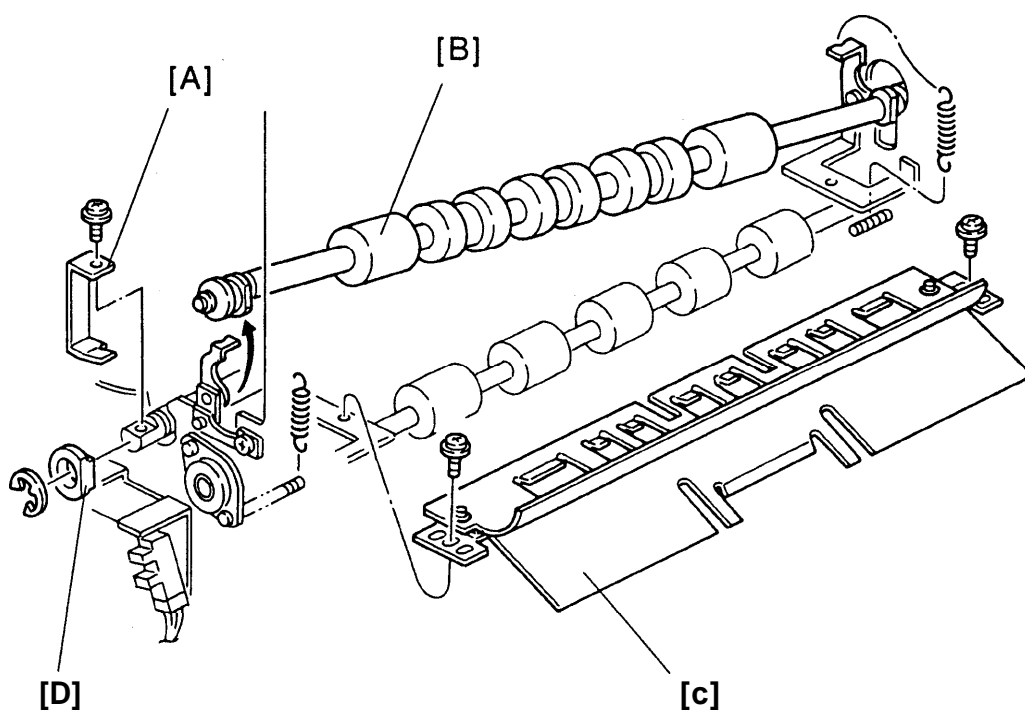
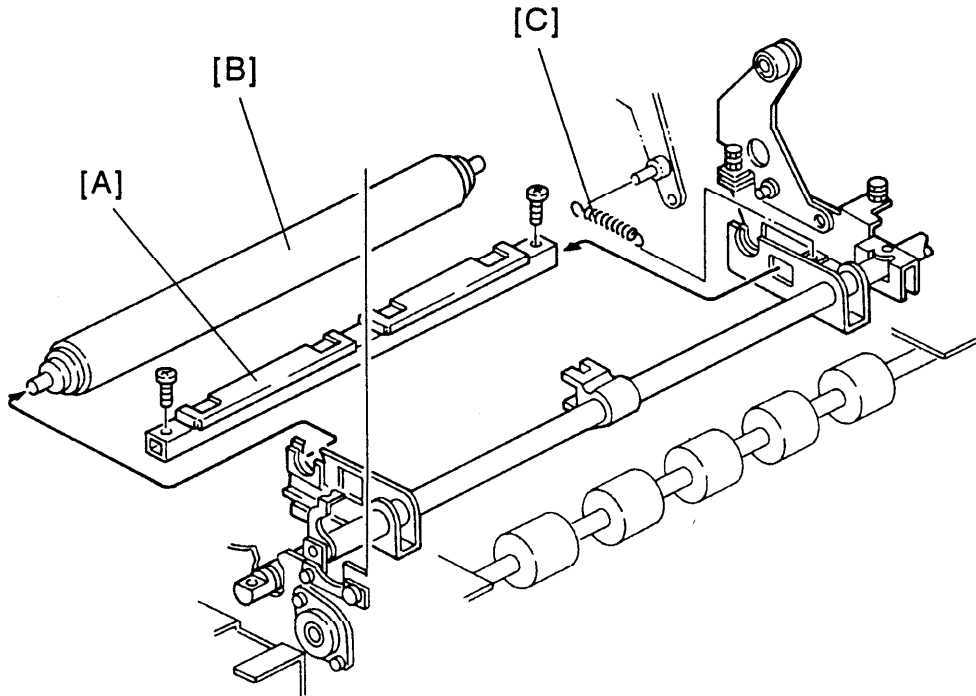
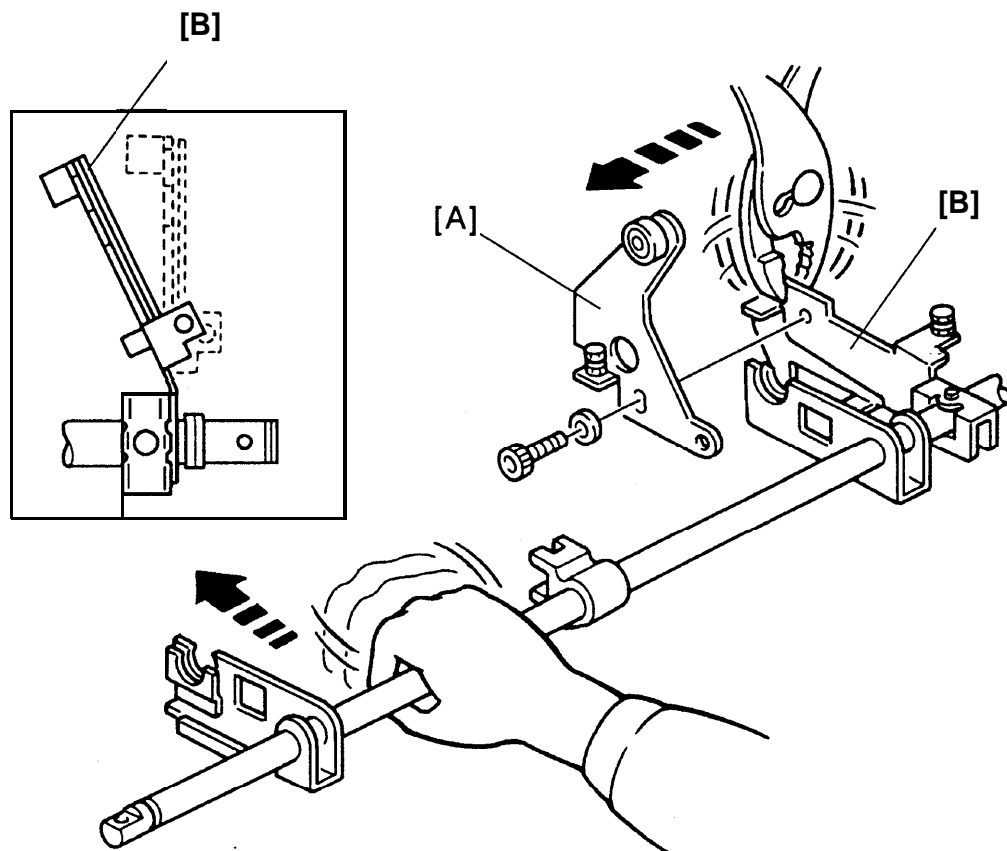
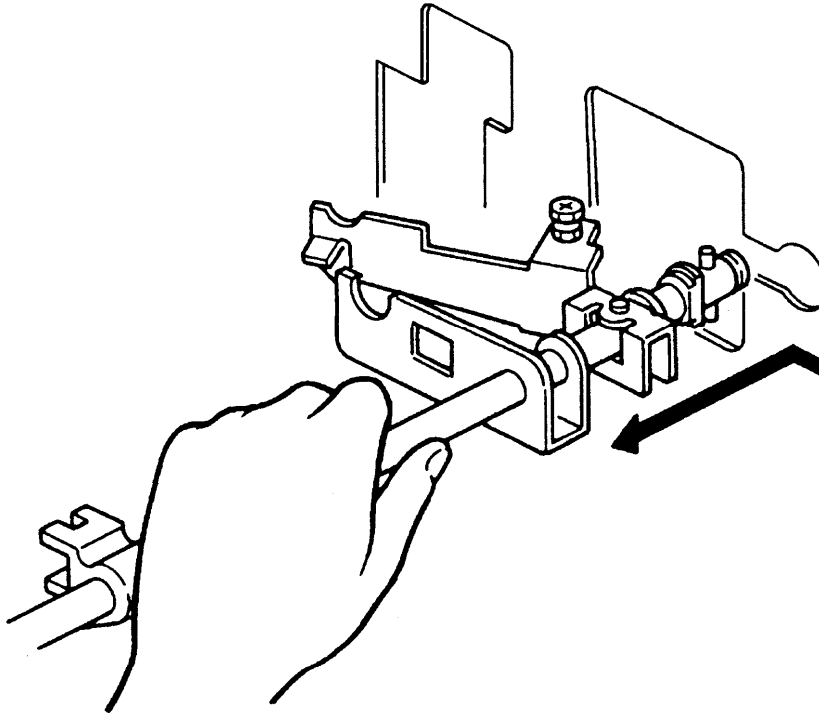
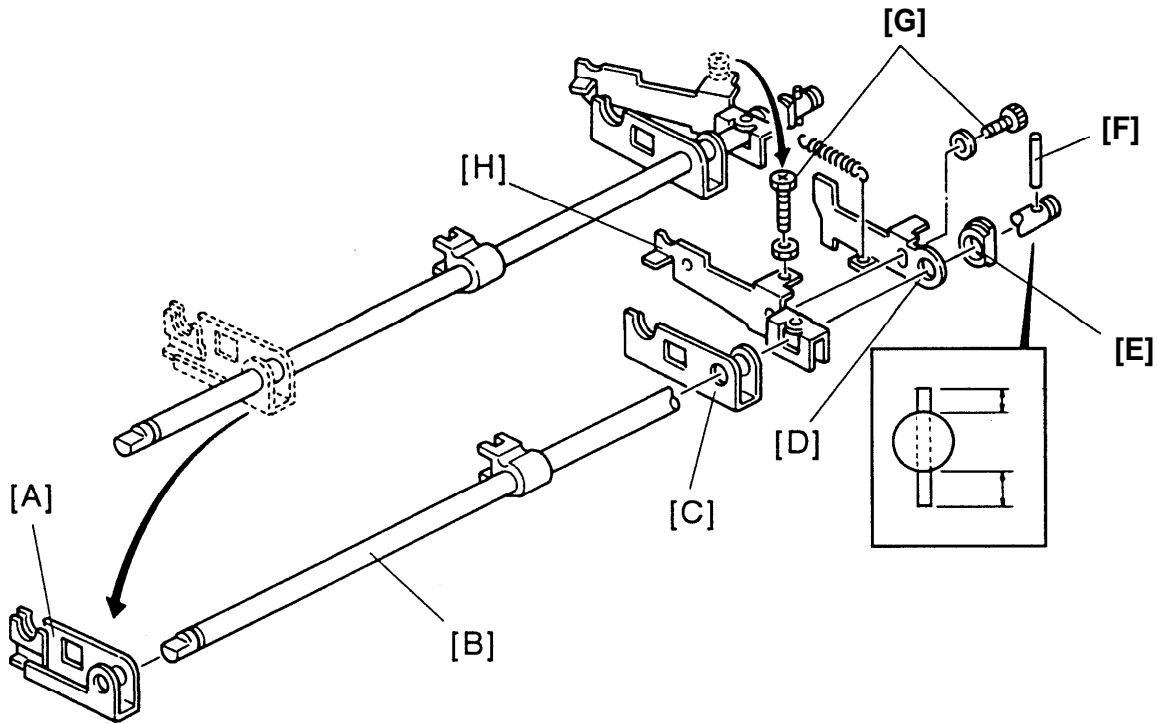
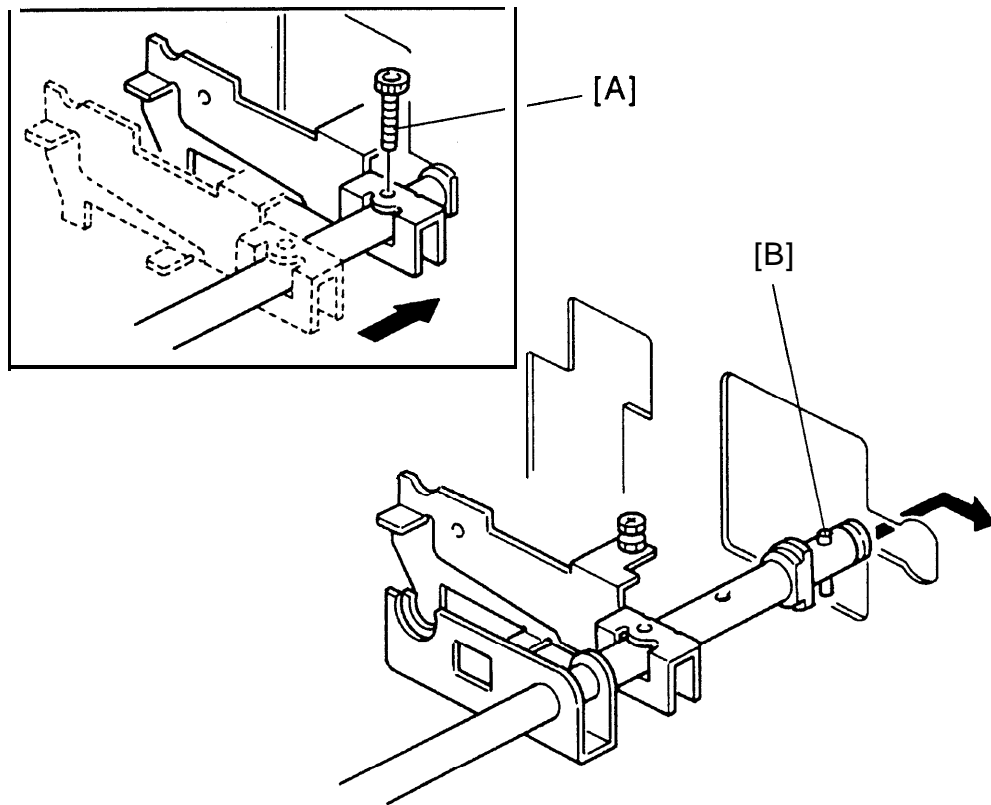
It was reported that the bolt (M5x14 hexagonal hole head bolt) that secures the A4 pressure on/off lever on the press roller shaft breaks. This will cause the exit pawl to hit the drum surface because the exit pawl drive cam is fixed with the A4 pressure on/off lever.

At worst, you may have to replace the A4 pressure on/off lever together with the press roller shaft if the head of the bolt is broken and the lever cannot be removed from the press roller shaft.

6. While pressing the plunger of the pressure release solenoid [D], disengage the paper detection arm [C] from the A3 pressure on/off lever [B]. Using a spanner, turn the drum shaft manually until the printing pressure is applied.
7. While the printing pressure is applied, remove the printing pressure spring by loosening the two nuts [A].

8. Remove the A3 pressure on/off lever [B] with the pressure spring arm [C] as shown.

9. Remove the upper second feed roller [B] (2 springs), then remove the upper and lower paper guide plates [C] (2 screws),

11. Remove the press roller [B] and press roller guide [A] (2 screws).
12. Remove the spring [C].

13. Slide the A4 pressure on/off lever to the front, so that you can remove the press roller shaft.

3) Remove the press roller shaft through the cutout of the rear frame as shown.

14. Remove all parts from the press roller shaft. Then, replace the defective parts with new ones. If you use the press roller shaft kit (see Note below), remove the front press roller arm [A] and two bolts with the nuts [G] from the old press roller shaft, and add them to the kit.

15. Assemble the press roller shaft and install it in the machine,

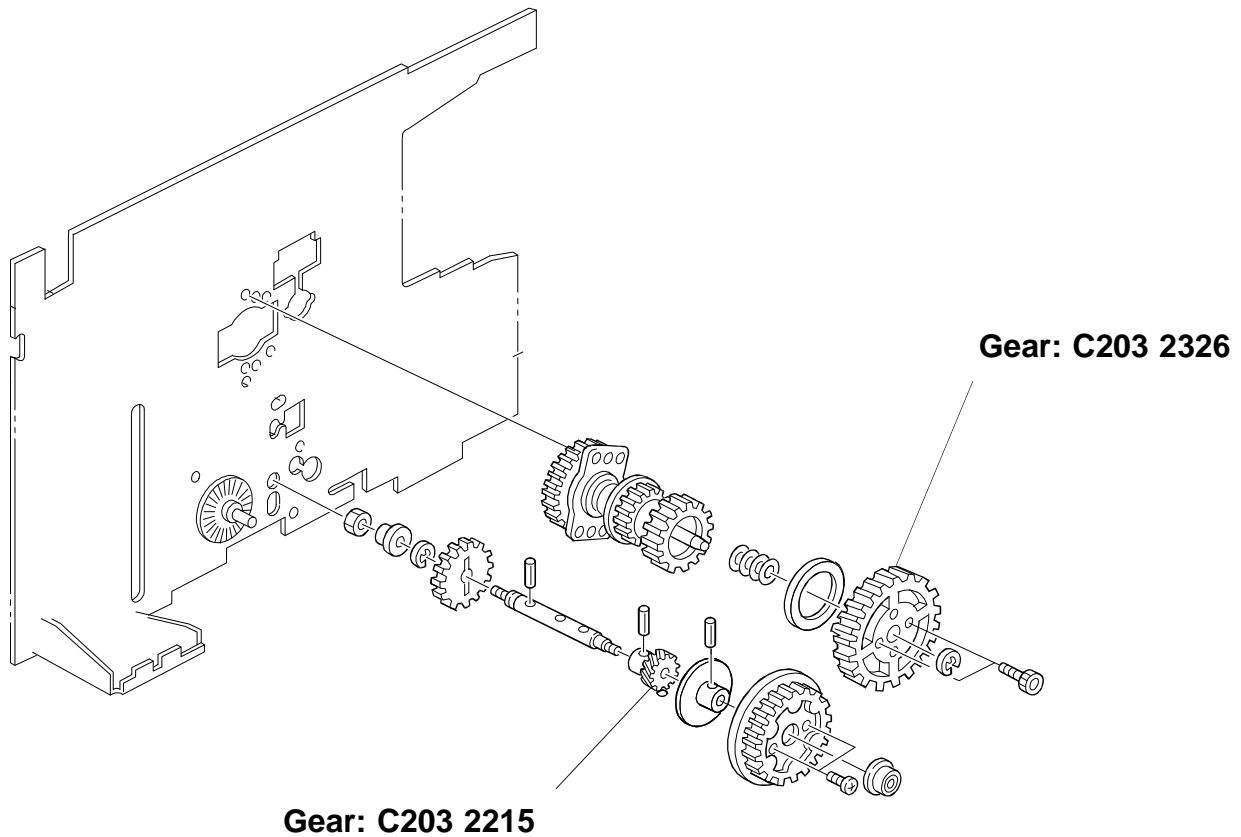
It was found that gears C2032215 and C2032326 (see the illustration on the next page) can rapidly wear out if they are not greased. In particular, gear C2032215 wears out faster (after about 30,000 to 50,000 copies).

It was also found on the production lines that some machines which were manufactured during the period from the end of 1994 to May 1995 have a lack of greasing for these gears. From April 1995, an inspection process was added to check the greasing of these gears.

Grease the gears (evenly on the surface of the gear C2032215) in the following cases:

1. For the machines detailed above (the NA3 and NB2 manufactured between the end of 1994 and May 1995), check if grease is properly applied and grease if necessary.
2. Grease the gears every time when they are replaced.
3. Grease at yearly PM intervals (as mentioned in the service manual).

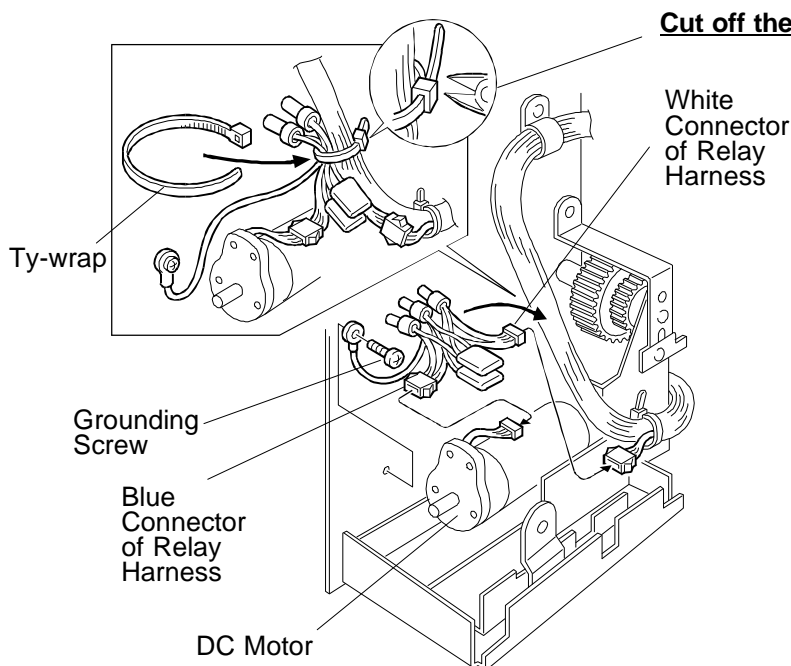
**For N850**

The dc motor that drives the table occasionally generates electrical noise when it starts rotating. This electrical noise is input into the ac drive board and damages IC301 on the board.

- NOTE:**
- The layout of the dc motor is slightly different between the N850 and NA33 models as shown. To prevent the relay harness from being caught by the gears, firmly secure it with the Ty-wrap as shown in the illustrations for each model.
  - Since the Ty-wrap is too long for the N850 model, cut off the excess, as shown.

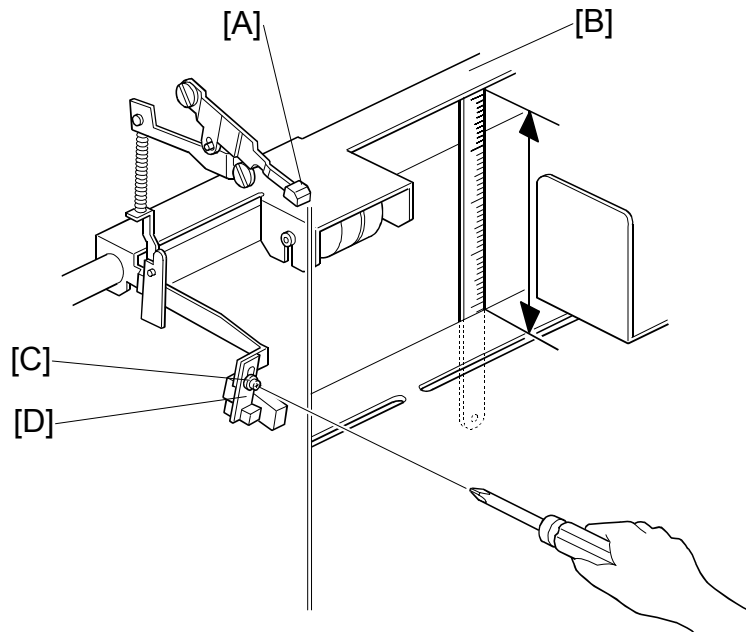
The table height can NOT be adjusted using the procedure on Page 5-29 (because there is no lower stay at the measuring point).

Adjustment Standard:  $52 \pm 0.5$  mm

1. Set the paper feed pressure adjusting lever [A] to the upper position.
2. Remove the right cover of the machine (5 screws).
3. Turn on the main switch and access the SP mode.
4. Select output check mode (SP131) no.19, and press the Print start key to raise the table.
5. After the paper table stops, insert a scale into the slot in the paper table. Make sure that the distance between the feed roller stay [B] and the surface of the paper table is  $52 \pm 0.5$  mm.
6. If it is not, loosen the screw [C] and adjust the position of the actuator [D].
7. After adjusting, repeat step 5 by lowering the paper table (output No. 18) and raising the paper table (output No. 19) several times, checking the height each time.
