ORIGINS

This is a trial first issue for a monthly newsletter covering the SIGNAL/ONE transceivers. I have sent out quite a number of my "Trouble Guides" and many owners have returned comments concerning setting up some sort of SIGNAL/ONE club and net. I think the best way to build a club is with a monthly newsletter covering topics of interest to owners such as modifications, trouble shooting information, where to procure parts, and so forth.

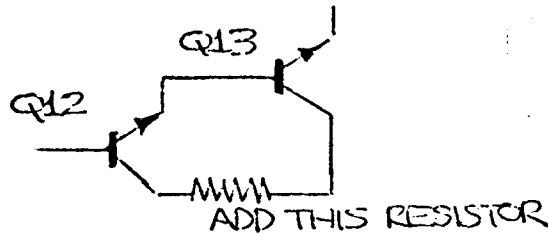
Rob, WB4RSK, suggests the following for CX7 owners: Adding one resistor as shown below will eliminate loud pops in receive due to AGC action. Q12 and Q13 are located on IF board, A8. Value is 6800 ohms, 1/4 watt.

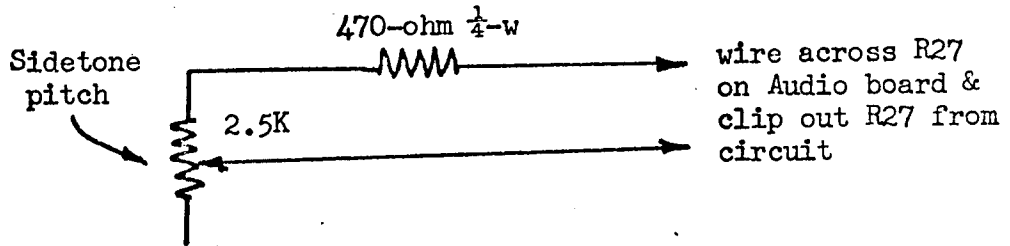
Johnson (Johnson and Associates) forwarded the following suggestion for those who tire of a monotonous side tone when operating CW. The new potentiometer can be installed as a dual concentric unit with the CW speed control. See diagram below:

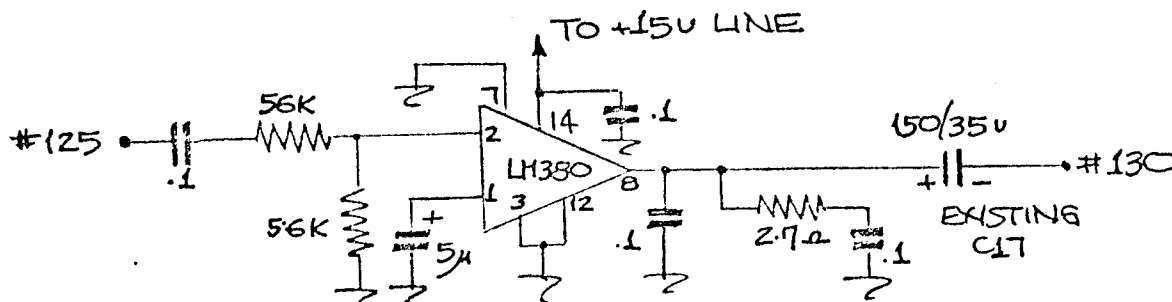
Wiring for the LM380 is as follows:

Notice that C17 may be reused but with reversed polarity. The output transformer is no longer used. Wire pin #130 from the power supply board directly to the speaker jack.

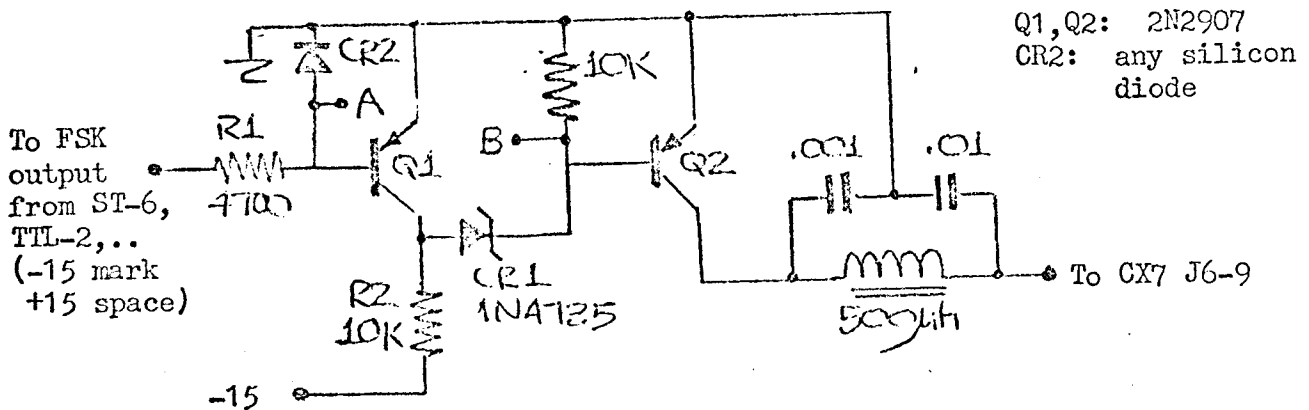
The following RTTY interface is via W2GRU. The circuit results in mark high for unmodified CX7A. If FSK operation has been modified to LSB (previously described), remove Q1, CR1, R2 and add a jumper from A to B.

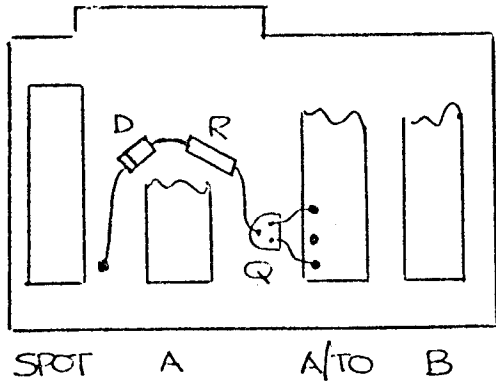
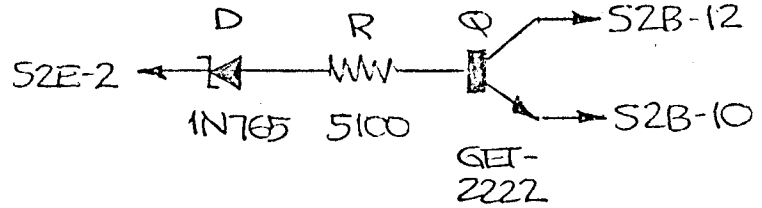
John, W2GRU, notes that when operating in the A/T.O. mode, an image appeared (about 40db down) at a frequency that was as far removed from the actual signal as the transmitter was offset from the desired frequency. The cause was due to leak-through of the offset 34.2 Mhz oscillator. John's solution to this problem is to gate the offset oscillator to off in receive and key it on in transmit or spot modes. All modification work is done to the Transmit VFO/Spot switch board. (See schematic and drawing on next page). To get at this switch board remove the cover from the counter board, remove the counter board hold-down screws and rotate the board towards the back of the set. This will expose two screws under the board. Remove these screws and fold the entire "tray" toward the rear. The switch board is held in place by two screws. Remove the screws and unplug the edge connector and it is easy to put in the modification from this point. John reports no evidence of keying transients (chirp) as the oscillator is keyed and the modification worked well during the last CW SS contest.

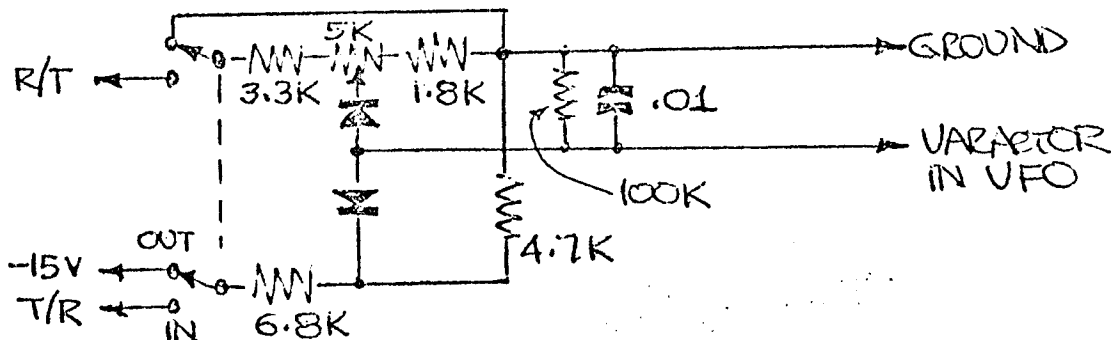
I have a couple of items this month concerning receiver incremental tuning (RIT). The first is from W7IV. In issue Volume II, Number 3, of S/1 NEWS a RIT modification by W7IV was described which utilized two transistors and a handful of resistors. Harry wrote me again and indicated that the transistors were not necessary. His revised circuit is shown below. Make the modification as follows:

Connect terminal 1 of VFO A, the FSK varactor, to a pin on J5, the accessories connector on the rear panel. Many of the present connections would never be used such as Front-end AGC. Disconnect one of these to free a pin (Make a note in your manual for future reference! ed.) All other necessary connections (T/R, R/T, and -15 volts) are already on J5. The RIT potentiometer and components now can be assembled in a small "minibox" and placed near the CX7. Harry did not indicate if the circuit was built up and tested.

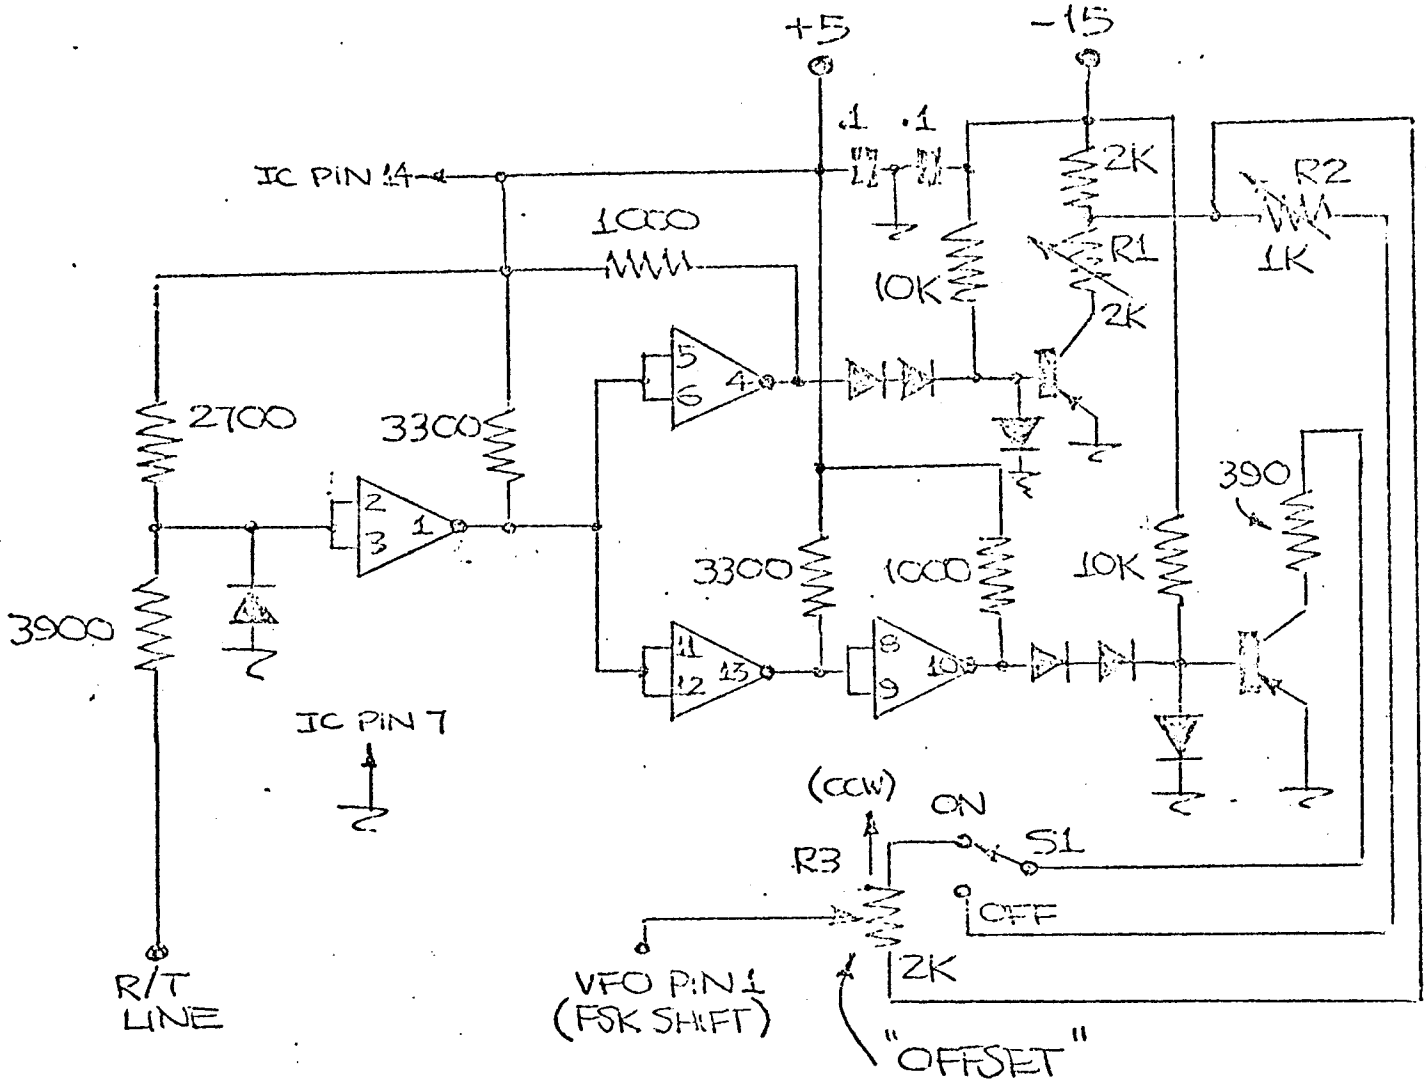
Jerry, W4MLA, also send a schematic of his RIT modification which is installed in his CX7 and working well. His circuit is a bit more involved but can be easily built up on a small piece of vectorboard. The existing FSK potentiometer is removed and replaced with a new RIT potentiometer and switch assembly. (See schematic on next page). The small vectorboard with all necessary components can be attached to the new RIT potentiometer. Make the modification as follows:

1. Remove existing FSK potentiometer and replace with the new RIT potentiometer and switch (R3 and S1 on schematic below)
2. To use with VFO B, connect white wire #10 on the arm of the FSK potentiometer to the arm of R3.
3. The blue wire #52 is - 15 volts. Connect to vectorboard as required.
4. Route new wires for +5 volts, ground, and R/T and connect as required to the vectorboard assembly.
5. Turn RIT on and adjust R3 for the center of the frequency range and install the knob so that the pointer is at 12 o'clock.
6. Turn RIT off and adjust R2 for the same frequency as read in step number 5. above.
7. Key transmitter and adjust R1 for the same frequency read in step number 5. above.

The RIT range with this modification is approximately ± 4 Khz. On schematic below, the IC is a SN7401, transistors are 2N2907, and all potentiometers are linear taper.

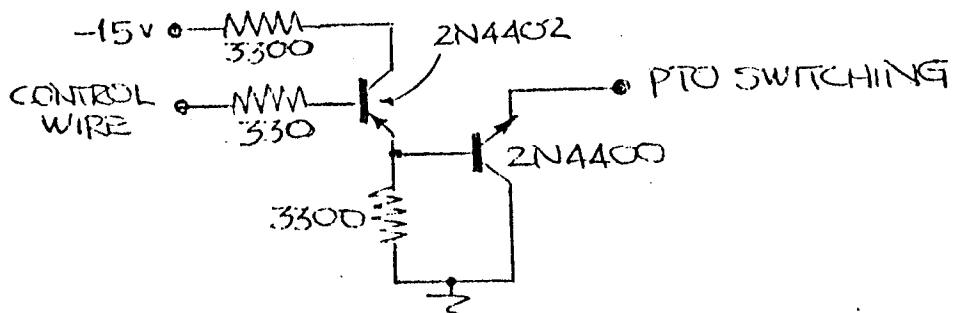
1. The VFO on/off switching line is either ground or about 0.3 v in the on state (See table 3-1 in technical manual)
2. The load seen by the VFO counter output depends on which VFO is selected at the counter.

To make switching potential independent of switch states, hand the following circuit on back of each VFO (circuit is by WA7VEN):

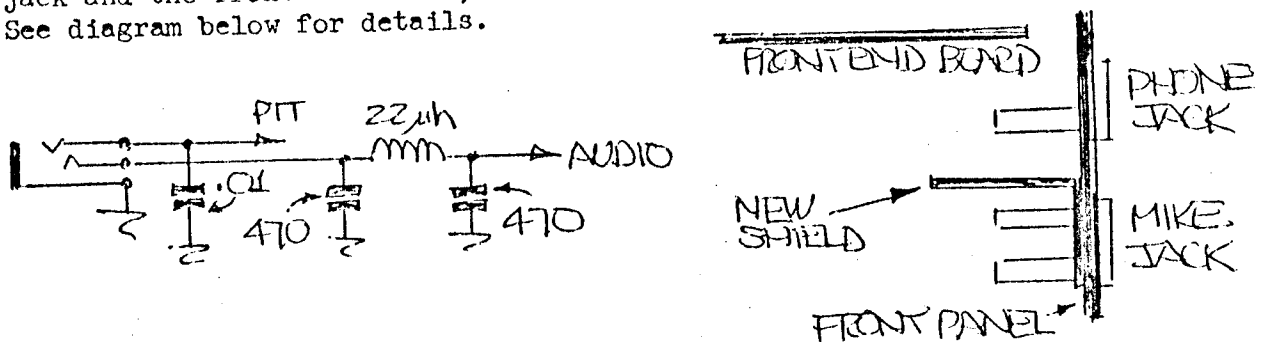
Here is a very unique (maybe not??) problem also described by Harry, W7IV. It seems that when Harry would lower his tower (a crank up type) about 20 feet, his CX7 would feedback and oscillate on the 20 meter band - no other band was affected! The problem was caused by the fact that when the tower was lowered, the CX7 was subjected to a slightly higher RF field. Experiments proved that the mike cable was the culprit. The mike jack is right above the section of the Front-End board on which the crystal oscillator is located. Harry explains it as so: "RF enters through the mike cable, and is coupled to the crystal oscillator. On 20 meters, the crystal frequency is 5.4 Mhz. It is then conducted to IC-1, the mixer. There the 14 Mhz RF and the 5.4 Mhz oscillator signal mix to produce 40 Mhz, which goes straight through the IF (39-40 Mhz). Harry would like to know if anyone has a better explanation...

The cure for this problem is to put a small shield between the mike jack and the front-end board, and a filter in the mike audio lead. See diagram below for details.

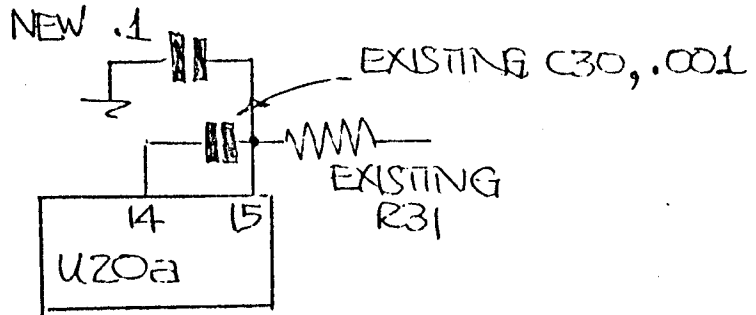
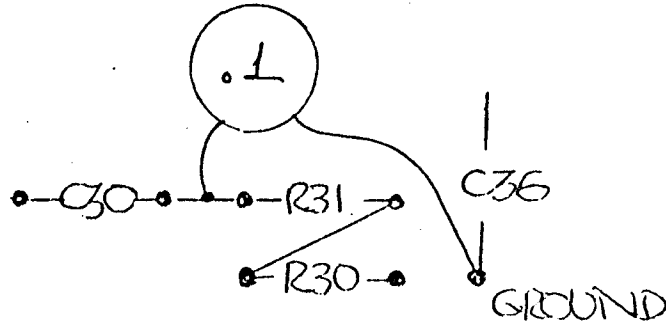
A recent issue of S/1 NEWS described a programmable keyer by HFB Enterprises, W7BBX/4. I recently discussed a minor problem with the keyer with W7BBX concerning the fact that if the keyer is turned on in the XMIT mode, readout will generally occur from the selected memory position until RESET is depressed. This could cause damage to relays in the CX7 or a linear if the keyer is sending at the instant a relay is switching. Howard has generated a simple modification to cure this problem. With the modification the keyer will automatically reset itself on turn-on. None of the other keyer functions are affected.

The modification consists of the addition of one .1uf capacitor (50 volt disc) at pin 15 of U20a to ground. See diagrams below for details.

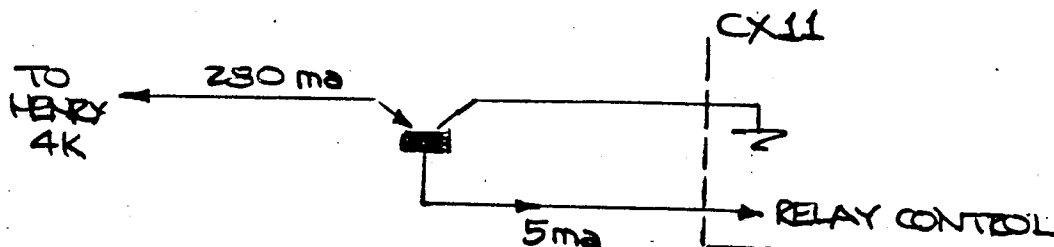
Jordan, WA1HBP, has received his CX11. In his words.. "...[it] is nothing less than sensational...." He did indicate that a slight modification was required to allow it to operate with the 4K Ultra Henry amplifier. See the schematic below. The CX11 did not operate the relay on the Henry because it was designed to operate primarily with Alpha linears.

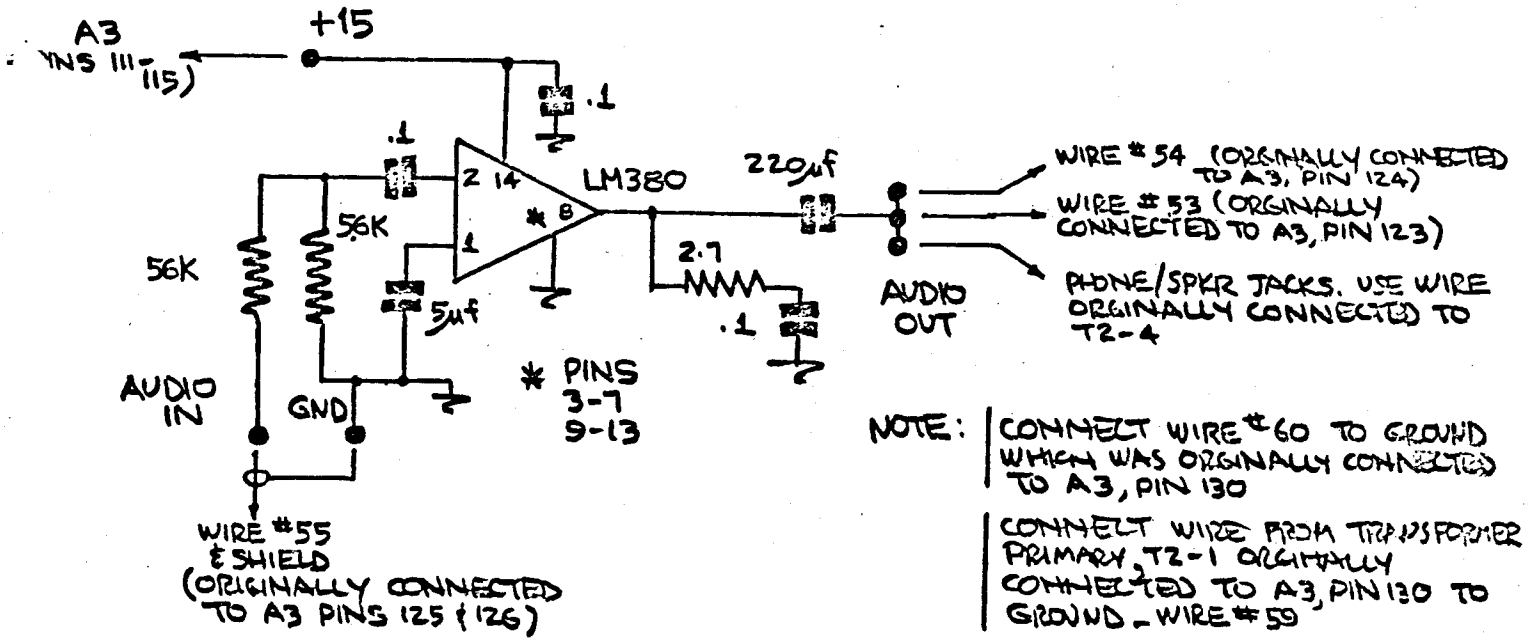
|| FIGURE 1 ||

Figure 1: This is the schematic of the module along with a pictorial showing parts layout for the PC board.

NOTE: The figures do not show the following modifications necessary for proper operation:

1. The heat sink area on the power supply board for Q11 (see Figure 3) must be isolated from the +34 volt line by cutting a land on the rear side of the power supply board, A3. Connect a short jumper from the Q11 heat sink area to ground (this can be done on the top of the board).
2. On the CX7A series move zener tied to the +34 volt line to another location. This is necessary since the +34 volt tie point used by this zener is the heat sink area for Q11 which is modified in step 1 above to be at ground.

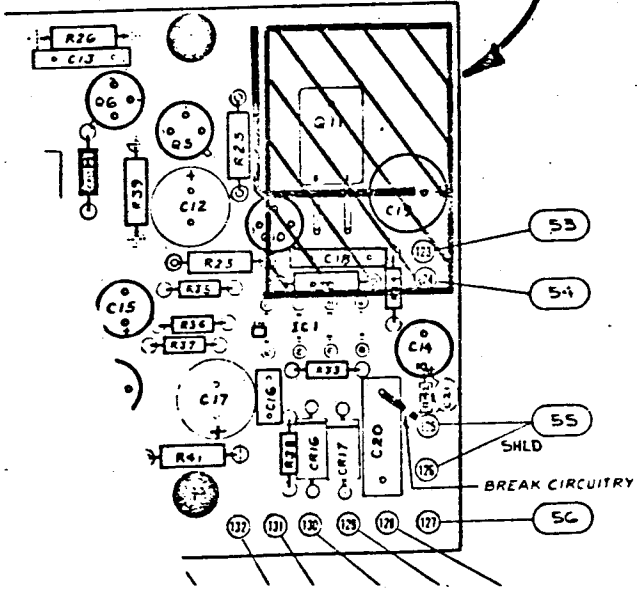
FIGURE 3

Figure 3: Pictorial showing location of the new module on power supply board, A3.

MOUNT NEW MODULE IN THIS
LOCATION USING $\frac{1}{4}$ -INCH
STANDOFFS.

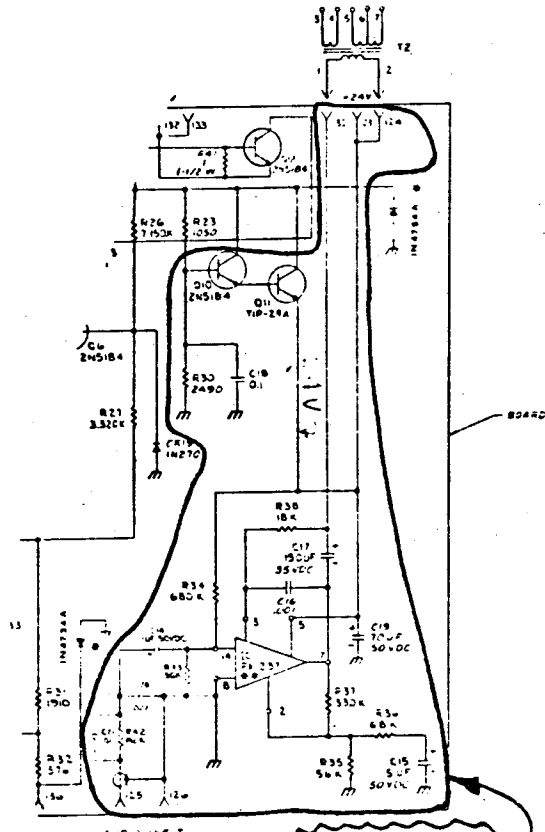
FIGURE 4

Figure 4: This shows parts to be removed from the power supply board to make room for the new module. All parts removed are from the existing audio output circuitry and its power supply.

REMOVE ALL
THESE COMPONENTS

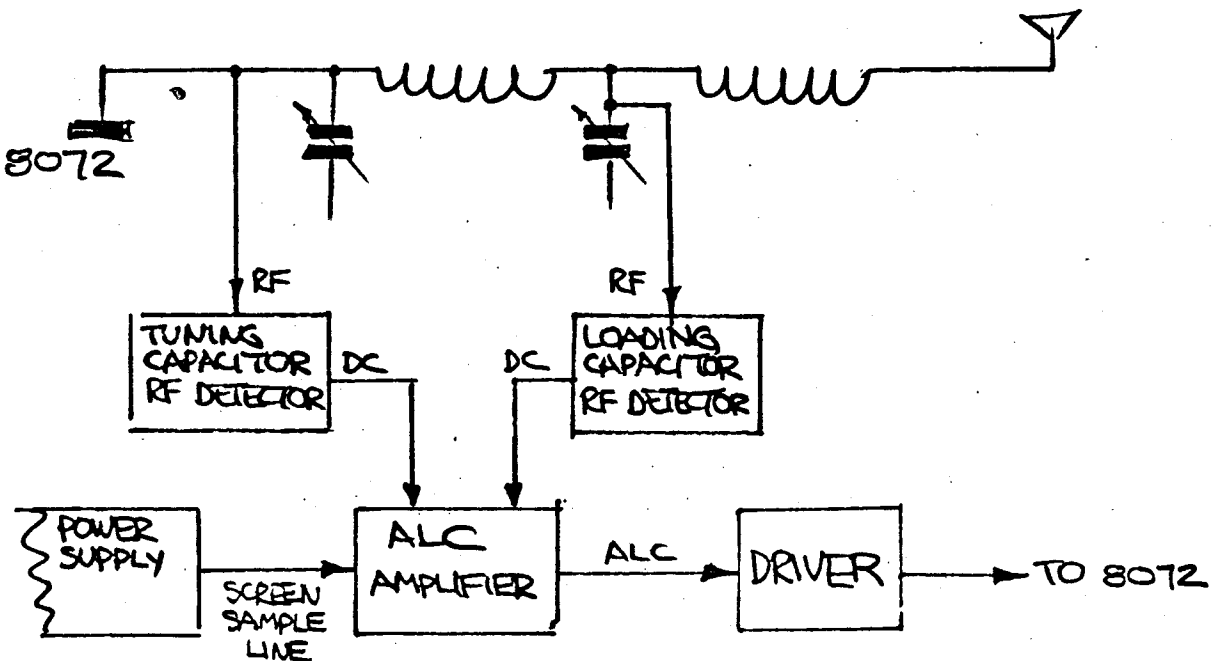
FIGURE 1

The original design includes a "screen ALC circuit" which, however, never functions, due to the currents and voltages involved. The amplifier corrects this situation by adding the necessary gain. The same amplifier is also used to enable the ALC circuits in the driver to control the RF levels in the PA, thus eliminating the arcing and component damage. The control signal for the screen current is provided by the power supply circuit in the original design. The control signals for the tuning and loading capacitor RF levels are provided by the added PA detectors. A block diagram of the entire system is shown in Figure 1.

ALC AMPLIFIER

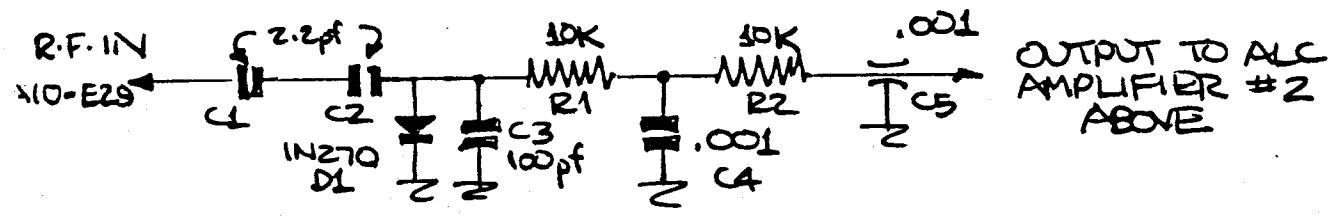
TUNING CAP R.F. DETECTOR

RF LEVEL DETECTORS. The circuits for the RF level detectors are shown in Figure 3 and 4. They are identical except for the RF voltage dividers. The dividers were chosen to provide approximately 3 volts at the amplifier trimmers, which requires about 10 volts at the detector diodes. Thus dividers providing 100 times and 30 times attenuation were chosen, corresponding to 1000 volts and 300 volts peak RF at the tuning and loading capacitors, respectively. These levels are merely nominal; the exact thresholds are set by the trimmers.

1. The ALC Amplifier (built on a small 2 x 1.3" PC board) is epoxyed to the RF driver PC board as described in the text.
2. The RF detectors are mounted on miniature terminal strips on the upper PA box as described in the text.

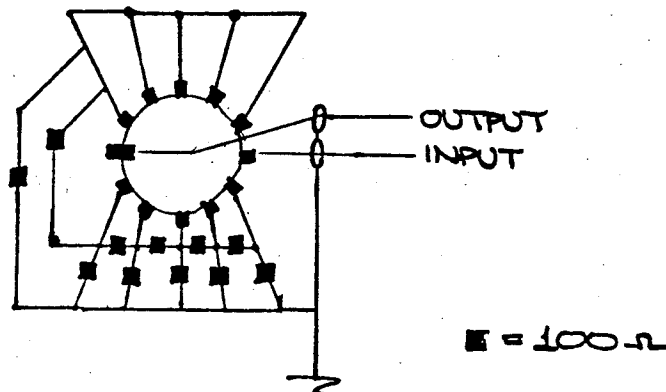
5. A receive attenuator may be constructed using a Mallory 3226J switch and 1/4-watt/100-ohm resistors in the following manner. This will give 10db steps up to 50db max. Install the switch in place of the FSK control. Use miniature coax for connections.

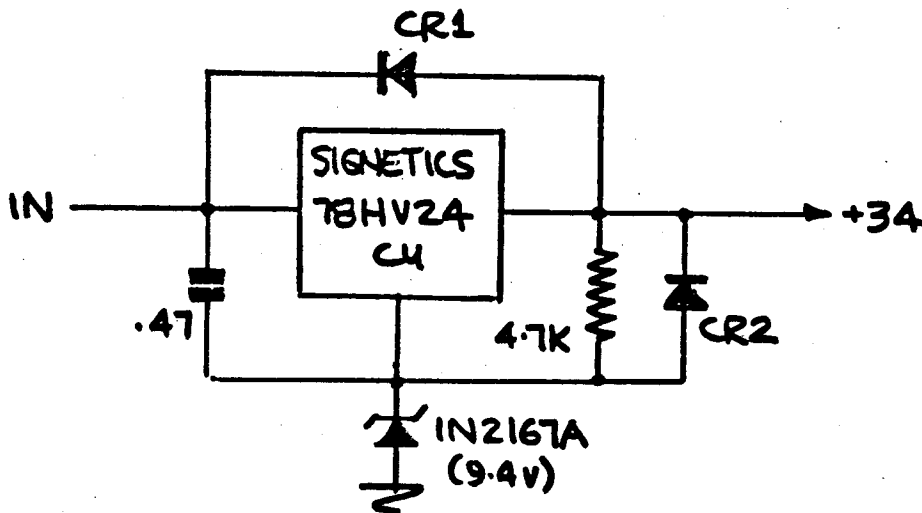
The following regulator circuit is from W2GRU and will provide the required +34 volts for the CX7 thereby eliminating additional discrete components on the power supply board. According to John, the Signetics 78HV24CU can withstand 60 volts across the input-output, unlike the LM-317, and will not short like the 317 may since it is only rated for 40 volts input-output. Be sure to include the diodes as shown. CR1 prevents any output capacitor discharge from going through the IC if the input falls faster than the output. CR2 prevents any high current discharges through the low current circuitry in case of an output short. Repeated output shorts will not damage this regulator. See schematic below:

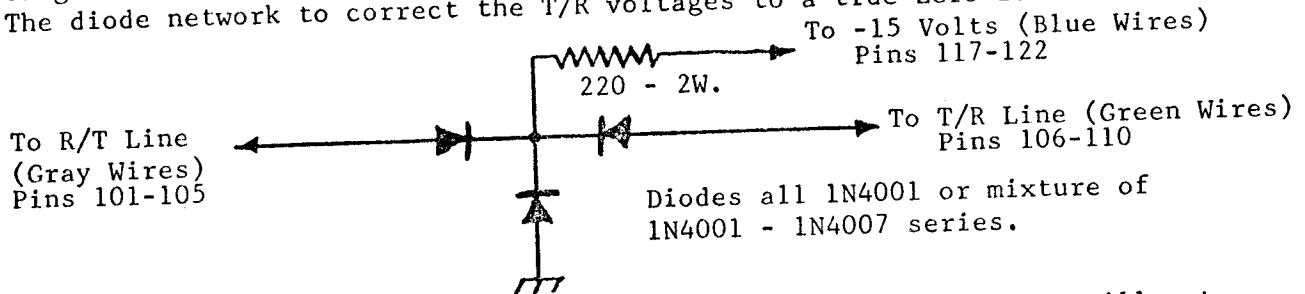
23. Circuit changes on the audio board A6 to change the T/R voltages: Install jumper wires in place of R65 & R66 (12 Ohm), and remove Q16 & Q17. In place of these two, install Motorola MPS UO5 transistors. Observe E, B, & C markings stamped on the new transistor pins and connect to the same points as the original 2N5183 types. See October, 1975 issue of S/I News if more info req'd.
24. The diode network to correct the T/R voltages to a true Zero is as follows:

25. The diodes should be matched by experimentation. Identical diodes will not work best. Start with an ohmmeter check for forward resistance. In general, a high voltage drop diode will work best to the Green Wires, a 1N4007 seems to be best. A medium drop diode is best at the one going to ground, a 1N4001 to 1N4004 is best. A low drop 1N4001 or TWO of them in parallel seems best for the one going to the Gray Wires. Start by metering the PTO switching terminal of one VFO with the 3 diodes in place and both the transmit and receive VFO on B or A. This grounds the PTO terminal. With a dummy load on the transmitter and output lowest setting, switch the receive channel to the other VFO, push the TUNE button, and again measure the VFO terminal for PTO switching.

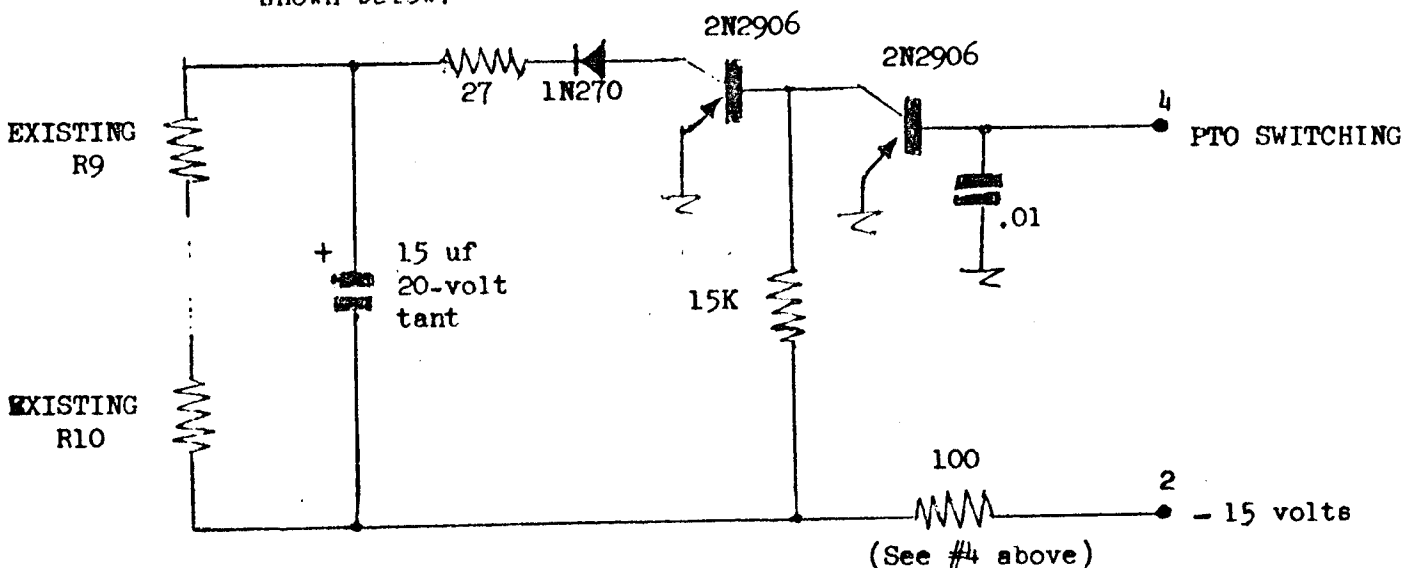
Here is some information concerning modifications to the PTO's (by K6BE/5). The changes reflect CX7B updates and modifications to reduce spurious emissions (especially on 80 meters)

1. R7 should be selected to provide 0.12 volt as measured with an RF probe.
2. Check for the proper type CR1 (especially on low serial number units). It should be a Hewlett-Packard HPA 5082-2800.
3. Change R2 to 150-ohms to reduce zener diode drain. This change was made in the CX7B's.
4. Add a 100-ohm resistor in the -15-volt line. This change was made in the CX7B's.
5. Filter the +15 and -15 volt lines to minimize spurious emissions at +100 KHz on 80-meters. Use a 2.2uf/35-volt and .1uf disc ceramic on each line. Observe polarity.
6. Install break timing circuit (A CX7B modification) and switching isolation circuit (a K6BE modification) inside the PTO's as shown below:

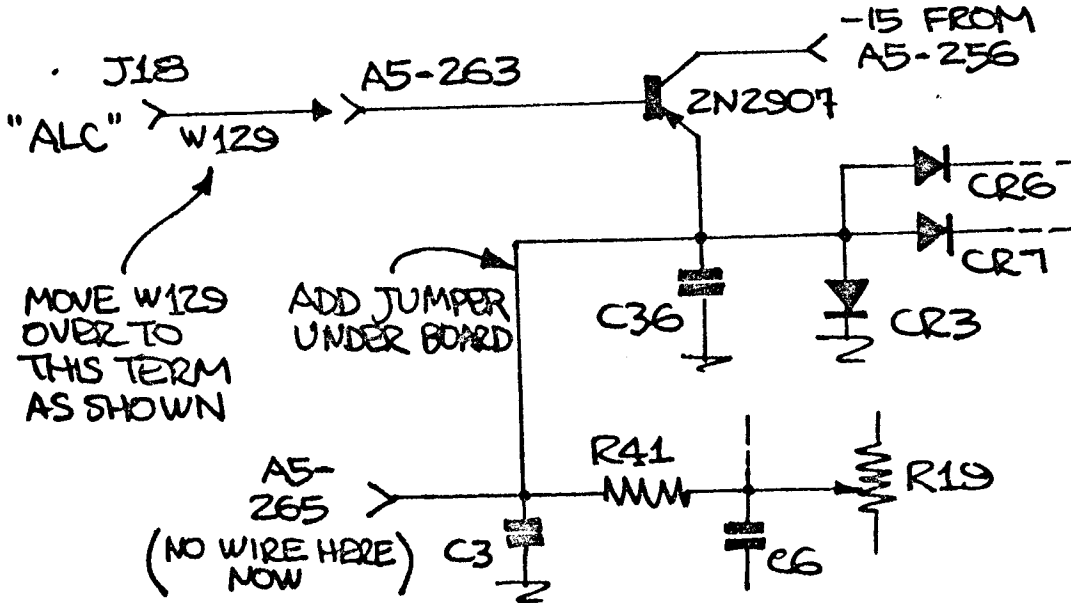
The following modification (by K6BE) will allow the use of ALC when the external amplifier ALC is a hi-Z circuit:

1. Clip out and discard W#127. Add a jumper as shown above
2. Remove CR2. (See S/1 NEWS, Volume III, Number 3)
3. Clear foil, drill #54, use Berg pins to mount Q8 as shown below

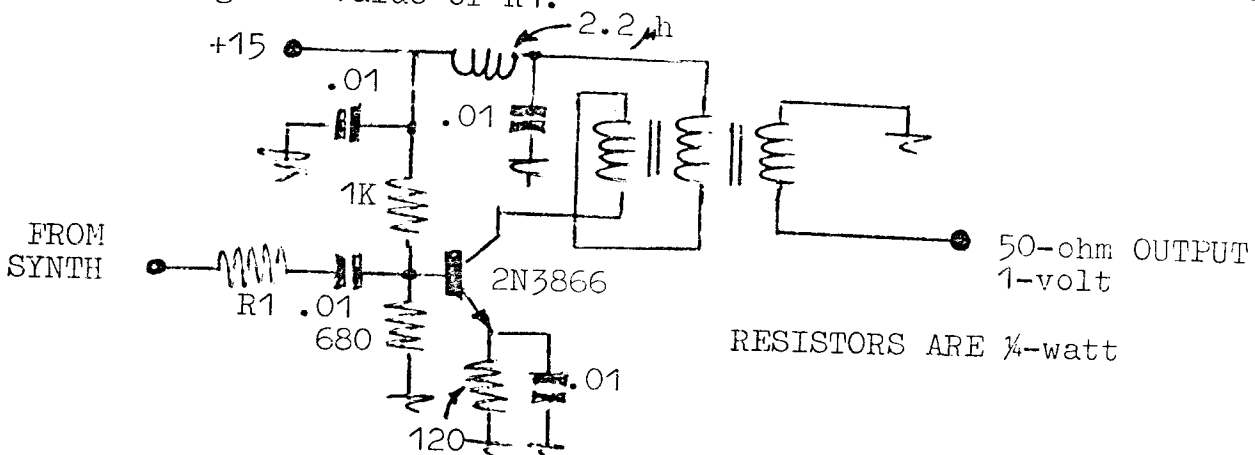
Harry's synthesizer requires a bit of amplification for best conversion gain. See circuit below for a solution. This will give 1-volt into 50-ohms. The output transformer consists of 12 tri-filar turns on a CF102-Q1 core. Each tri-filar conductor is three strands of #32, tightly twisted. Output is adjusted to 1-volt by selecting the value of R1.
