38Hot Volt-Nuts > Solartron 7081 Repairing (continue)

Solartron 7081 Repairing (continue)

2012-01-08

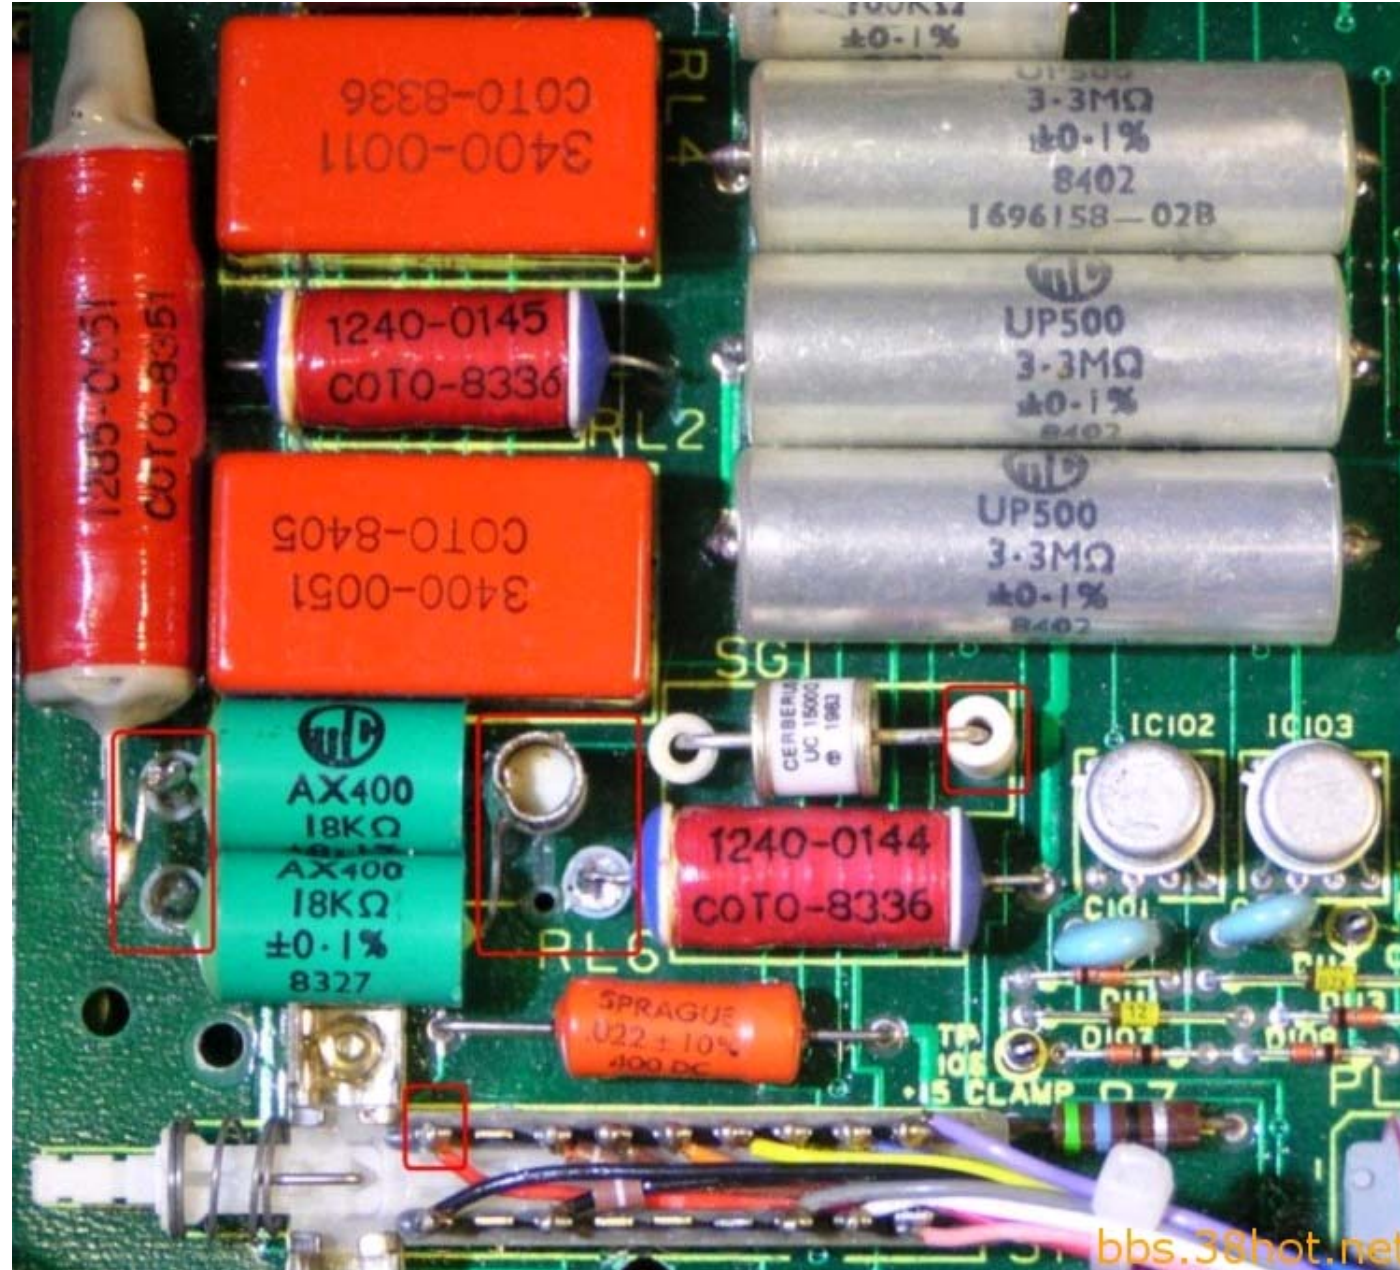
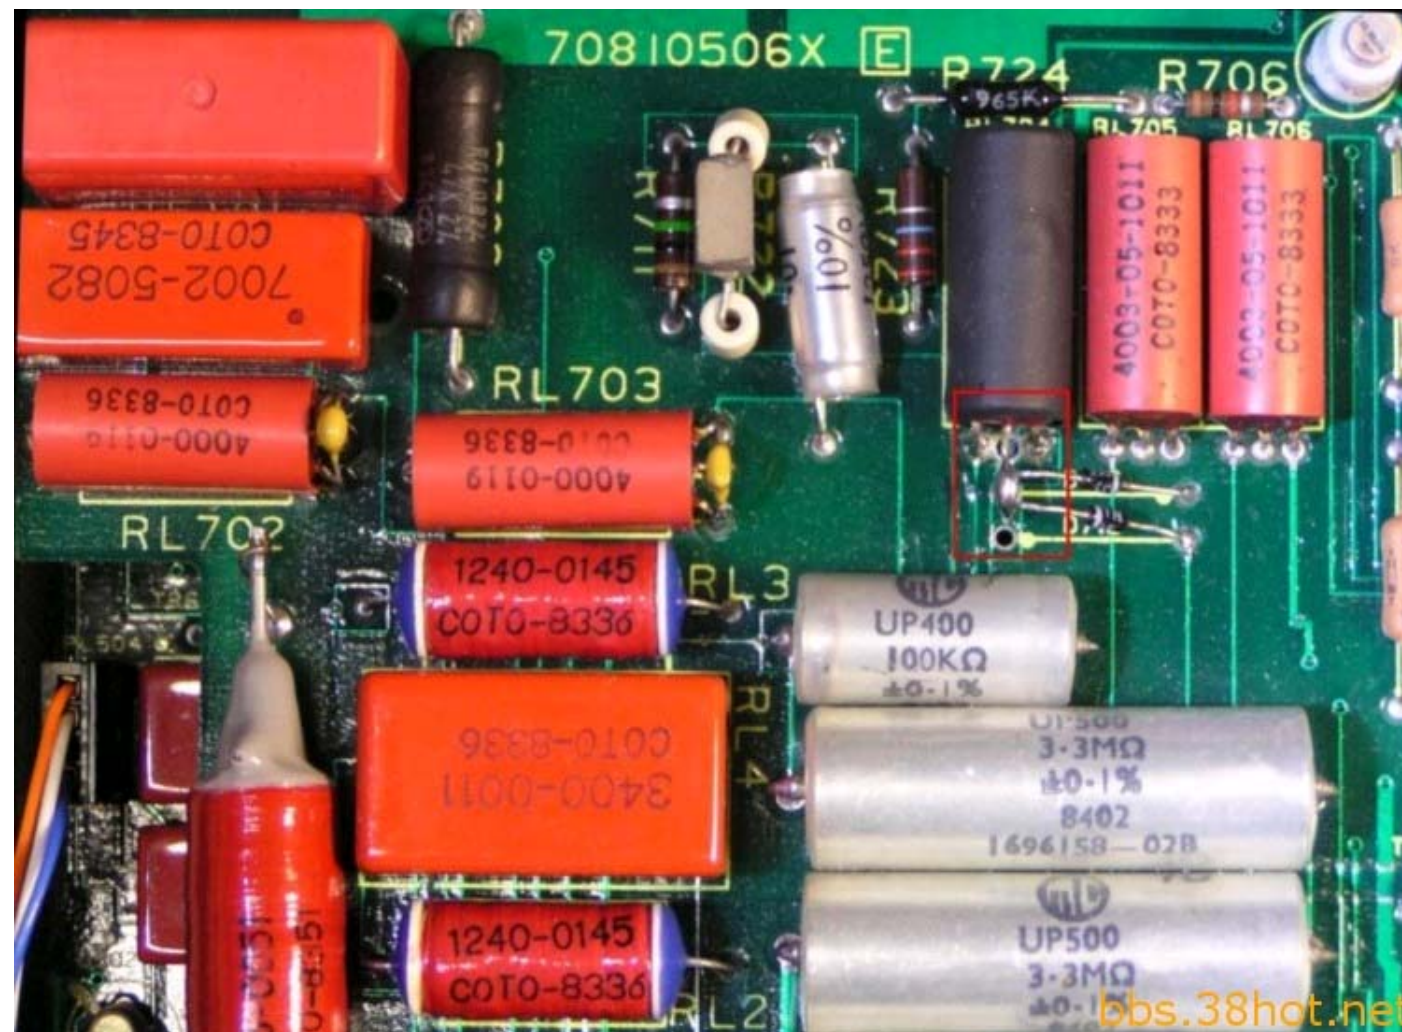
Three month ago I was purchase a Solartron 7081 DMM. It's one of the first model, dated Apr. 1984.
1) My tests showed a huge input bias current and suspiciously large noise. After 8 hours of heating at 25 Celsius degrees input current was 330 pA causing a zero shift in the short-circuited input – 12 uV. After checking each critical item in the input circuits (attenuator, DC ranging, input amplifier with MDM channel) and installing the PTFE bushings and insulators input bias has been reduced down to 1-2 pA!

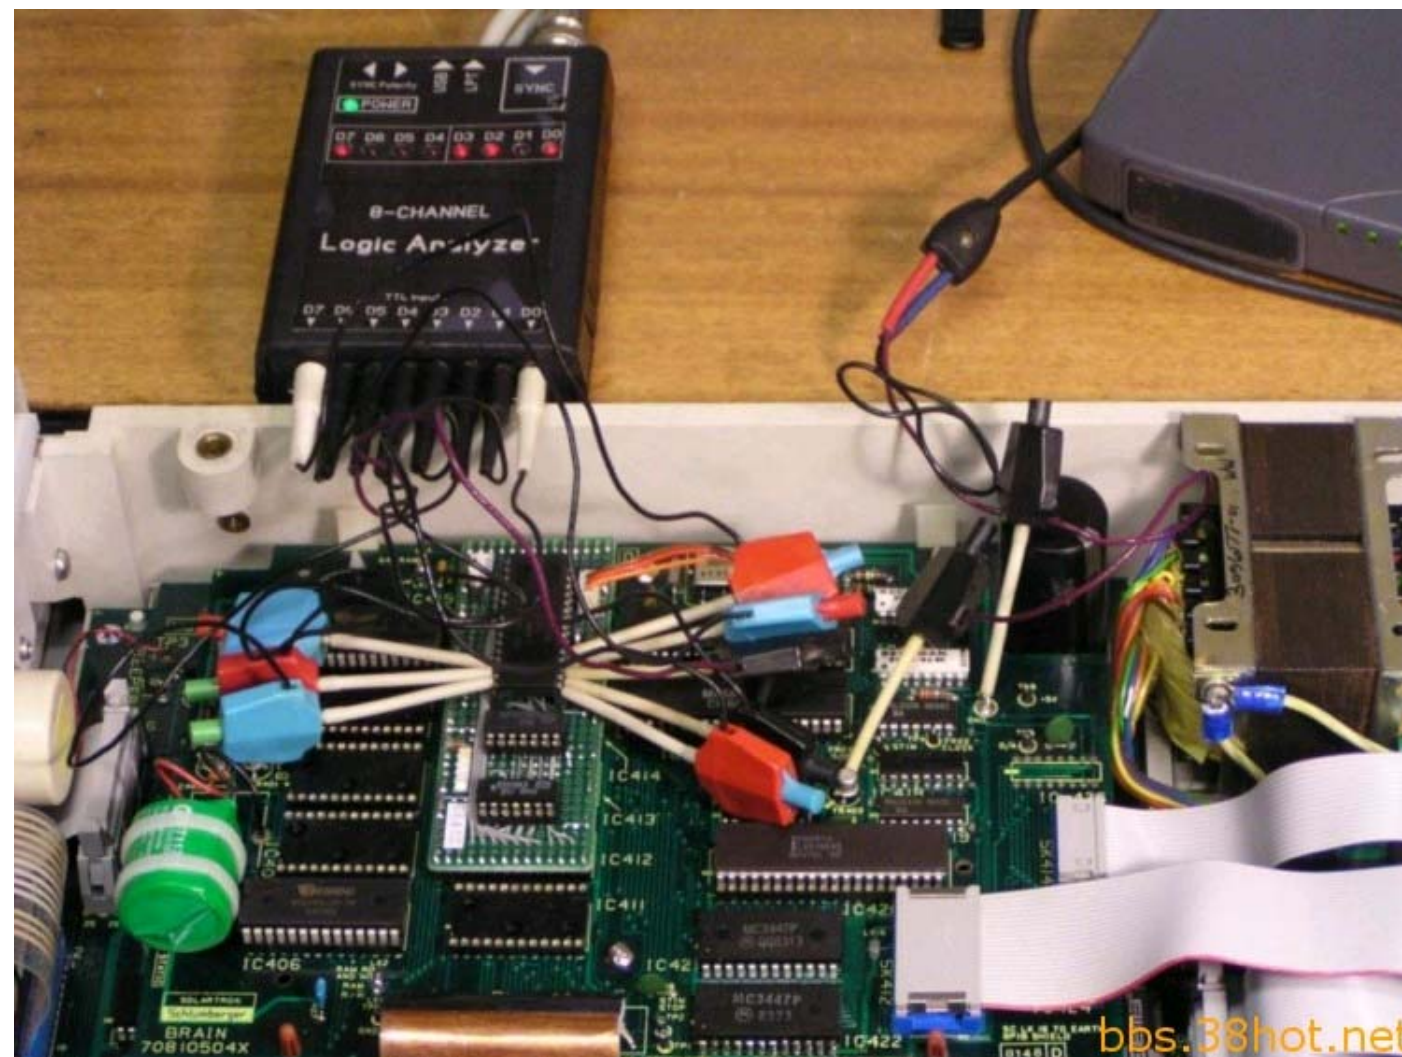
Earthy Logic I/O Map

First of all I tried to build a Solartron 7081 processors IO/Memory maps and reconstruct inter-boards messaging system protocol. Then, within two weeks, I reversed the Floating Logic processor's firmware and drew one of the two Finite-State Machines. After that I wrote a patch code using the free areas at the end of the ROM space.

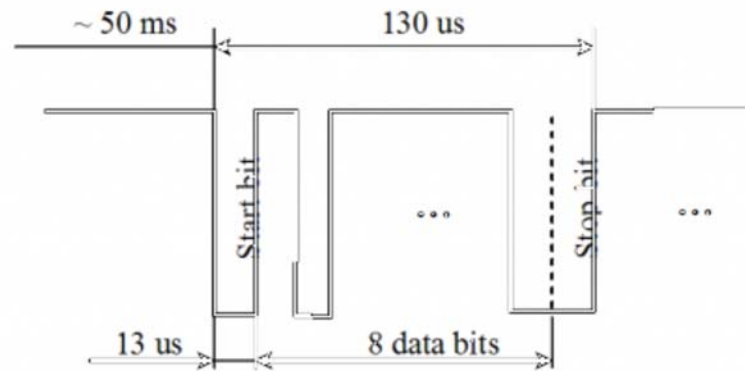
Table 1 – Single message structure

The basis of the Earthy and Floating Processors interface is a simple serial link and special messaging protocol. Serial link have a two selectable clocks: 76800 bauds for normal operation and 300 bauds for debug purposes.

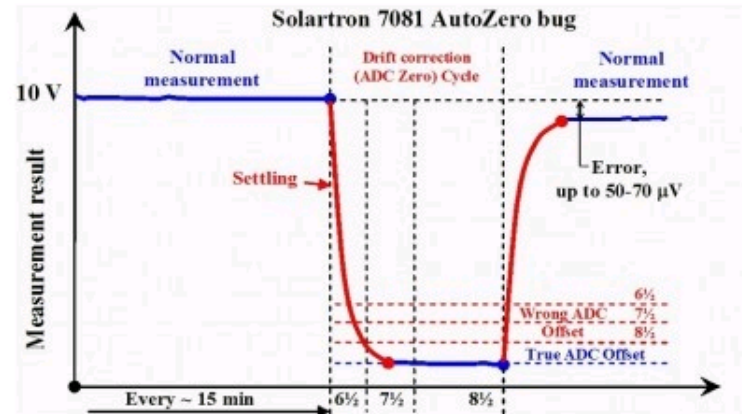
Now, the problem is solved:
