SONY® Service Bulletin

NO: CTV-98-001

SUBJECT: VERTICAL JITTER; R504 AND/OR R521 DAMAGED

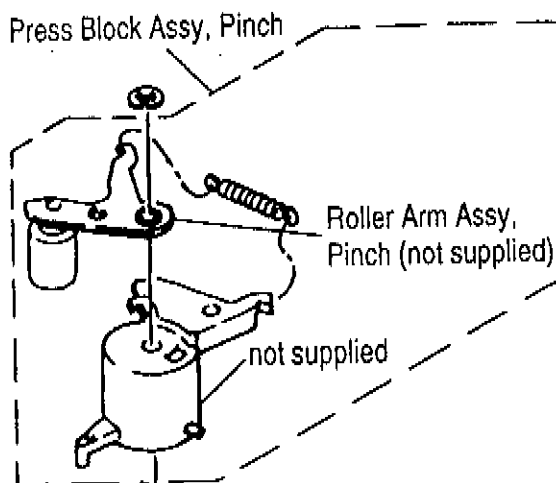
Contrary to the information given in some Service Manuals, the part "Roller Arm Assy, Pinch" is not available as a service part. It is only the part "Press Block Assy, Pinch" which is available as a service part.

MECHANISM	DESCRIPTION	PART NUMBER
H	Press Block Assy, Pinch	A-6746-072-A
S	Press Block Assy, Pinch	A-6759-615-A
