**Car Stereo
Service Bulletin**

Model: CDX-A20

No. 135

Subject: Improvement Of Signal To
Noise Ratio

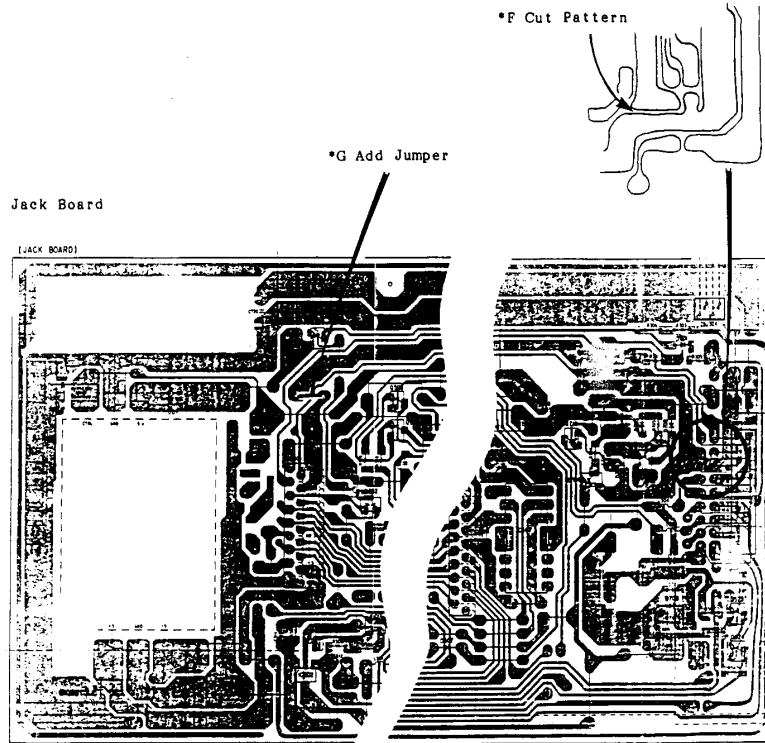
When between tracks (no sound) or quiet passages, servo noise may be heard.

Solution: Perform the following:

Ref. No.	Description		Part Number
	Former	New	
C302-305	100/6.3V	1/50V	1-121-912-00
