Car Stereo
Service Bulletin

Model: XR-U220/U330/U550/U660 **No.** 322

Subject: Loses Memory Presets; Clock Resets To 1:00 **Date:** May 13, 1994

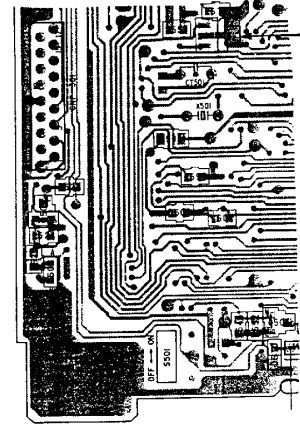
[MAIN BOARD] (CONDUCTOR SIDE)

Symptom:
(13) The memory presets are lost, and the clock resets to 1:00.

Solution: Replace reset IC101 on the Main board for the XR-U220 and XR-U330, or IC504 on the Main board for the XR-U550 and XR-U660.*
