Hi-Fi Products
Service Bulletin

Model: D-35

No. 149

Subject: Battery Pack BP-5 Cannot Be Fully Charged

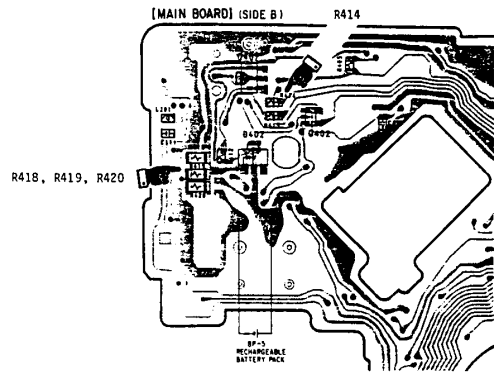
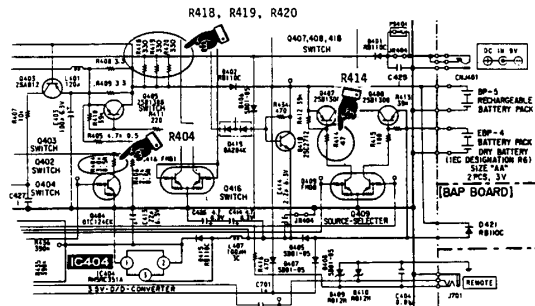
Symptom:
(22)

The repetitive charging and discharging of BP-5 causes insufficient charging ability.

Solution: If this symptom occurs, replace the following resistors:

Description			
Ref. No.	Former	New	Part Number
R418	330 Ohm	560 Ohm	1-216-192-00
R419	330 Ohm	560 Ohm	1-216-192-00
R420	330 Ohm	560 Ohm	1-216-192-00
R414	47 Ohm	150 Ohm	1-216-029-00
R404	3.0k Ohm	6.8k Ohm	1-216-671-11
