Hi-Fi Products  
Service Bulletin

Model: STR-AV910/1010

No. 150

Subject: Missing Adjustment Procedures For Amp Bias Current      Date: December 10, 1990

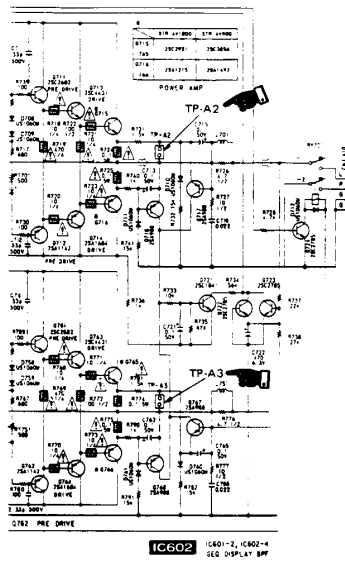
AMP SECTION

The adjustment procedures for the Amp Bias Current are not listed in the service manual.

- Connect the digital voltmeter to Bias Check Point ( L : L-CH, R : R-CH)
- Increase the AC power voltage gradually to 120 V confirming that the voltmeter will not indicate an abnormal value.

- Confirm that the display is normal.
- Adjust RT701 (L-ch) or RT751 (R-ch) so that the reading on the voltmeter becomes 0.1 mV within 30 seconds after the power turned on.
