Service Bulletin Multi-Disc Players

Model: DVP-S360, DVP-S560D, DVP-S570D, DVP-C660, No. 68R1 DVP-C670D

Subject: PLAYER MAY NOT PLAY CD/DVD OR VCD Date: February 4, 2002

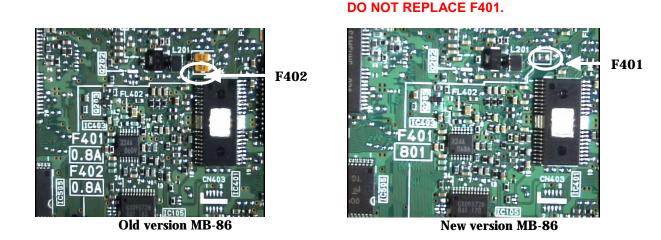
NOTE: There are currently 2 versions of MB-86 boards available. The newest version board is modified with F402 omitted from the board.

NO MODIFICATION IS REQUIRED.
