Computer Monitors Service Bulletin

Model: GDM20SE1, GDM17SE1

No. 89R1

Subject: Failure of Q511 on D Board due to CRT Arcing Date: August 8, 1995

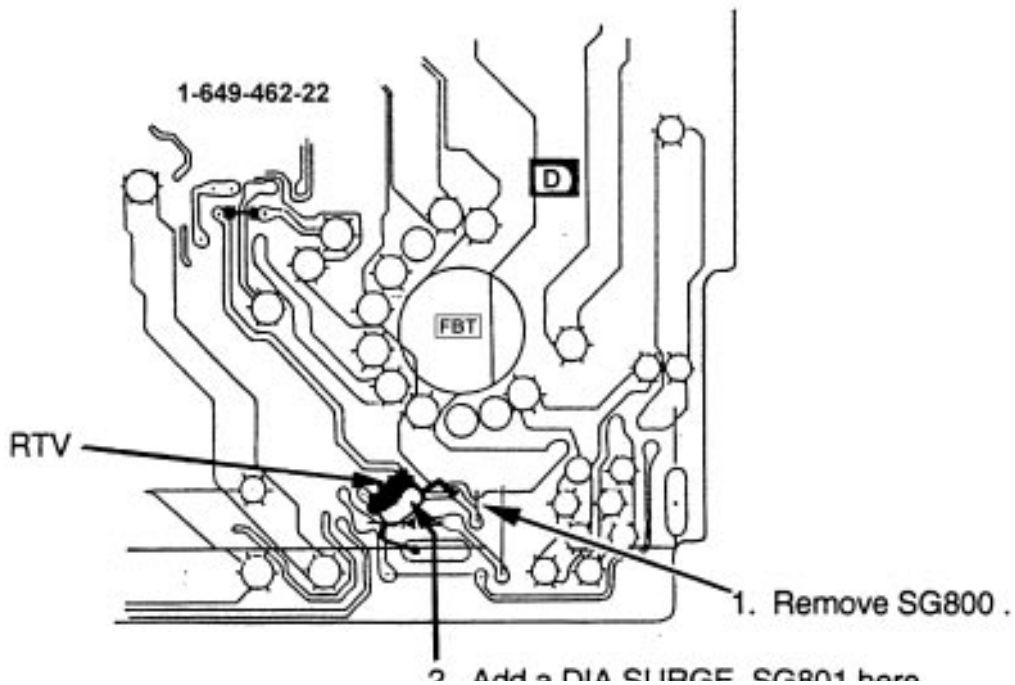
Schematic diagram changes.

Original Design: SG800 is connected to circuit ground.

For other foil patterns, perform modifications according to the schematic changes described as follows. cont.
