Video8

B-mechanism know-how

8 MECHANISM DECK

SONY®

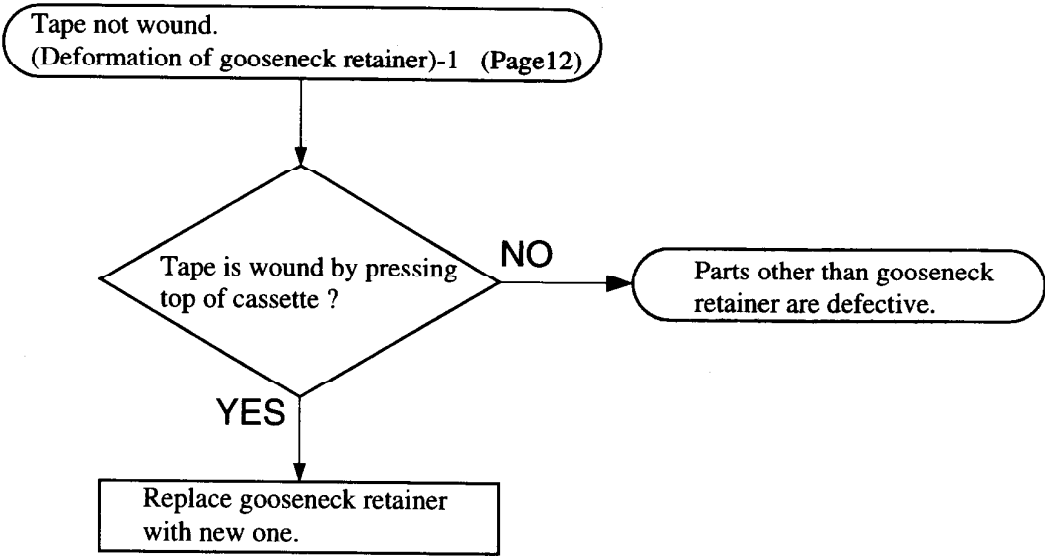
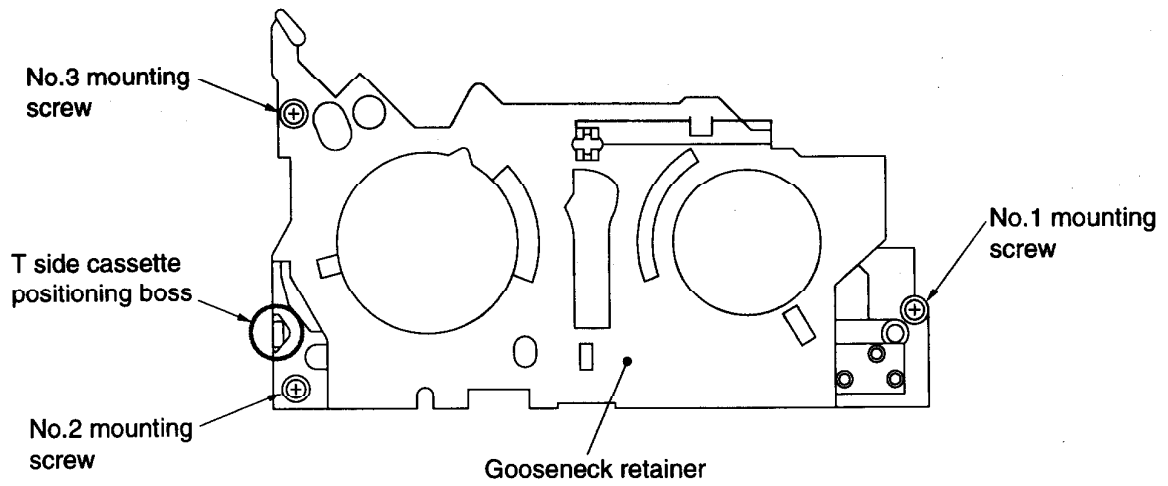
Gooseneck retainer is warped (center top) or deformed (inclination of T side cassette positioning boss (see diagram at page15)), so cassette is not set in place. Reel hub in cassette touches cassette shell and tape is not wound on reel.

Former parts		New parts
Part No.	3-965-584-01	➔	3-965-584-08
Shape of T side cassette positioning boss

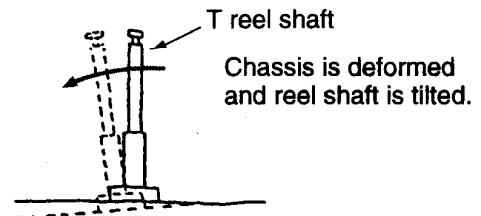
Reel hub touches the bottom of the case of video recording guide tape cassette, and tape cannot be wound due to failure of reel rotation.

1. Flatness of video recording guide tape cassette is NG.
2. The height of T reel is low due to deformation of chassis at cassette compartment DOWN with the spring force of cassette compartment, causing a fall of T reel shaft.

1. Change the verticality tolerance of T reel shaft.
2. Correct the flatness of video recording guide tape cassette.
3. Change the height of T reel (spacer can be used temporarily).

- Replace video recording guide tape cassette.
- Check T reel shaft for bending.

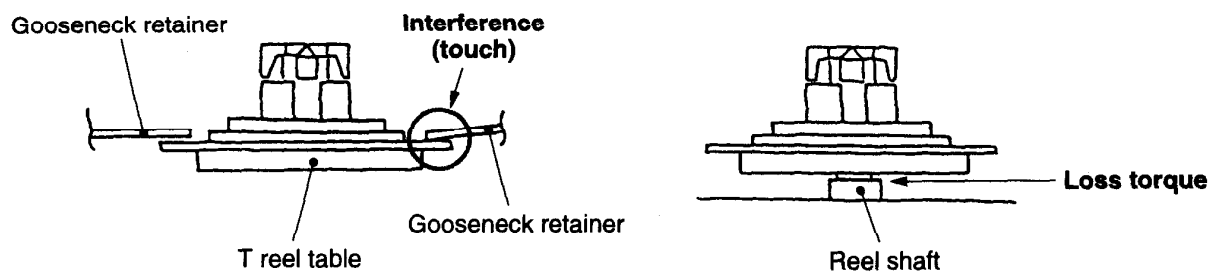
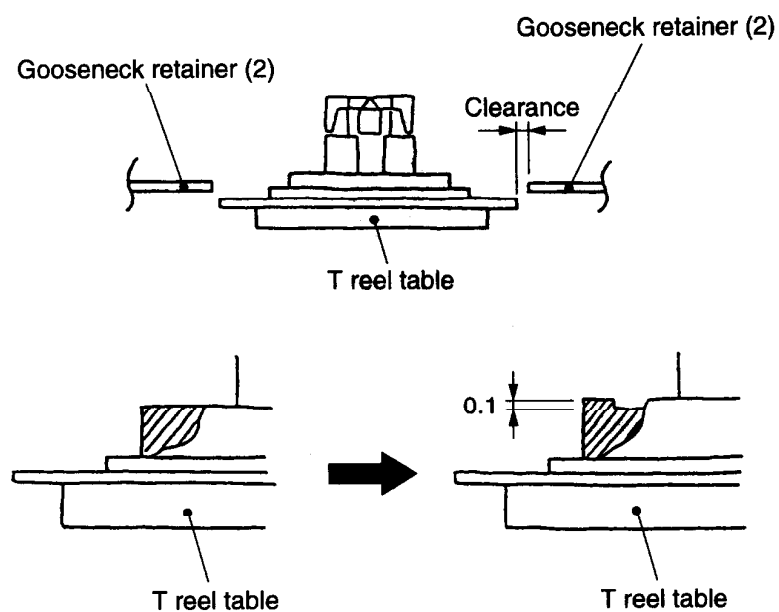
1. The outer surface of T reel touches gooseneck retainer due to deformation of gooseneck retainer (no clearance in the direction of height).
2. The margin of T reel height is insufficient (the height of reel table is low).
3. Loss torque between reel table and reel shaft is large, reducing FWD winding torque.

(Remedy)

1. Move T reel up and down and check that it is not loosened (gooseneck retainer touches T reel table), and change gooseneck retainer with gooseneck retainer (2).
2. When winding torque is small (less than 4g·cm), apply oil to T reel shaft.
3. If it is not corrected by 1 and 2, replace T reel table.
4. If it is not corrected by 1-4, replace LS chassis (reel shaft may be tilted).

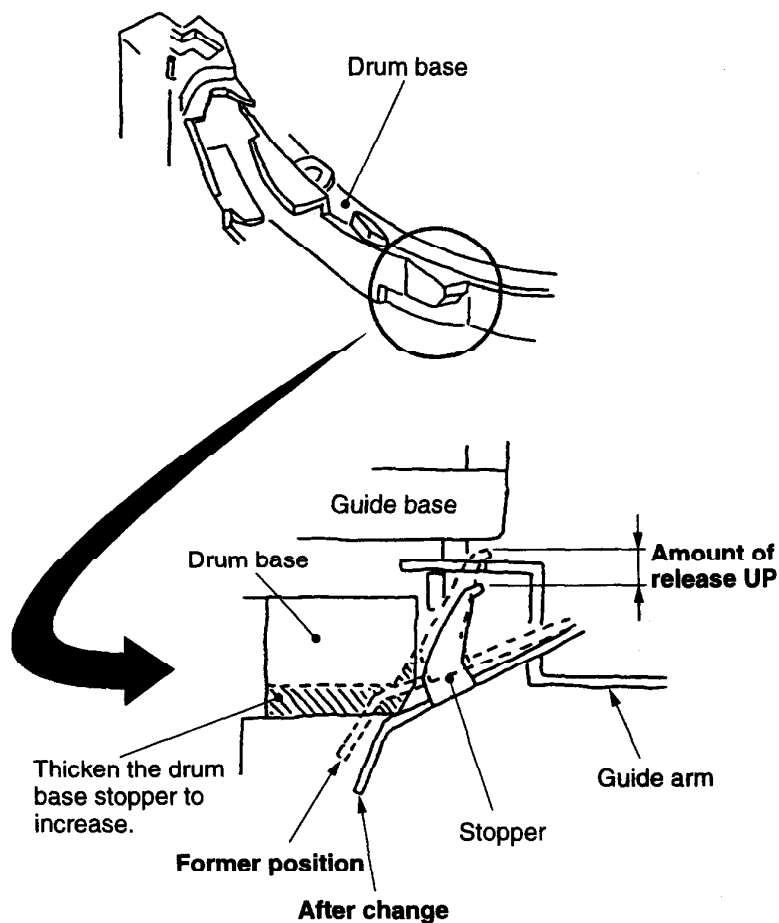
Stopper is not released at guide load, causing loading failure.

Thicken the drum base stopper to increase the amount of releasing the stopper.

Replace drum base ass'y.

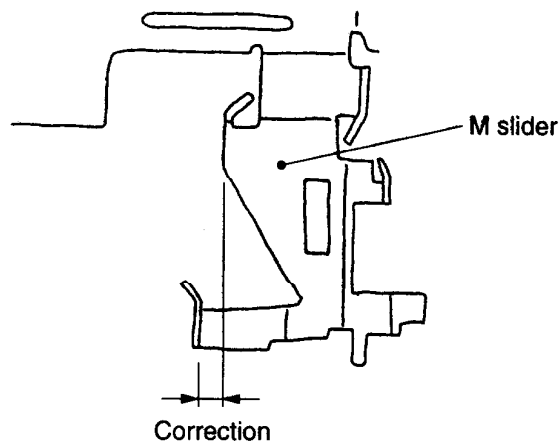
The shaft at tip of T soft claw is caught in the bent portion of M slider and damaged at the time of unloading. T soft brake is not working or is caught at loading/unloading.

Correct the width of bent portion of M slider.

Replace M slider ass'y.

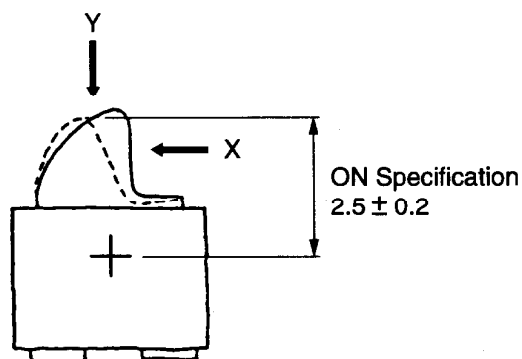
Insufficient margin of stroke at ON point of C-IN SW

1. SW ON point specification differs from standards of using MD.
2. Clearance between SW lever dowel and case hole is large, causing improper fit.

Replace SW with improved C.C. LOCK switch (1-572-680-11).

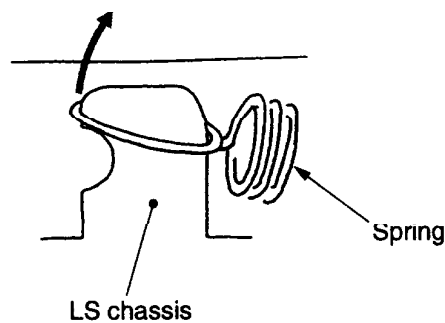
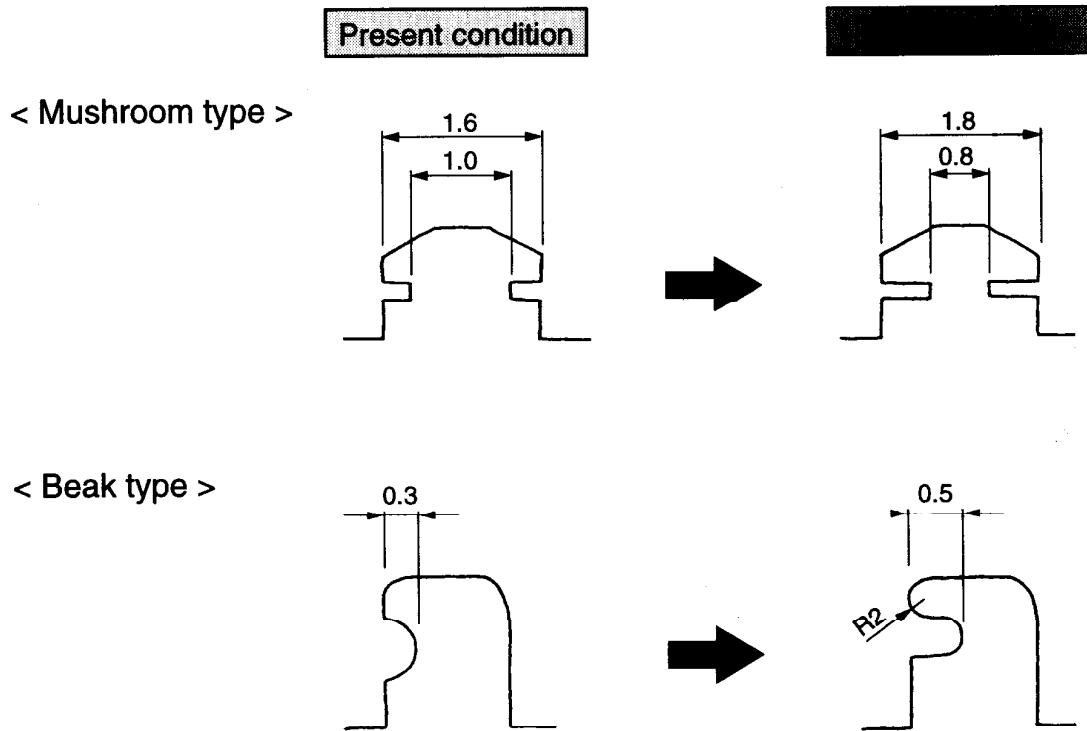
1. Spring is separated due to failure of hooking the spring claw (improper assembling).
2. Spring is easily separated by a touch of spring claw due to incorrect phase of spring hook or small overlap between LS chassis spring claw and spring hook.

1. Push spring hooks with jig and check (prevention of hooking failure).
2. Change the shape of spring claw to increase overlap between spring claw and spring hook, and margin UP against separation of spring.

- Mount the spring hook correctly to prevent separation (repair).
- Improved parts are available from our stock.

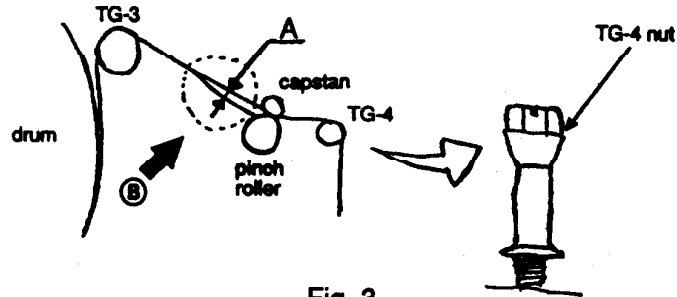
Fig. 3

Discrepancy in the TG-4 height adjustment leads to more deviation of the height of tape running between the capstan and TG-3 in the FWD and RVS directions. This results in tape warp causing tape wrinkle to be produced by the pinch rollers. (Fig. 2)

- ① Run tape (regardless of the tape type) . View the part indicated by the arrow ⑧ from above the MD and place a point of view so that the upper edge and the lower edge of tape are aligned with each other and look like a line ($A=0$) at CUE.

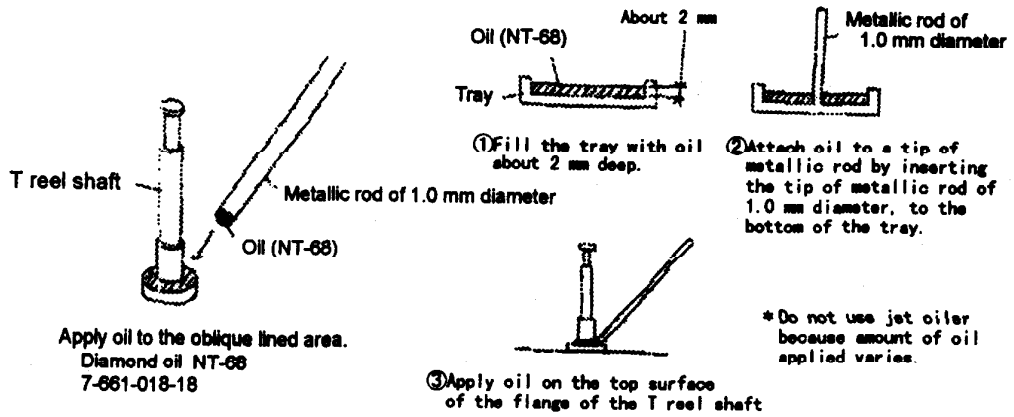
[Fig. 1 FWD torque is small]

If the FWD torque (measuring T side torque during playback) using torque cassette, is 5 g-cm or less, there is a possibility that the take up torque becomes insufficient due to the torque loss between reel shaft and reel table. Apply oil to the T reel shaft as shown in Fig. 1.

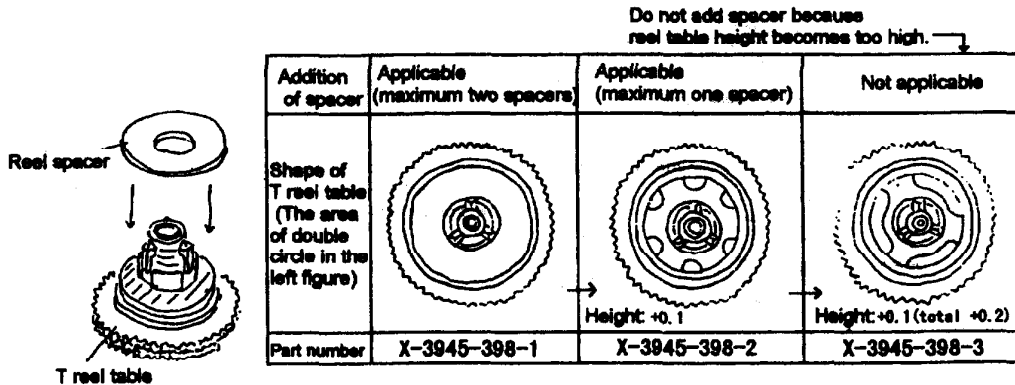
For the troubles on market that "reel does not wind tape", the remedial measures are issued by the technical news PV-985016. At present there are three different remedial measures are being introduced to market. The remedial measure for this trouble is unified to the method using the suffix -3 hereafter due to the part supply problem and for improvement of part reliability.

Supply of the parts having suffix -1 and -2 is stopped. Part having suffix -3 only is supplied.

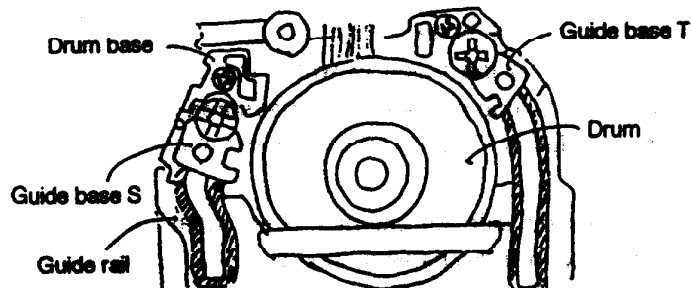
* Water drops may be visible at guide base supply/takeup sliding surface of drum base (the areas which are shown by slanted lines in the illustration). The water drops are oil contents which is oozed from grease.

(1) Clean guide rail and guide base supply/takeup sliding surface of drum base using alcohol.
