Tektronix 49x/275x-Series Spectrum Analyzer Service Notes

John Miles, KE5FX
jmiles@pop.net

March 29, 2009

Errata and helpful notes on calibration/service procedures

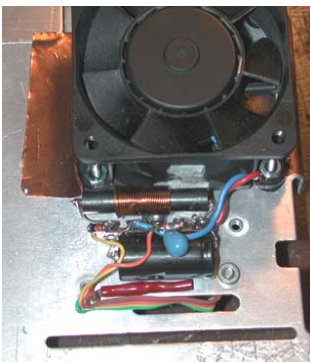
Symptom: Excessive phase noise

Check ESR on the two aluminum electrolytics on the YIG oscillator interface board. These capacitors are paralleled for low ESR, so one of them will need to be temporarily disconnected in order to measure them independently.
