Replace Aeroshield Support Tab, HV Battery 1.0/1.5

Classification	Repair Bulletin	Section/Group	16 - Battery System	Country/Region	All
Year	2012-2015	Model	Model S	Version	HV Battery 1.0/1.5

This Service Bulletin supersedes SB-15-16-002, dated 6-Nov-15. Each content change is marked by a vertical line in the left margin. Discard the previous version and replace it with this one.

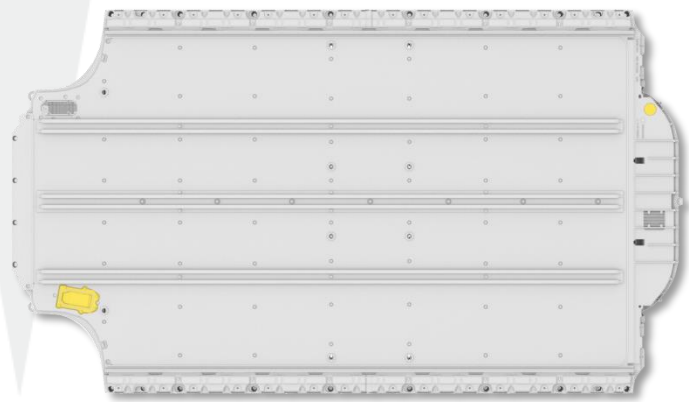
Figure 2 (Underside of HV Battery 2.0; fuse cover and discharge port highlighted)

NOTE: This procedure applies only to HV Battery 1.0 and 1.5 (Figure 1). Refer to SB-15-16-003 for HV Battery 2.0 (Figure 2).
