Tesla, Inc. Service Bulletin		<i>Inspect Charge Port Busbar Safety Cap And Protective Earth Busbar</i>	
SB-20-44-002 July 24, 2020			
Classification		Section/Group	Mobile Service
Campaign Bulletin		44 - High Voltage System	Can Perform (where permitted)
Model Year	Model	Country/Region	Version
2020	Model Y	North America	All
<small>The model(s) and model year(s) listed are a general approximation of the affected VIN list. Refer to the VIN/Bulletin Tracker or Customer/Vehicle profile to determine applicability of this bulletin for a particular vehicle.</small>

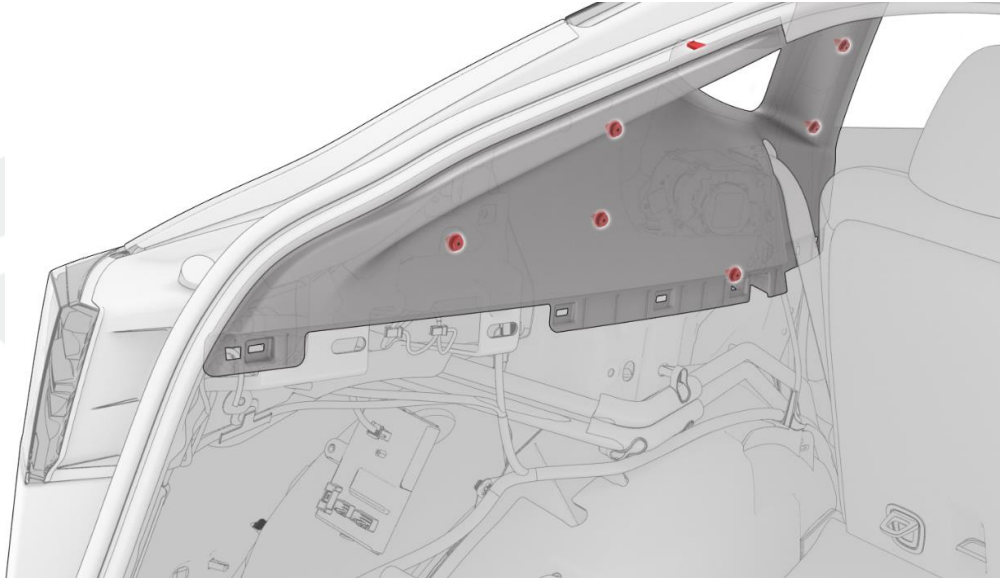
Figure 1

1. Remove the LH trunk side trim (refer to Service Manual procedure [15245002](#)).
2. Release the clips (x6) and tab (x1) that attach the LH upper C-Pillar trim to the vehicle (Figure 1), and then set the trim aside.

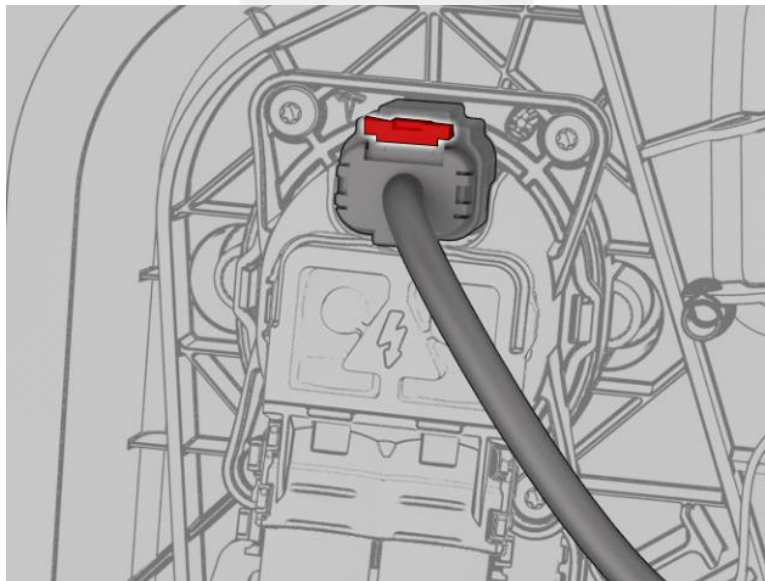
Figure 6

11. If not already performed, disconnect 12V power (refer to Service Manual procedure [17010200](#)).
12. If not already performed, perform the charge port voltage check (refer to Service Manual procedure [44012100](#)).
13. If not already disconnected, release the locking tab from the charge port low voltage connector, and then disconnect the connector from the charge port (Figure 6).

⚠ CAUTION: DO NOT push down on the red locking tab. Pull the tab away from the connector until the connector is unlocked, and then continue pulling to release the connector.
