TN-18-16-001 R2 December 15, 2021

Tesla, Inc. Technical Note
<b>Model:</b>	<b>Vehicle System:</b>	<b>Region:</b>
Model 3 Model Y	16 - Battery System	All

## Inspect the Model 3 and Model Y HV Battery for Underside Damage

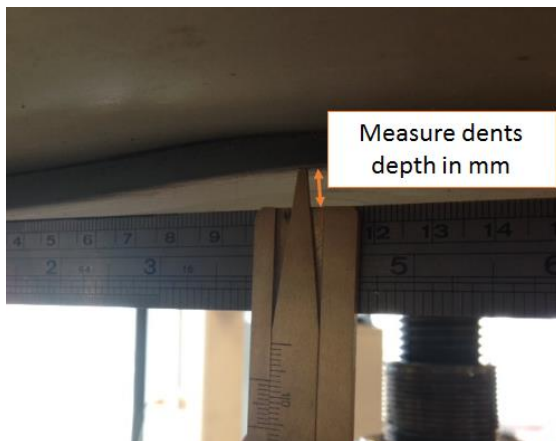
**Figure 7 – Measuring the depth of enclosure damage**

3. Collect the following information and upload it to the session:
  - a. Several pictures of the damage, taken with a high-resolution camera: If there isn't a visible open hole, crack, or tear, measure the depth of the HV battery enclosure damage (Figure 7) **while wearing proper PPE**. If the damage is not obvious, take an overall picture of the HV battery, with pointers to the damaged area or areas.

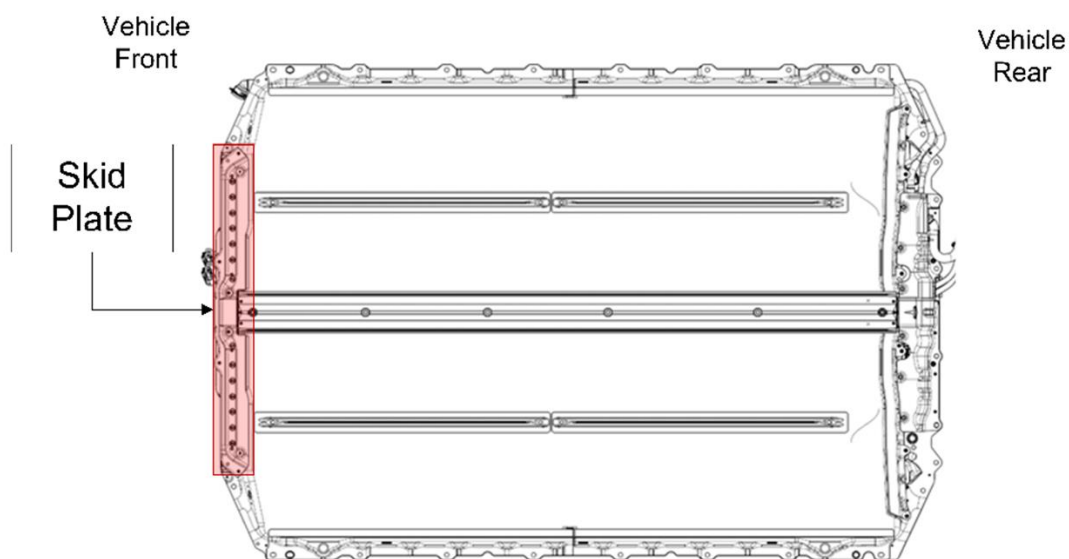
**Figure 8 – Front skid plate location**

The front skid plate is located at the front of the HV battery, as shown in Figure 8:

1. Visually inspect the front skid plate for tears, dents, or breaches (Figure 9).

**NOTE:** Replace the front skid plate if it does not cover front baseplate or its leading edge is dented, torn, or breached.

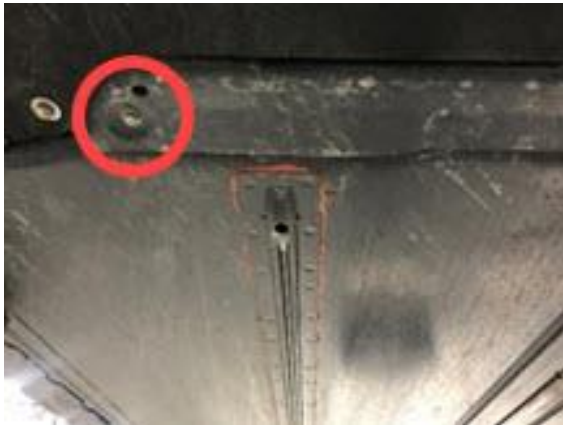
Figure 11 – Skid plate to doubler fastener

**NOTE:** The bolt that threads into the doubler is circled in Figure 11 and Figure 12. There is another bolt symmetrically on the other side of the vehicle. These bolts are prone to shearing in the event of front skid plate damage (Figure 12).

- Recommend replacement of the fastener if a fastener attaching the front skid plate to the doubler is damaged or stripped.
- Re-tap the fastener hole if a fastener hole is damaged and the fastener cannot withstand full torque.
- Recommend the replacement of the front skid plate if the front skid plate, or part of the skid plate, is detached, or not covering the baseplate.
- Recommend the replacement of the HV cables if the HV cables are damaged above the front skid plate.
- Recommend HV battery replacement if:
  - A passthrough is damaged above the front skid plate.
  - The HV battery enclosure fails leak test due to impact.
  - The HV battery enclosure has low isolation due to impact.

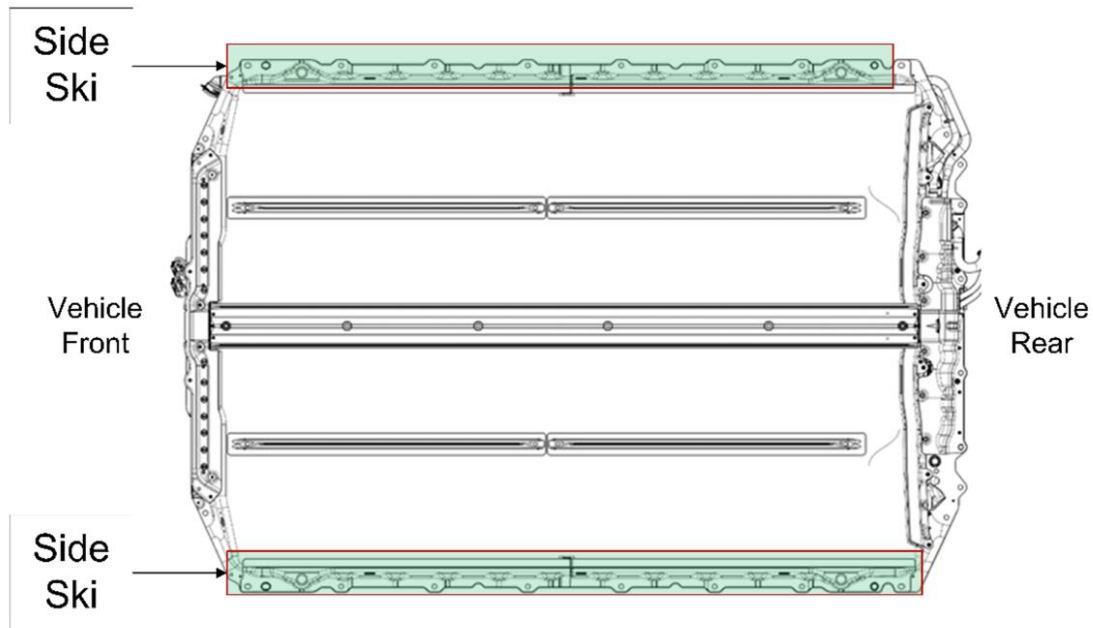
Figure 13 – Side Skis

There are two side skis on each side of the HV battery (Figure 13). For each side ski, there is a “Side Ski Zone,” which extends 5 inches (127 mm) inward from the edge of the HV battery.

- Recommend HV battery replacement if:
  - The ski, or part of the ski, is detached from the HV battery.
  - A jack point has extensive damage where it cannot be used to safely lift the vehicle.
  - The HV battery enclosure fails leak test due to impact.
  - The HV battery enclosure has low isolation due to impact.
- Recommend the replacement of the fastener if a fastener attaching the HV battery to the vehicle is damaged or stripped.
- Re-tap the fastener hole if a fastener hole is damaged and the fastener cannot withstand full torque.
- Deburr the area with a hand deburring tool to remove the sharp edges if sharp edges are found (Figure 14).

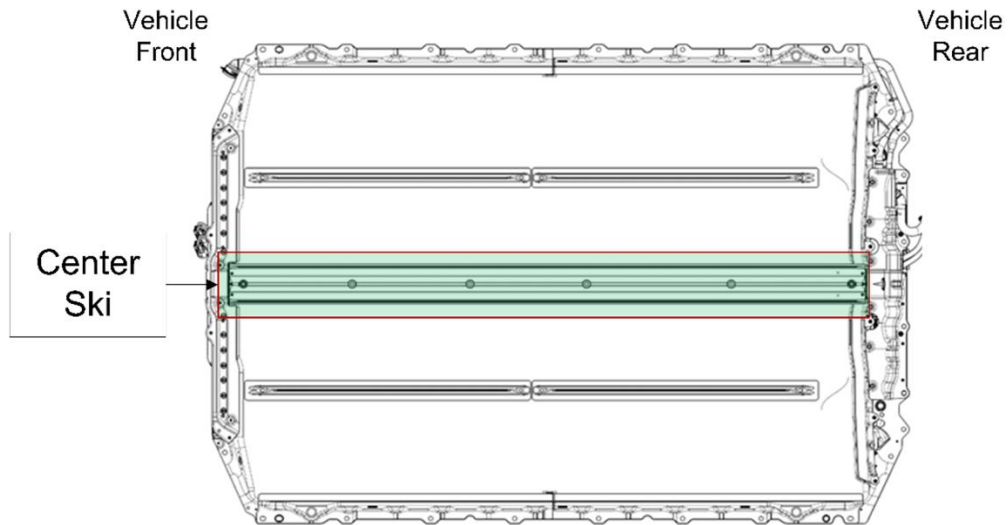
**Figure 15 – Center ski**

The center ski is in the middle of the HV battery (Figure 15).

- Recommend the replacement of the center ski if the center ski, or part of the ski, is detached from the HV battery.
- Recommend the replacement of the HV cables if the HV cables are damaged.
- Recommend the replacement of the fastener if a fastener attaching the center ski to the HV battery enclosure is damaged or stripped.
- Re-tap the fastener hole if a fastener hole is damaged and the fastener cannot withstand full torque.
- Recommend HV battery replacement if:
  - The HV battery enclosure fails leak test due to impact.
  - The HV battery enclosure has low isolation due to impact.

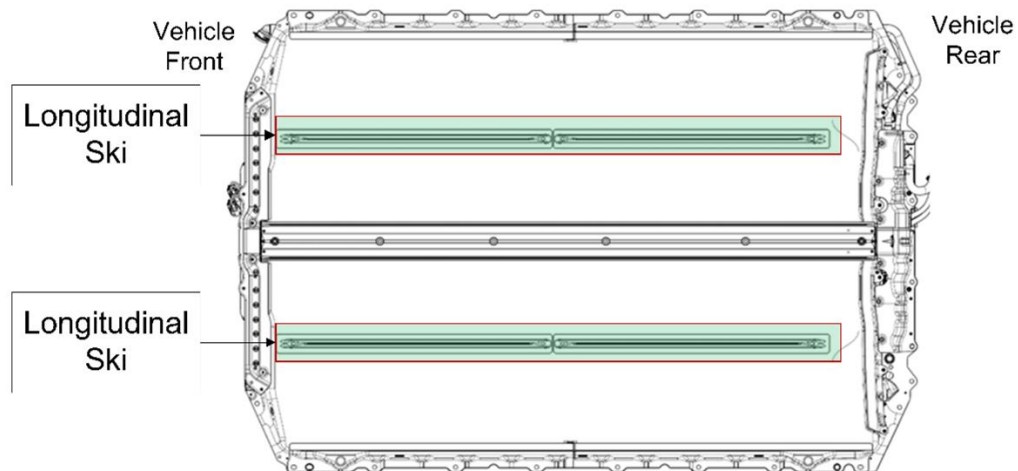
Figure 18 – Longitudinal skis

Longitudinal skis are located between the center ski and the side skis (Figures 18 and 19).

- Deburr the area with a hand deburring tool to remove the sharp edges if sharp edges are found.
- Recommend the replacement of the longitudinal ski if the longitudinal ski is detached.
- Recommend the replacement of the fastener if a fastener attaching the longitudinal ski to the HV battery enclosure is damaged or stripped.
- Re-tap the fastener hole if a fastener hole is damaged and the fastener cannot withstand full torque.
- Recommend HV battery replacement if:
  - The HV battery enclosure fails leak test due to impact.
  - The HV battery enclosure has low isolation due to impact.

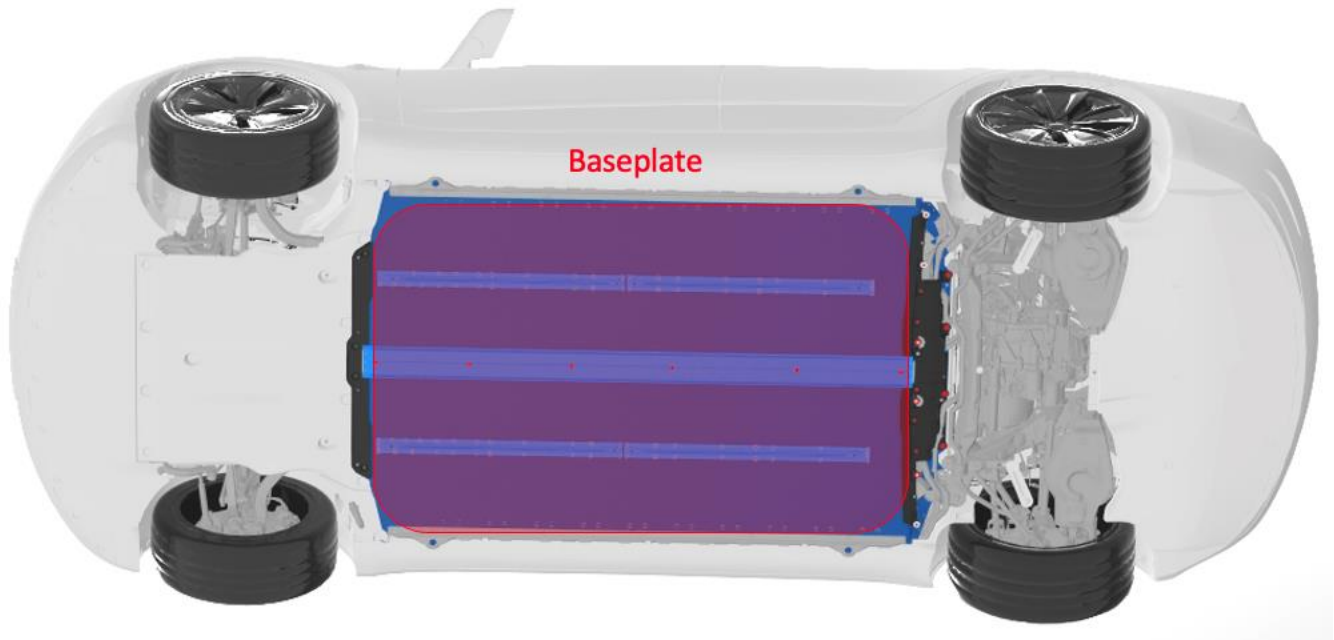
Figure 20 – Baseplate

The baseplate, shown in Figure 20, covers the underside of the HV battery, and serves as a base for the center and longitudinal skis.

The baseplate starts at the front edge of the HV battery, immediately to the rear of the front skid plate, and extends to the rear edge of the HV battery. When the baseplate is damaged, follow the steps below:

- Deburr the area with a hand deburring tool to remove the sharp edges if sharp edges are found.
- Recommend HV battery replacement if:
  - A dent is **8 mm** or more in depth (Figures 21 and 22).
  - If the HV battery enclosure fails leak down test due to impact.
  - If the HV battery enclosure has low isolation due to impact.

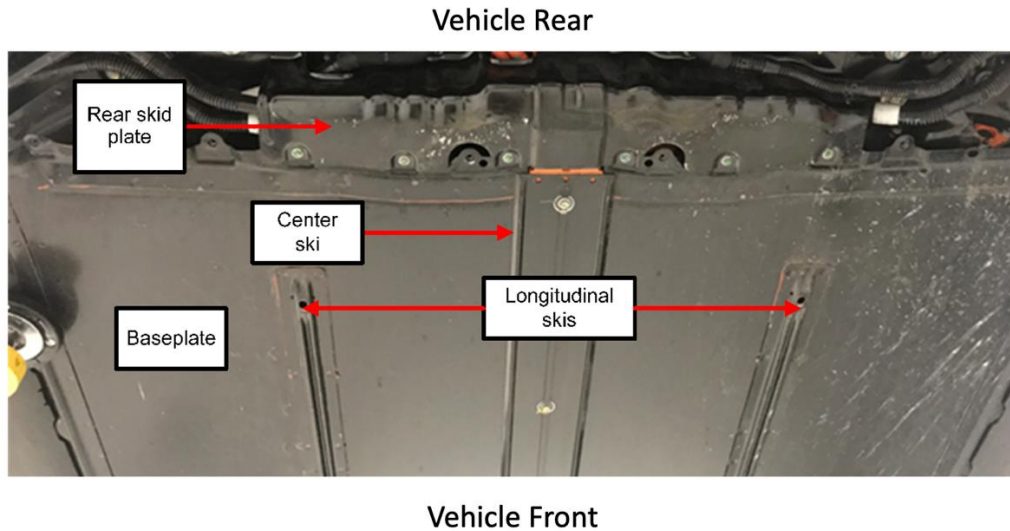
**Figure 24 – Skid plate location**

1. Visually inspect the rear skid plate for tears, dents, or breaches (Figure 24).

- Recommend the replacement of the rear skid plate if the rear skid plate is detached or does not cover the rear baseplate when secured and torqued correctly.
- Recommend the replacement of the HV cables if the HV cables are damaged.
- Recommend the replacement of the fastener if a fastener attaching the longitudinal ski to the HV battery enclosure is damaged or stripped.
- Re-tap the fastener hole if a fastener hole is damaged and the fastener cannot withstand full torque.
- Deburr the area with a hand deburring tool to remove the sharp edges if sharp edges are found.
- Recommend HV battery replacement if:
  - A passthrough is damaged.
  - The HV battery enclosure fails leak test due to impact.
  - The HV battery enclosure has low isolation due to impact.

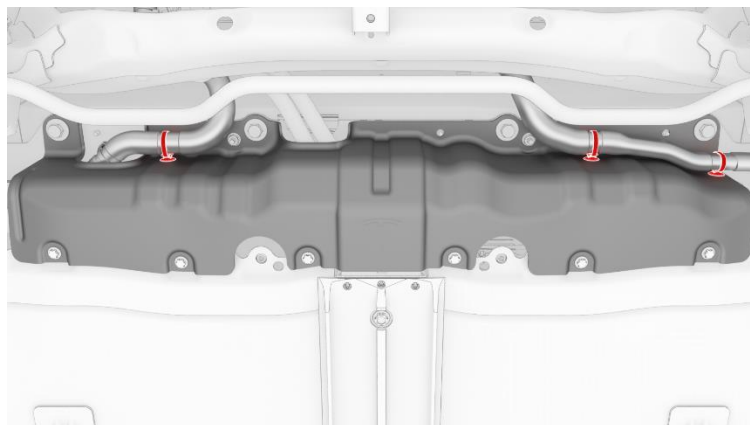
**Figure 25 –Skid plate**

2. Remove the rear skid plate (Figure 25) (refer to Service Manual procedure 16102202).

3. Inspect the HV cables and passthroughs and replace any compromised components.
4. Remove and assess damage to components such as HV cables, baseplate, fasteners, etc.
