2002	Toshiba America Consumer Products, Inc.	Date: 01/29/2002
Product	Technical Bulletin	TV0201
PJTV		Ref. No. 012902

2002	Toshiba America Consumer Products, Inc.	Date: 01/29/02
Product	Technical Bulletin	TV0202
PJTV		Ref. No. 012902

TECHNICAL BULLETIN

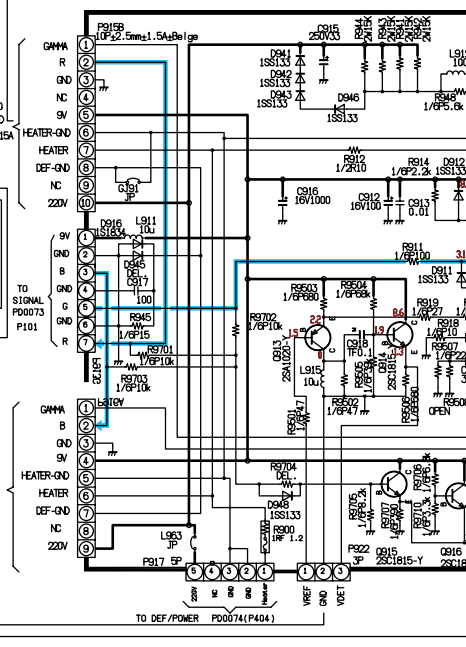
CRT-D/G

1. **HDX82 series:** Loss of red in video.
2. **HDX82 series:** Part number not included in Service Manual Replacement Parts list.
3. **H82 series:** The H82 series CRT drive boards differ from those shown in the schematic diagrams. Q9170 is not used in the series.

1. **HDX82 series:** Replace defective Q9170 on red CRT drive board. Type 2SA1015Y; Toshiba PN BZ510034.
2. **HDX82 series:** Update the appropriate Service Manual(s) Replacement Parts list to include the correct part number.
3. **H82 series:** Update the appropriate Service Manual to include the correct CRT drive board schematic diagram. The correct diagram is included as Pages 2 and 3 of this Technical Bulletin.
