J. AIRCRAFT

## Biotechnology Problems Relative to the Space Shuttle Vehicle

RICHARD CARPENTER\*

*NASA Flight Research Center, Edwards, Calif.*

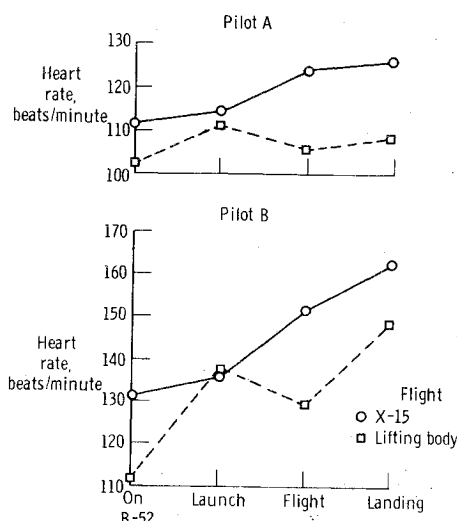
Fig. 1 Average heart rates for X-15 and lifting body flights.

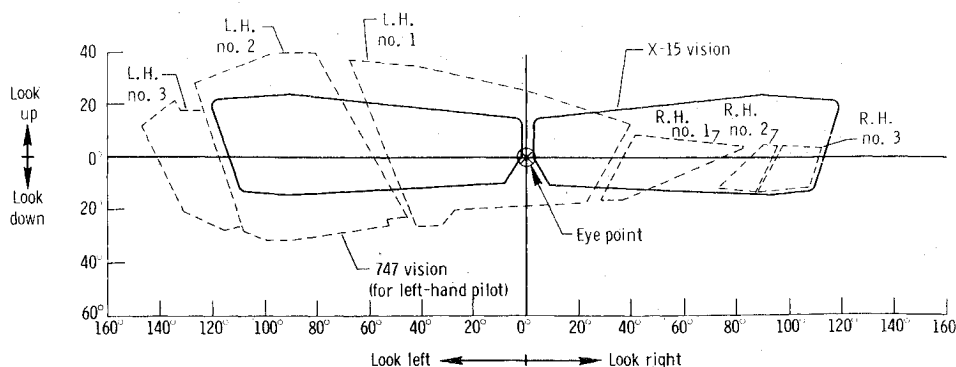
One design consideration affecting the landing task is the effectiveness of the visibility envelope in allowing the pilot to land the vehicle safely. The visibility envelope depends on the window surface area and eye position. In general, much smaller window areas are required for a single-place cockpit than for a cockpit with a side-by-side arrangement. In this regard, the right viewing angle available to a left-seated pilot during the approach and landing is considerably restricted compared with the visibility available to a pilot in a single-place cockpit. For example, the horizontal and vertical visual angles available from the X-15 airplane and the Boeing 747 airplane are compared in Fig. 2. As shown, the right viewing angle is restricted for the 747 pilot, whereas the X-15 pilot has equally good visibility to the right and left. The ratio of visible envelope areas between the 747 and the X-15 airplanes is 1.36, whereas the window surface ratio is 9.2. That is, the left-seated 747 pilot has only 36% more visibility (primarily to the left) than the X-15 pilot at the expense of nine times the window surface area.

Fig. 2 Comparison of X-15 and 747 visibility envelopes.

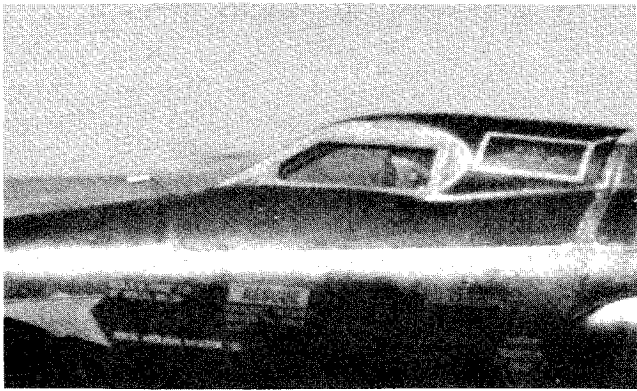
An incident that occurred in the X-15 program relates specifically to the advantages of having equally good left and right vision. During one flight, the right window became completely opaque as a result of windshield glass failure during re-entry. The pilot's comments during debriefing relative to the approach and landing phases are quoted as follows: "The landing was pretty much as usual except for the limited visibility, which came as a surprise. In the landing, I felt I must have been at least two seconds behind in making corrective control inputs. For instance, when the flaps went down and as I flared, and then trim change taking effect and the altitude change, I was two seconds behind on the control to prevent the airplane from ballooning. It ballooned quite a bit higher than it has on previous flights. It's pretty obvious now that both windshield panels are required." In the X-15 airplane the large viewing angle with the small viewing surface area was obtained by placing the pilot close to the window; consequently, the structure holding the window limited head movement. Figure 3, a photograph of a pilot in the X-15 cockpit, illustrates the limited head room which prevents the pilot from leaning toward the left window.

Fig. 3 View of X-15 airplane showing pilot's head position.
