## Single-Mode Panel Flutter of a Wind Tunnel Flex-Wall

Larry L. Erickson,\* Donald L. Kassner,† Leroy R. Guist,† and Mladin K. Chargin‡  
NASA Ames Research Center, Moffett Field, Calif.

Twice during the spring of 1978, the two steel-plate "flex-walls" that form the variable-geometry nozzle of the 11- $\times$ 11-ft transonic wind tunnel at Ames Research Center experienced a severe dynamic instability. Both walls fluttered in the fundamental beam-bending mode and experienced stresses approaching the yield strength of the material. Both flutter incidents occurred at Mach numbers of about 1.15. The tunnel, operational for 24 years, had no history of such an instability. The cause of these flutter incidents, the steps taken to prevent a recurrence, and the requalification of the facility are described.

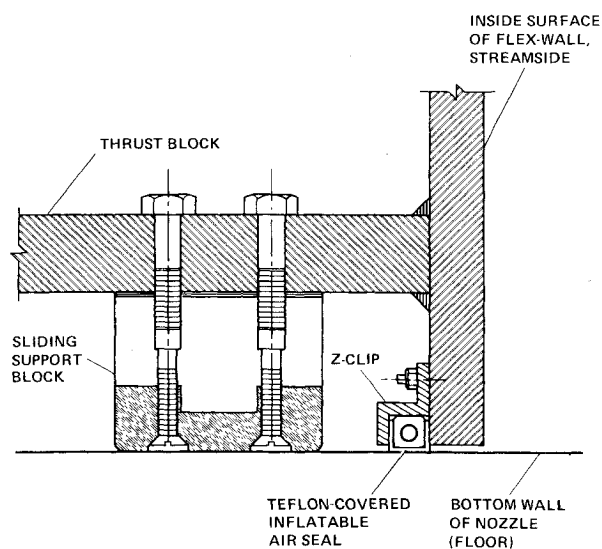
Fig. 3 Support block and inflatable seals.

Two support blocks are bolted to the underside of the thrust block. These support blocks rest on and slide across the nozzle floor, as shown in Fig. 3. This figure also shows the inflatable rubber air seal that runs along the length of the floor, ceiling, and leading edge of the nozzle wall. This seal sits in a U-

shaped Teflon boot and is held in place by Z-clips bolted to the vertical nozzle wall. During tunnel operations, the seals are kept inflated, except when the wall jacks are moving the thrust blocks. When the jacks start, the seals are automatically vented to atmospheric pressure; when the jacks stop, the seals are automatically inflated.

The seals, which had been used for about 10 years, were replaced in January 1978. Because the new seals were ordered in the same size as those used by other Ames wind tunnels (to simplify inventory control), the width of the new seals was about 0.16 cm ( $\approx 10\%$ ) smaller than that of the old ones.

As shown in the next section, the lack of shims had a large effect on the friction force between the seals and the nozzle floor and ceiling. The consequent loss in flex-wall damping is believed to have caused the flutter. The restoration of damping and other safety changes made prior to the requalification of the facility for supersonic operations are also described in the following section.

Having identified the probable cause of the flutter incidents, steps were taken to increase the flex-wall damping. This was done by shimming the seals. With the seals shimmed, there was still uncertainty about the sufficiency of the damping. Even if the former friction force had indeed been restored, it may still have been barely enough to prevent flutter. Because of this uncertainty, additional damping was provided by installing a piston damper system at the T-beam

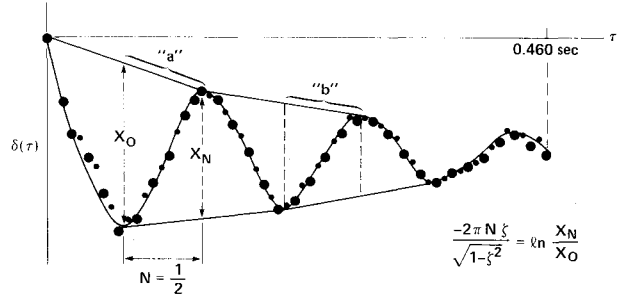
Fig. 12 Randomdec signatures of 4-15 Hz filtered strain gage signal.

Although several wind-on decays of the flex-walls were made, most of the flex-wall damping estimates were obtained from the Randomdec signatures. Due to higher mode responses, the strain gage signal had to be filtered prior to computing the Randomdec signatures. Figure 12 illustrates several points concerning the data reduction. The figure actually contains two 32-point signatures obtained over two consecutive record lengths of between 15 and 30 s each. The larger circles are those of one signature; the smaller circles are

The Randomdec signatures correspond to much smaller dynamic wall motion than that which exists during the initial portion of the cable-produced free decays. The cable usually breaks when the flex-wall has been displaced about 0.76 cm. The Randomdec signatures correspond to aerodynamic turbulence-induced wall displacements whose peak values at station 101 are only of the order of 0.05 cm or less. Comparison of the seals-vented damping, obtained from Randomdec signatures, and wind-on free decays are shown in Fig. 14 for the south wall at  $M=1.15$ . Results are given for four total pressures. Figure 14 also shows the seals-inflated damping (solid circles) at the highest and lowest total pressures, as determined from wind-on free decays.

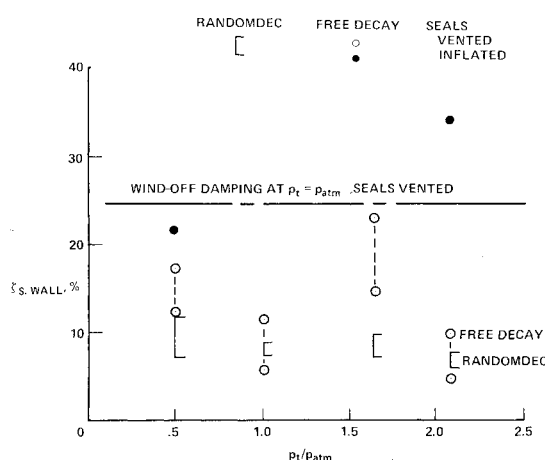
Fig. 14 Variation in flex-wall damping with total pressure at  $M=1.15$ .

The results of the requalification test showed that the flex-wall damping was positive over the normal tunnel-operating range at supersonic speeds, the lowest average of "a" and "b" values being  $\zeta \approx 4.4\%$ . Based on these results, the restriction of subsonic operations only was removed. In subsequent supersonic tests, there have been no flutter problems.
