AIAA 80-0776R

# Repair of Advanced Composite Structures

S.H. Myhre\* and J.D. Labor†  
*Northrop Corporation, Hawthorne, Calif.*

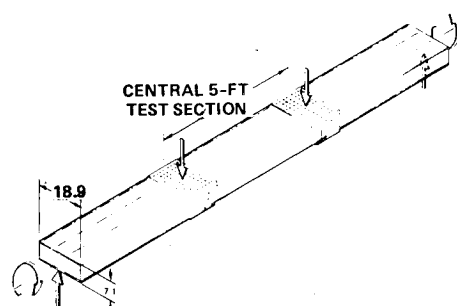
**Fig. 3 Large-scale demonstration component.**

The demonstration components were five panels, 19×60 in., representing both lightly-loaded and highly-loaded types of aircraft structure and each presenting a different repair problem. Each panel was repaired, loaded in various ways, and finally failed in tension. The panels were tested as the lower cover in the central section of the box beam of Fig. 3. Since each panel was mechanically fastened to the spars of the box beam with 3/16-in. fasteners, the parent laminate allowable could never be realized in the panel. The work of Verette and Labor<sup>3</sup> shows that unloaded 3/16-in. flush head fastener holes in a  $[(0/\pm 45/90)_2]_s$  laminate reduce the panel ultimate tensile strength to one-half of the strength without holes and that only a laminate with a much larger percentage of  $\pm 45$ -deg plies will result in a higher relative strength. Therefore, the panel design ultimate allowables have been

defined as 0.5 times the parent material ultimate allowables, except in one case (panel 5) where the allowable obtained was directly related to the simulated component.
