Evaluation of Bonding Parameters on Random Fatigue Life of Bonded Aluminum Joints

H.F. Wolfe* and C.L. Rupert†

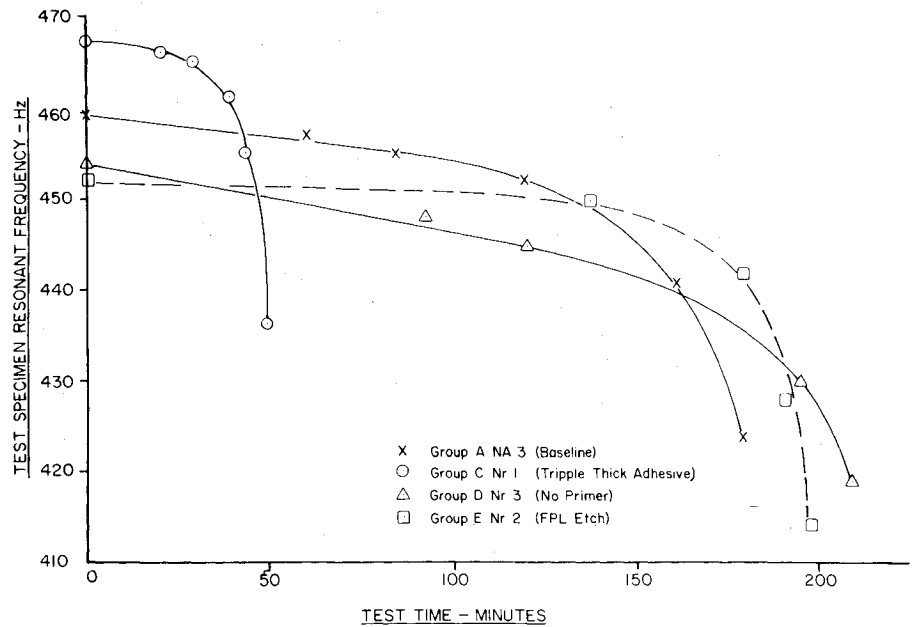
Fig. 4 Change in resonant frequency vs time.

Failure time was determined from visual inspection of each test coupon conducted at 2-3-h intervals, or whenever the coupon response frequency showed a noticeable decrease. When this point was reached, the test was terminated and the time-to-failure recorded. Figure 4 shows typical time histories of the frequency response. The exact time of crack initiation is not evident from these plots. The change in the slope of the frequency response vs time with the same bending load was not consistent. The beam coupons with the thicker adhesive failed much sooner. The resulting failure times are summarized in Table 3. The cycles-to-failure were obtained by multiplying the failure time by the modal frequency. Group B coupons failed at the midspan of the beam and were classified as skin failures. Further testing produced skin failures in two coupons and an adhesive failure in the third. A total of seven skin failures and 11 adhesive bond failures were obtained during this program. Most of the failures fell within 10^6 to 10^7 cycles. This scatter is normal for coupon testing at the same rms strain. The beam coupons with the thicker adhesive had somewhat shorter fatigue lives. Changes in the surface preparation and primer thickness did not produce a significant change in the fatigue life. Since conclusions drawn from a small number of fatigue failures can be misleading, these data were compared with the results from previous investigations and are identified herein as FDL/ML data. The

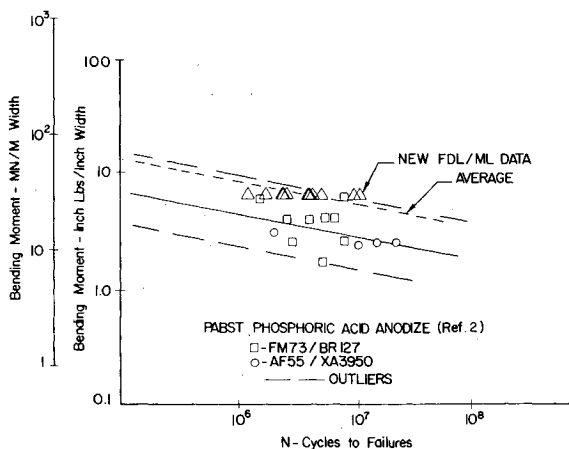
Fig. 5 Comparison of FDL/ML bond failures with PABST data.

Figure 5 shows the 11 new adhesive fatigue failures (FDL/ML data) compared to previous data obtained from FM73 and AF55 adhesives. The dashed lines were constructed through the outlying points of the previous data and are parallel to the previously established *M-N* curve. Most of the new data fell within these outliers established from the previous data. A new *M-N* curve was then constructed from the FDL/ML data through the average value of the fatigue failures and parallel to the previous *M-N* curve. For a given bending moment, an increase in life by a factor of approximately 20 can be expected using the *M-N* curve developed with the FDL/ML fatigue failures.

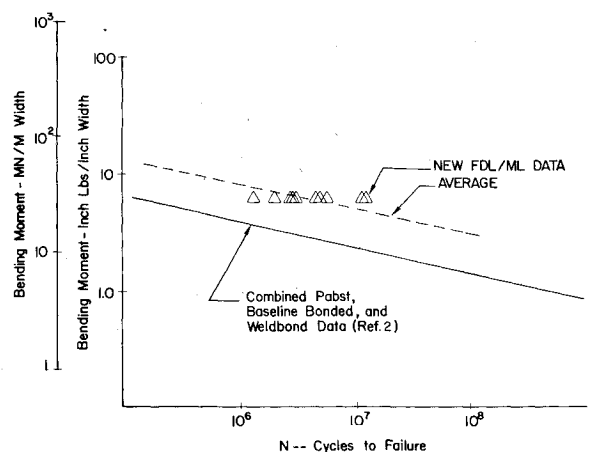
Fig. 6 Comparison of FDL/ML bond failures with combined PABST, baseline, and weldbond data.

Figure 6 shows the FDL/ML data and the *M-N* curve developed using the combined PABST, baseline bonded and weldbonded data.² The *M-N* curve for the FDL/ML data was constructed through the average value of the fatigue failures and parallel to the previous combined curve. For a given bending moment, it is shown that an increase in life by a factor of approximately 30 can be expected with the *M-N* curve developed with the FDL/ML fatigue failures.

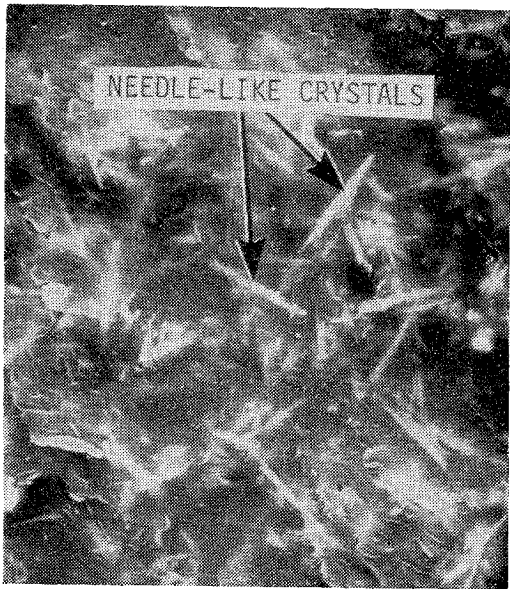
Fig. 8 Example of photomicrograph of BR127 primer layer.

The BR127 primer, used in conjunction with FM73 adhesive, contains a chromate corrosion inhibitor in the form of needlelike crystals. This gives the primer layer (and interfacial regions incorporating the primer) a distinctive, easily recognizable appearance, as shown in Fig. 8.

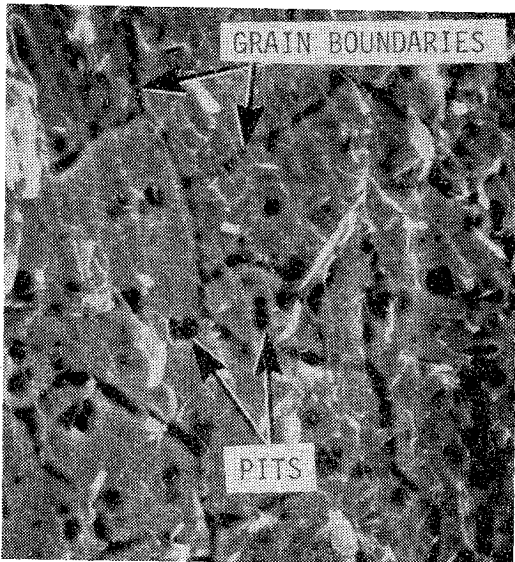
Fig. 9 Example photomicrograph of aluminum oxide surface.

The aluminum oxide surface can be recognized by grain boundaries and pitting in the surface, as shown in Fig. 9. This particular photomicrograph of the fracture surface of a primed adhesive bonded specimen shows a very thin layer of primer polymer adhering to the oxide surface. (This photomicrograph is of a fracture surface of a different adhesive/primer system from that investigated in this program and is included only to illustrate this specific type of fracture.)
