# Composite Material Repairs to Metallic Airframe Components

T. F. Christian Jr.\* and D. O. Hammond†

The repair of metal structures by using composite materials is a technology that was pioneered in Australia, and excellent results have been obtained in over 500 repairs of corrosion and fatigue cracking. This paper will present details of the first in-service composite material repair applied to metal structure on USAF C-141B operational aircraft. This engineering study evaluated five locations representing both fatigue and corrosion cracking susceptible areas on the C-141B strategic airlift transport aircraft. Repairs using either boron/epoxy or graphite/epoxy are beneficial for crack retardation, end fastener effect relief, and field stress reduction. The most obvious time saving feature of these repairs is that no fastener removal or installation is involved. Extensive structural analysis utilizing finite element modeling was done to ensure that the repair design not only would have the requisite strength and durability but also would reduce the inspection burden after the aircraft was returned to service. A test program was also undertaken to substantiate the analytical inve

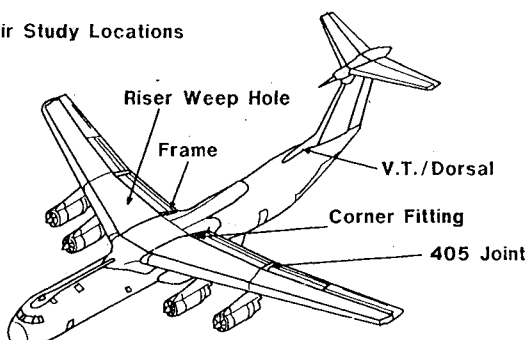
Repair Study Locations

These five areas were chosen on the basis of need and not necessarily for ease of application of composite repairs. The areas chosen provide a good cross-section of problems facing the composite repairs. These repair locations are in Fig. 1. Selection of the five study areas is based on cracks found on the C-141A fatigue test article and on in-service aircraft. As the C-141B force exceeds 30,000 flight-hours, the probability of cracking in these areas increases. The extensive costs and down time involved with conventional metallic repairs makes composite repair an attractive alternative to a metal design for repair or as a reinforcement to improve fatigue endurance and stress corrosion resistance.

Fig. 1 C-141 repair using composite materials.

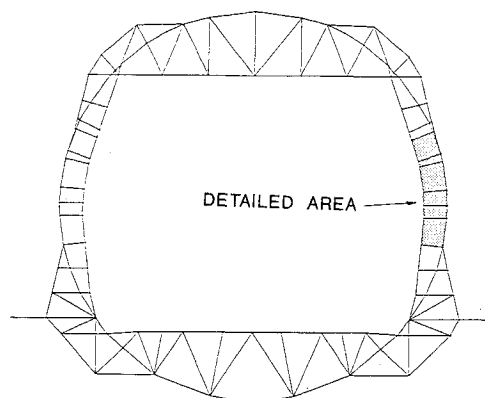
At the FS 998 fuselage/main landing gear frame location, a FEM was developed to evaluate the effect of a composite doubler spanning a crack in the web-to-cap radius of the FS 998 mainframe. Three model configurations were analyzed:

Fig. 8 C-141 FS 998 mainframe finite element model.

1) uncracked (baseline), 2) cracked, and 3) repaired. Axial and shear stress levels for the three configurations were then compared. The analysis is carried out in two steps. The model for the structural analysis of the FS 998 mainframe is run with design loads, and boundary loads from it are extracted and applied to a 3-dimensional model. Figure 8 shows the frame model and the location of the detailed model. The 3-dimensional detailed model of the FS 998 mainframe crack area consists of the structure from W.L. 183 to W.L. 213. Figure 9 shows the detail model, placement of composite doublers, and location of the 2.0-in. crack used in the cracked and repaired configurations. Two (1 forward, 1 aft) back-to-back composite angle doublers are attached to the frame web and inner cap. The doublers are modeled using membrane-type elements that match the geometry of the frame web and inner cap. Clearly, the main goal of composite repair of metal structures is to reduce stress levels and thereby slow crack initiation and growth. Consequently crack growth analyses were performed for each of the selected locations in order to estimate repairs benefit. As the WS 405 repair a good benefit of 2.4 was found, but an even better ratio was determined for the weep hole location as shown in Fig. 10. This figure graphically presents the effect on repair life from residual stress induced by temperature changes. For the wing weep hole repair area, the life at room temperature is reduced by 70% when subjected to a temperature differential of 135°F but is still a factor

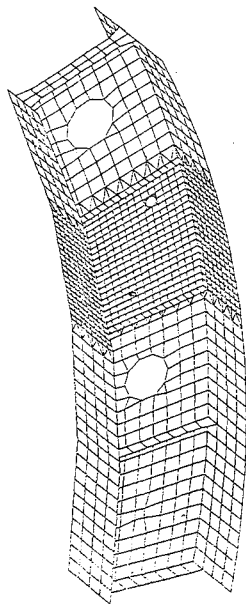
Fig. 9 C-141 FS 998 mainframe detailed finite element model.

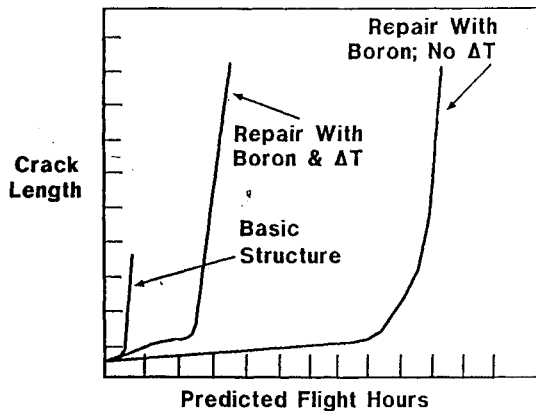
The weep holes are nominally 0.25-in.-diam. holes drilled through the panel risers and approximately 0.25 in. above the inner surface of the wing panel. They help increase usable fuel by allowing fuel to flow between the riser bays. Approximately 30 weep holes are in each inner wing lower surface riser. The stress concentration caused by the weep holes adversely affect the aircraft service life.

Fig. 10 C-141 weep hole analysis.
