Behavior of Compression-Loaded Composite Panels with Stringer Terminations and Impact Damage

Dawn C. Jegley*

NASA Langley Research Center, Hampton, Virginia 23681-2199

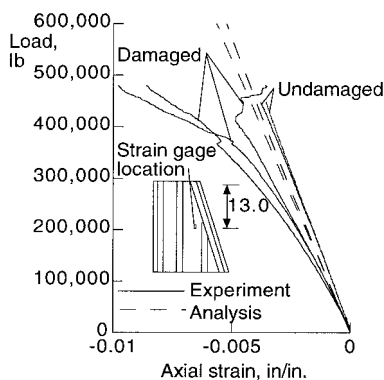
The panel was subjected to impact damage resulting in an indentation with a depth of 0.11 in. The allowable strain of 0.0053 in./in. at the impact site is exceeded for loads greater than $580,000$ lb. Applying the method of Ref. 5 results in a predicted failure load of $570,000$ lb. The panel failed through the impact site for a load that is $\sim 85\%$ of that predicted by analysis. The panel failed with a stress at the impact site of 44.6 ksi, which is 113% of the design stress. A photograph of panel L-2 after failure is shown in Fig. 14.

Fig. 13 Axial surface strains in the skin at the impact site of panel L-2.
