Observations from the Inspection of an Aged Fuselage Panel

An aged aluminum 7075-T6 fuselage panel was inspected for evidence of time-based degradation. Although corrosion pitting and intergranular attack (IGA) were the focus of the investigation, evidence of cracking and fretting wear were documented as well. The investigation was performed at several levels of magnification through the use of magnifying glasses and stereoscopic, metallurgical, and scanning electron microscopy. Comparisons were made for the various levels of investigation. Significant levels of corrosion or cracking damage were discovered in approximately 40% of the fastener holes during the initial low-magnification inspection. Several fastener holes were investigated via sectioning. These specimens were examined with metallurgical and scanning electron microscopes. This investigation revealed tunneling pits, pitting in the countersink region, IGA, cracking and pitting in and away from fastener holes, as well as fretting within the fastener holes and on the faying surface of the panel. This work is significant and applicable to the structural integrity of aging aircraft; it lends credence to the multitude of pas

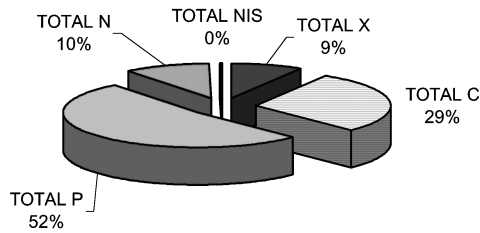
Fig. 3 Results of stereoscopic inspection.

**Summary of discovery from panel inspection
using 10X-70X stereoscope.**
(Note hole selection criteria outlined in text.)

Figure 3 shows the results from the stereoscopic inspections. Figure 4 compares the difference in discovery between the macroscopic (4–7 \times magnification) and stereoscopic inspections. An interesting item to note in Figs. 3 and 4 is that the number of fastener holes with no indication of damage (N) increased. This indicates that some of the fastener holes that were suspected of having some level of damage were incorrectly diagnosed; this was primarily due to residual grime and sealant that were not removed prior to macroscopic inspection but were removed during the cleaning process prior to the stereoscopic inspection.

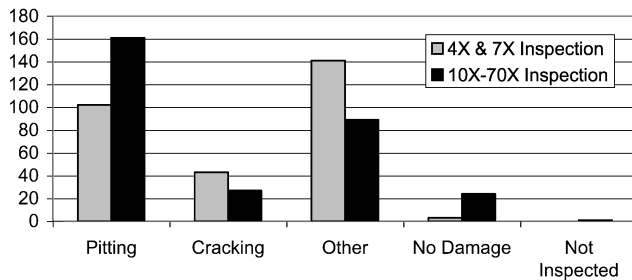
Fig. 4 Macroscopic vs stereoscopic comparison.

**Comparison of the same 310 rivet holes for magnifying
glass vs. stereoscope inspection results**

The significance of higher magnification inspection is evident in the comparison of the records in Figs. 3–5; the closer one inspects, the more one is able to find. This may seem irrelevant; however, in

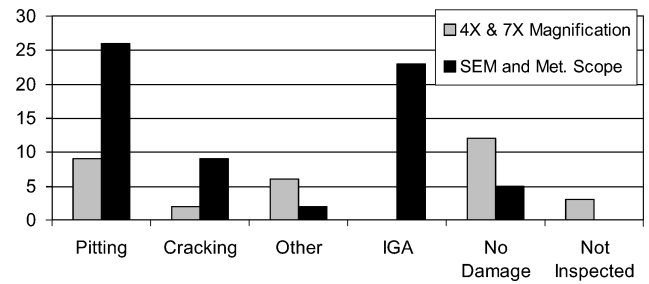
Fig. 5 Macroscopic vs microscopic comparison.

Figure 5 shows results from the SEM and metallurgical microscope (metscope) investigation. The trend of increased numbers for N was reversed upon microscopic inspection. This is displayed in Fig. 5; 12 fastener holes were suspected to have no damage, whereas only 5 were found to display no damage upon SEM and metscope investigation. The numbers increased in nearly all categories except N; for the microscopic investigation, these observations can be clarified by the following statements:

**Comparison of the same 32 rivet holes for magnifying glass
vs. SEM and metallurgical microscope inspection results.**

Figure 5 compares the results of the sectioning investigation via metallurgical microscopic inspection with the high-magnification inspection using an SEM. One of the main differences of Fig. 5 from the other figures is the classification of damage. For each of the other figures, each fastener hole was only assigned one type of damage (in line with the stated classifications). For the data in Fig. 5, if a fastener hole showed more than one type of damage, then all forms of damage were counted. Only 32 fastener holes were inspected, yet there are 65 damage classification counts recorded in Fig. 5. Note the change in the "no damage" classification: 12 fastener holes were inspected that showed no signs of damage at 4–7 \times magnification; however, after SEM investigation, only 5 of those 12 holes still qualified to be placed in the "no damage" category. Pitting was found in 26 of the 32 fastener holes along with some level of IGA. Cracking was documented in 9 of the 32 fastener holes. The "other" classification began with six fastener holes that were suspected to have some type of corrosion or wear damage and all but two were reclassified into an appropriate category. The two remaining "other" fastener holes were eventually classified as having mechanical damage (likely from fastener removal).

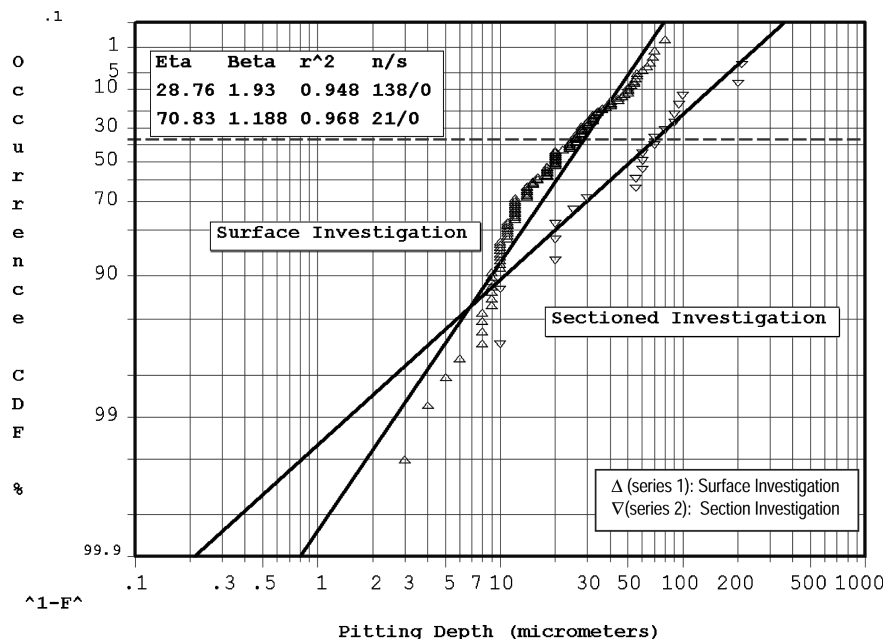
Fig. 8 Weibull plot of pit depths for surface investigation vs section investigation.

Surface investigation compared with sectioned investigation revealed dissimilar pitting characteristics. Weibull analyses were performed on pitting depth data from both surface investigation and sectioned investigation. Figure 8 shows the difference in the trends

The variation in the results from the different investigation techniques and associated pitting depth measurements are demonstrated in Fig. 8. Beyond the divergence between the pit depths and shapes, the section investigation revealed a propensity for IGA and intergranular cracking; one of these cracks measured 2980 μm (nearly 3.0 mm) in length, with several measuring from 600 to 1800 μm . Pitting corrosion linked with intergranular corrosion can readily exceed the commonly perceived "rogue flaw" of 0.05 in. (1.27 mm). Therefore, it is imperative that corrosion receives adequate consideration during design, analysis, and aging fleet sustainment. With regard to aging aircraft, this research demonstrates that 0.05 in. is not a rogue flaw. The effect of intergranular corrosion on structural integrity is not well understood; coupled with pitting and MSD, the effect becomes even more anomalous. It will become increasingly important to reevaluate the current approach to analysis of aging aircraft as structures are utilized and continue to degrade.
