# New Ground Deicing Hazard Associated with Freezing Drizzle Ingestion by Jet Engines

DOI: 10.2514/1.20799

A new ground deicing hazard is described, consisting of the accretion of freezing drizzle onto jet engine fan blades and cowlings, and subsequent shedding of the accreted ice during takeoff leading to damage to jet engine fan blades. Cases of damage to aircraft from hazardous surface icing conditions at Denver, Colorado and Oslo, Norway are described. The two cases at Denver cost United Airlines over \$2 million in damage to 12 B737-300 engines. The hazard is identified as heavy freezing drizzle through examination of National Weather Service observations of upper level temperature and humidity, satellite, radar, and freezing rain sensor data. The official National Weather Service observation during these cases, however, was either light snow and mist or light freezing drizzle. The reason for this misreport and underestimate of intensity lies in the current reporting rules for determining freezing drizzle intensity by visibility and not by precipitation rate. Theoretical relationships are presented that show that the variation in drizzle size distribution and the difference

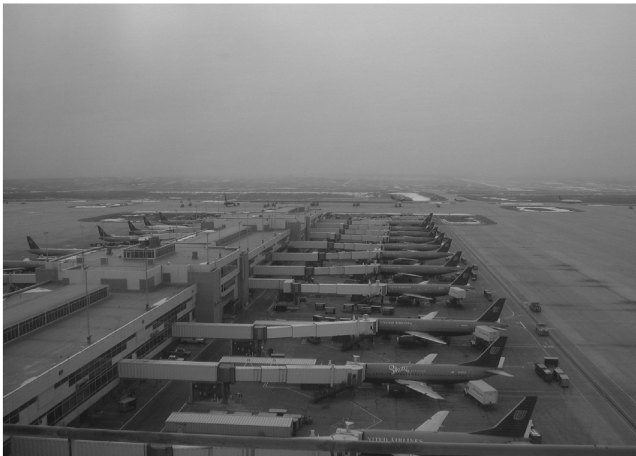
Fig. 2 View of Concourse B and United deicing pad at Denver International Airport.

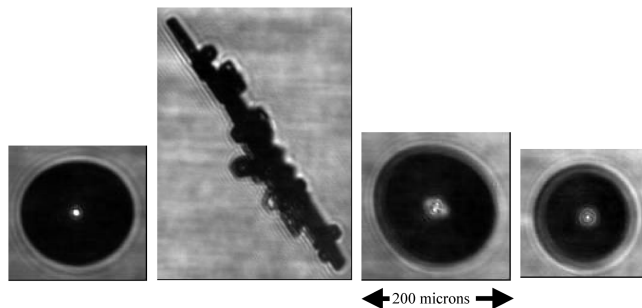
The engine damage at Denver occurred towards the end of a three-day arctic outbreak over the central U.S. A surface high-pressure region containing unseasonably cold, arctic air propagated southward from Canada and entered the northern portion of Colorado early on 29 October. Light snow fell at Denver on 29 and 30 October, producing a snow accumulation of 2 in. Temperatures during this period decreased to a low of  $-11^{\circ}\text{C}$  on 30 October. Aircraft observations from the NCAR C-130 research aircraft on 29 October, 2100–2138 UTC at Jeffco Airport (50 miles west of Denver International Airport) show that freezing drizzle drops were also present in the arctic cloud at this time in addition to the snow observed at the surface (Fig. 3).

Fig. 3 Images of freezing drizzle and ice crystals from the Cloud Particle Imaging probe onboard the NCAR C-130 research aircraft at 2100 UTC 29 October 2002 from a cloud over Jeffco Airport, Colorado.

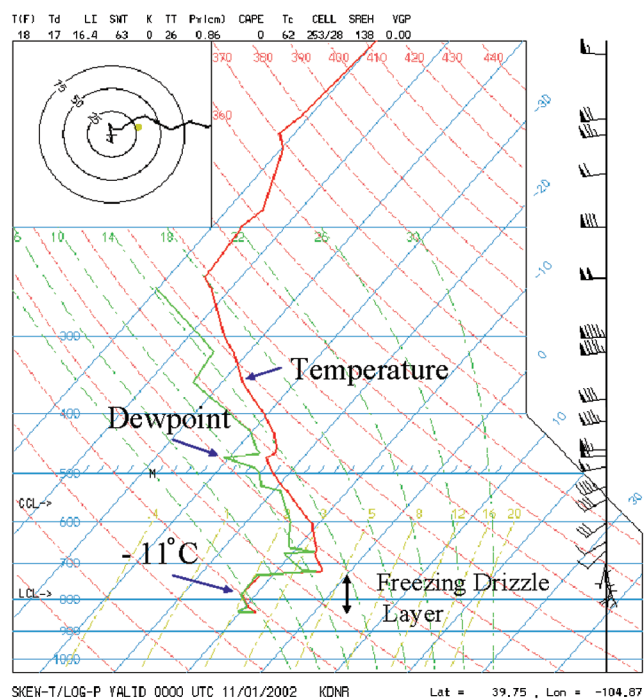
A skew-T/log P plot of the Denver 1 November, 00 UTC upper air balloon sounding, released during the period of engine damage, is shown in Fig. 4. It shows that the low-level cold air mass was saturated throughout, and was capped by a strong temperature inversion at about 720 hPa. The coldest temperature in this air mass was  $-11^{\circ}\text{C}$ . This type of sounding is typical of freezing drizzle

Fig. 4 Denver upper air sounding from 0000 UTC, 1 November 2002.

conditions produced by frontal overrunning in arctic air masses [2,3], as discussed in the preceding section. The key to the formation of freezing drizzle is the relatively warm cloud-top temperature, which leads to the production of relatively few ice crystals that could deplete the drizzle drops. Above the inversion the air is just below saturation, and at certain locations is likely ice saturated. These pockets of ice saturation likely produced a few ice crystals that fell into the lower cloud and produced the observed light snow conditions.

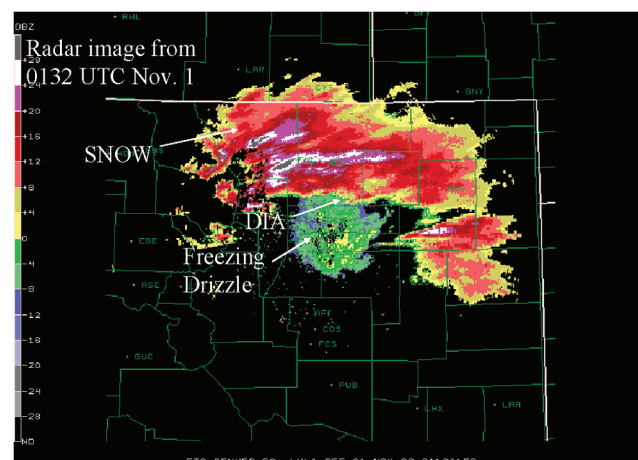
The radar return from freezing drizzle is typically between  $-10$  and  $0$  dBZ due to the relatively small sizes of the drops (typically less than  $0.5$  mm in diameter). Snow, on the other hand, typically can have much larger radar reflectivity values (typical maximum values are  $5$ – $30$  dBZ) due to the presence of snowflake sizes up to a centimeter in diameter. The radar reflectivity from the  $0.5$  deg lowest level scan from the NexRad Denver radar during the engine damage period is shown in Fig. 5. Two distinct features are evident in the image. Near Denver International Airport (DIA), there is a circular reflectivity pattern that is between  $-10$  and  $0$  dBZ in intensity with a fairly uniform horizontal pattern. This type of echo pattern is consistent with either freezing drizzle or light snow [6]. The METAR reports at LIMON (to the southeast of DIA) and Arapahoe (to the southwest of DIA) both indicate the presence of freezing drizzle (LIMON actually is reporting freezing rain, which can occur when the intensity of freezing drizzle is high) beneath the uniform radar reflectivity pattern, suggesting that the echo was produced primarily by drizzle drops.

Fig. 5 Low-level ( $0.5$  deg tilt) Denver NexRad radar image of radar reflectivity from 0132 UTC, 1 November 2002. Scale (in dBZ) is on the left side of the figure.

Note that the ASOS LEDWI instrument did not report snow until the end of the engine damage period (0400 UTC) when the heavy snow band shown in Fig. 5 moved into the area from the north. Thus the light snow report on the METARs during the engine damage period was generated manually by the observer overriding the automatic ASOS precipitation type algorithm, which would have reported unknown precipitation based on the 1 min LEDWI data.

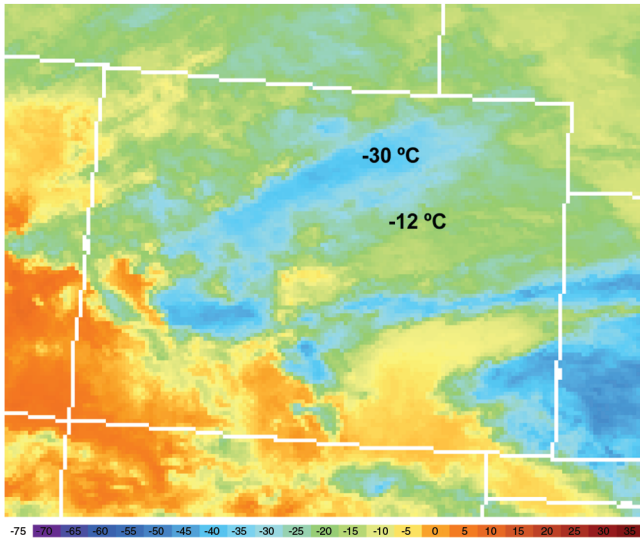
The infrared satellite image shows the presence of relatively warm cloud-top temperatures near  $-12^{\circ}\text{C}$  during the engine damage period (Fig. 6) similar to what the sounding data suggested. The region to the north of Denver where the radar suggested the presence of snow has a cloud-top temperature near  $-30^{\circ}\text{C}$ , and thus large numbers of ice particles are expected to be present, consistent with the higher levels of radar return.

**Fig. 6** Infrared satellite image of the cloud field over Colorado on 1 November, 0045 UTC. Cloud-top temperature is indicated by the color scale on the bottom of the figure. The upper cloud north of Denver is indicated by the location of the  $-30^{\circ}\text{C}$  annotation in the figure and the location of Denver International Airport by the  $-12^{\circ}\text{C}$  annotation, which is also the approximate cloud-top temperature.

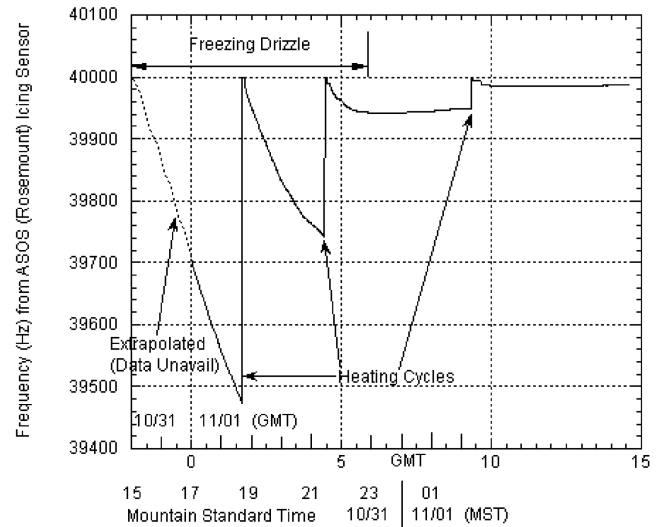
**Fig. 8** Time series of the freezing rain sensor frequency for 31 October 2002.

The raw output from the freezing rain sensor is the vibration frequency of the sensing rod. When no ice accretes on the rod the vibration frequency of the rod is approximately 40,000 Hz. When ice accretes on the rod, the frequency drops in proportion to the mass of the ice accretion. This information is used by the current ASOS system to indicate the presence of freezing rain using the algorithm described in Table 2. High values of mass accretion are related to the presence of freezing rain, whereas lower rates of accretion are correlated with the presence of freezing drizzle [8–10] (Table 2). Freezing drizzle is reported if: 1) the frequency is less than 39,967 Hz and the accretion rate on the sensor produces a frequency drop greater than 6 Hz in 15 min; 2) the light-emitting diode weather identifier (LEDWI) present weather sensor reports “no precipitation”; 3) the ambient temperature is less than or equal to  $0^{\circ}\text{C}$ ; and 4) sky cover is overcast. All of these criteria were met during the engine damage period. The time series of frequency during this period (Fig. 8) shows a dramatic decrease in frequency during the engine damage period; this time series is a typical signature of ice accretion from freezing drizzle. The rapid increase of frequency observed in this plot is due to heating cycles of the instrument required to remove the ice. Ramsay [10] developed a method to determine freezing drizzle intensity (actually, ice-accretion rate) using the rate of frequency drop from the freezing rain sensor (Table 3). The frequency drop during the engine damage period was approximately 12 Hz per 5 min (Fig. 9), or 37 Hz per 15 min, indicating that the drizzle intensity was  $>0.02$  in/h, equivalent to heavy drizzle intensity (Table 3). Figure 10 compares the drizzle algorithm to the LEDWI precipitation type and intensity algorithm that is currently used on ASOS. The thick bars are the freezing drizzle algorithm and the thin bars are from the LEDWI. Both the LEDWI and the drizzle algorithm reported no precipitation

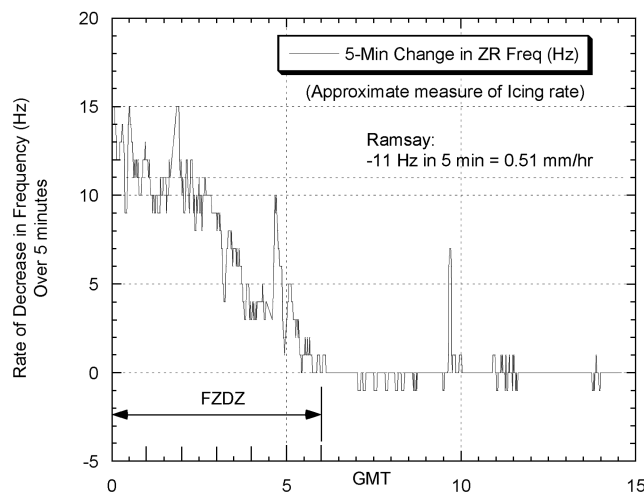
**Fig. 9** Time series of rate of frequency decrease over 5 min from the Goodrich sensor on 1 November, 0–15 UTC. The positive values between 0 and 6 UTC corresponds to the presence of freezing drizzle.

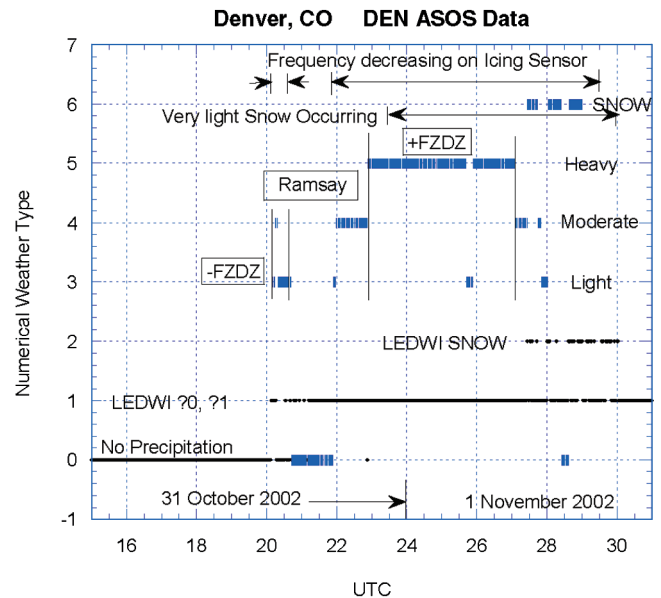
This figure indicates that the drizzle algorithm would have reported heavy freezing drizzle during the engine damage period (00–03 UTC) instead of the light snow reported by the observer. The LEDWI instrument reported ?0 or ?1, which indicates that the sensor detected precipitation, but did not have sufficient signal to determine the type or intensity.

**Fig. 10** Time series of numerical weather type between 31 October 2002, 1500 UTC and 1 November 2002, 0700 UTC. Thin solid line indicates LEDWI observations, thick solid line indicates Ramsay algorithm reports of light, moderate, or heavy freezing drizzle, snow, or no precipitation.

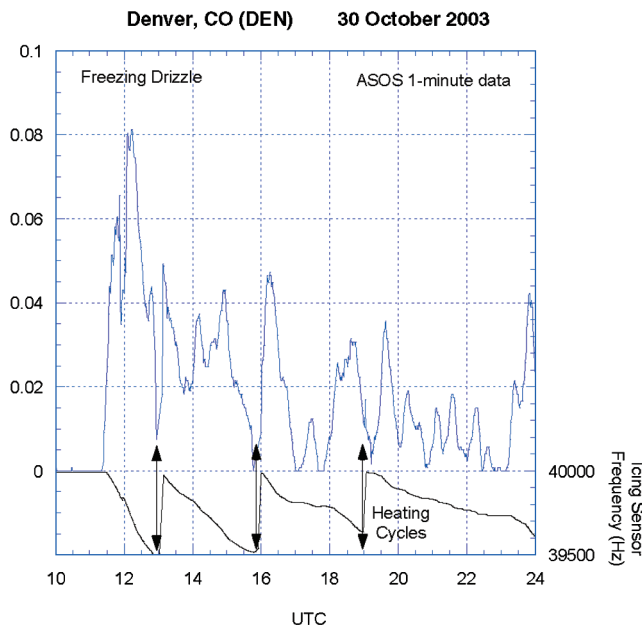
**Fig. 12** Time series of icing sensor frequency and ice accretion rate, 30 October 2003.

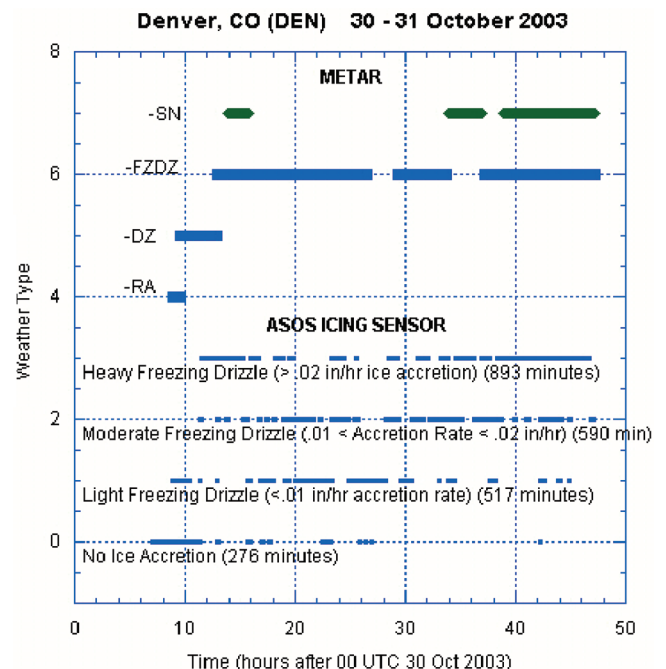
On 30–31 October 2003, another freezing drizzle event occurred at Denver International Airport, *exactly* one year from the date of the first event described. Six B737-300 engines were damaged during this event, with similar damage to the previous year. The METAR was of light freezing drizzle during the engine damage period, whereas the actual ice-accretion rate was again equivalent to moderate to heavy freezing drizzle based on the freezing drizzle algorithm (Figs. 12 and 13), radar data (reflectivity between 0 and  $-10$  dBZ with a cloud top of 3 km, typical of freezing drizzle conditions in the Denver area) and sounding data (cloud-top temperature of  $-11^{\circ}\text{C}$  with dry air above the cloud top).

**Fig. 13** Time series of freezing drizzle rate based on the Goodrich icing sensor with the Ramsay algorithm applied (thin lines), and the METAR observations (thick lines) between 30 October 2003, 0000 UTC and 1 November 2003 0200 UTC.
