Liquid Oxygen Cooling of Hydrocarbon Fueled Rocket Thrust Chambers

Elizabeth A. Roncace*

NASA Lewis Research Center, Cleveland, Ohio 44135

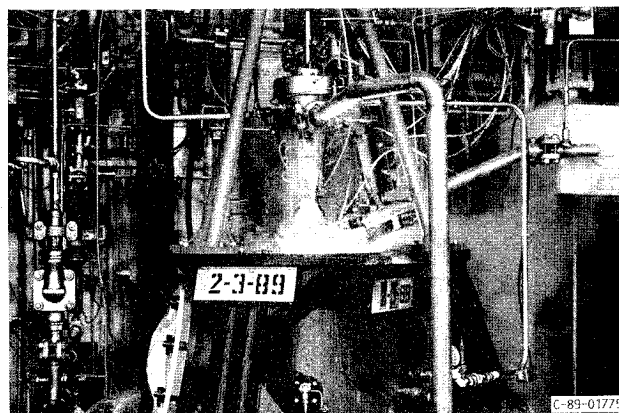
**Fig. 4** Chamber 702 during test firing.

Four combustion chambers were tested in this program. Chamber 702 is shown in Fig. 4 during a firing. To determine

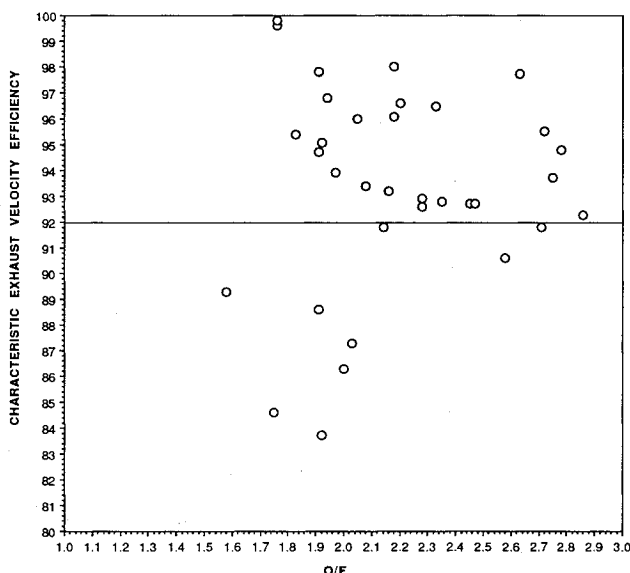
Fig. 14 Characteristic exhaust velocity efficiency as a function of mixture ratio.

Figure 14 is a plot of the C^* efficiency (characteristic exhaust velocity efficiency) versus mixture ratio. The C^* efficiency is the experimental C^* divided by the theoretical C^* , where the theoretical C^* is calculated from the CEC computer program⁸ for the given combustion conditions. The experimental C^* is calculated from

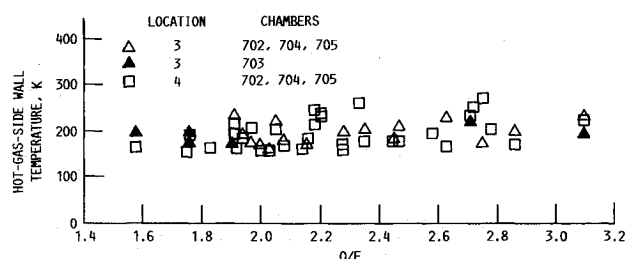
Fig. 15 Hot-gas-side wall temperatures 22.9 cm from the injector.

Thermocouples were located on the chambers at the slot locations and 2.54 cm (1.0 in.) downstream of the slots to determine the effect of LOX leaks on wall temperature. A one-dimensional analysis was used to determine the hot-gas-side wall temperatures from the thermocouple readings. The wall temperatures downstream of the slots in chamber 703 (16.46 cm upstream of the throat) are compared for the chambers in Fig. 15 which shows similar temperatures for the chambers. In chamber 703, the slots were at locations 1 and 3. The wall temperatures on chamber 703, at slot location 3, are well within the data scatter of the wall temperatures at locations 3 and 4, for those chambers where there were no slots.

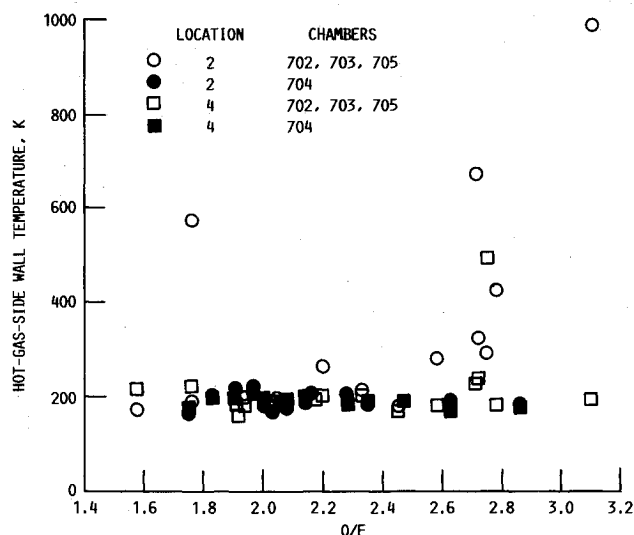
Fig. 16 Hot-gas-side wall temperatures 15.2 cm from the injector.

The wall temperatures downstream of the slots in chamber 704 (15.24 cm downstream of the injector) are compared for the chambers in Fig. 16. In chamber 704, the slots were at locations 2 and 4. The wall temperatures on chamber 704 were within the data scatter of the other chambers.

The peak temperatures in Fig. 16 indicate a hot spot on the chamber wall. However, the hot spot was not in line with the machined slots, but occurred in line with the oxygen-rich streaks from the injector. Therefore, these results would in-
