## Hypervelocity Impact Tests on Space Shuttle Orbiter RCC Thermal Protection Material

Donald H. Humes\*

NASA Langley Research Center, Hampton, Va.

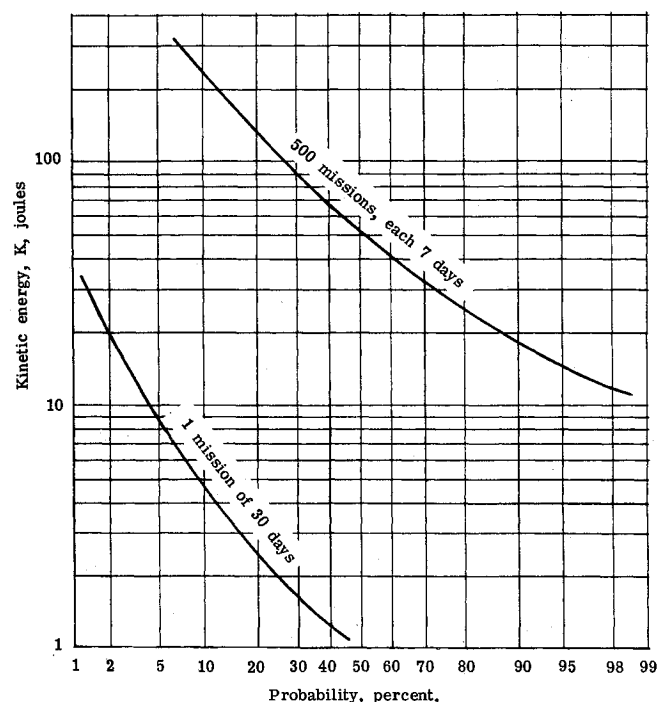
Fig. 2 Kinetic energy of meteoroids expected to strike the leading edge and nose of the Shuttle Orbiter.

The impact energies that can be expected from meteoroids striking the RCC material on the Shuttle Orbiter are shown in Fig. 2. This calculation is based on the NASA meteoroid environment model.<sup>3</sup> The area of the nose and leading edge of the Shuttle Orbiter was taken to be 38 m<sup>2</sup>.

The probability of the RCC material being penetrated on a single mission of 30 days duration is only 0.01 (using 34 J as the energy necessary for penetration). However, over 500 missions of 7 days duration are shown in the 1973 Space Shuttle Traffic model,<sup>4</sup> and the probability that a penetration will occur on at least one orbiter increases to about 0.70. More likely than not, during one of the 500 shuttle missions, the RCC material will be struck by a meteoroid with kinetic energy in excess of 50 J. Damage caused by a 1 J impact must be expected to occur about once during each 30-day mission. Of course, many impacts with kinetic energy in excess of 0.2 will occur during each mission.
