Striped-Pattern Deterioration and Morphological Analysis of Injection Moldings Comprising Polypropylene/Ethylene α -Olefin Rubber Blends. I. Influence of Ultraviolet Irradiation

ABSTRACT: Unique deterioration with a periodical striped pattern on the injection moldings of polypropylene/rubber blends is reported. After exposure to ultraviolet irradiation with a sunshine fade meter, striped patterns appeared on the injection moldings along the flow direction of the molten resin during the filling process of injection molding, even though the initial specimen showed no sign of any stripe pattern on its surface. The stripe was carefully observed with ultrasonic echo imaging, scanning electron microscopy, transmission electron microscopy, and Fourier transform infrared spectroscopy. As a result, a number of microvoids were observed

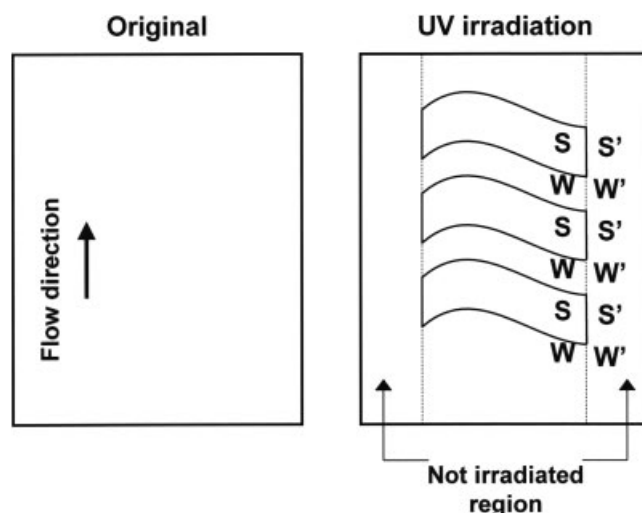
Before the discussion, the tested sample is confirmed again in Figure 6, which presents a schematic view of the deterioration of sample C as shown in Figure 4. The irradiated specimen provided severe striping, but the stripe did not develop to both edge sides of the plate because these edges were not irradiated with UV on account of the aluminum holders that supported the plate on its edges during the irradiation test (Fig. 2). These edge sides could sustain the original state of the injection-molding plate without the irradiation. If the edge sides had been irradiated with UV, striped deterioration should have been caused. The parts just adjacent to S and W are defined as S' and W', respectively. S' and W' become S and W, respectively, by irradiation. Thus, we were able to confirm the influence with or without UV on the deterioration.

Figure 6 Definitions of the stripes caused by UV irradiation: S is the strongly whitened part; W is the weakly whitened part; and S' and W' are the unirradiated areas on the extension of S and W, respectively.
