CASE REPORT

A Particular Case of Oxidation Colors on Bulb Filament After a Car Crash

REFERENCE: Baudoin, Ph. and Lavabre, R., "A Particular Case of Oxidation Colors on Bulb Filament After a Car Crash," *Journal of Forensic Sciences*, JFSCA, Vol. 41, No. 2, March 1996, pp. 304-309.

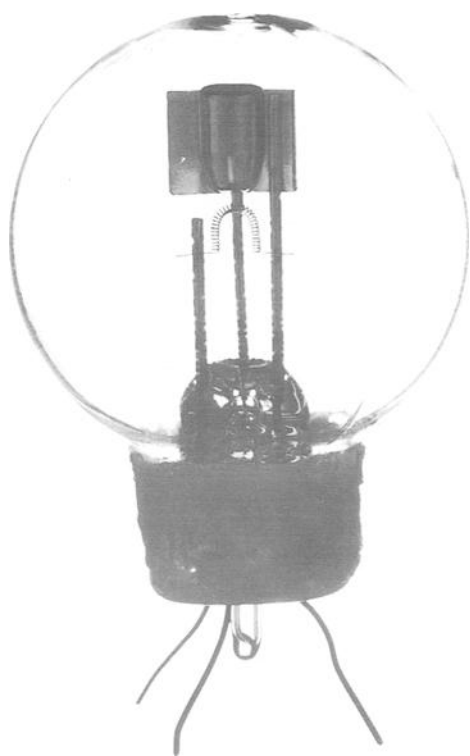
A series of tests were performed (Fig. 9) at the Philips manufacturing center laboratory in Chartres (France) in an attempt to reproduce this type of oxidization (see Tables 3 and 4). For interpretation, it is important to remember that the R2 type bulb filament (diameter 170 μm) reaches its functioning temperature in roughly 0.05 second and cools down from 2500°C to 200°C in roughly 2 seconds (1,4).

FIG. 9—Example of bulb used for surveys presented in Tables 2, 3 and 4. Power is supplied by the copper conductors out of the base. The glass tube ($\varnothing \approx 0.5$ mm), once broken, allows air entrance into the bulb.
