TECHNICAL NOTE

Donald J. Van Kirk,¹ P.E., MSEM, MBA; John P. Sas,¹ E.I.T, BSME; and Paul N. Cross,¹ B.Sc.

When Is 100% Inspection Not Enough? An Analysis of Three Pickup Truck Front Wheel Assembly Failures

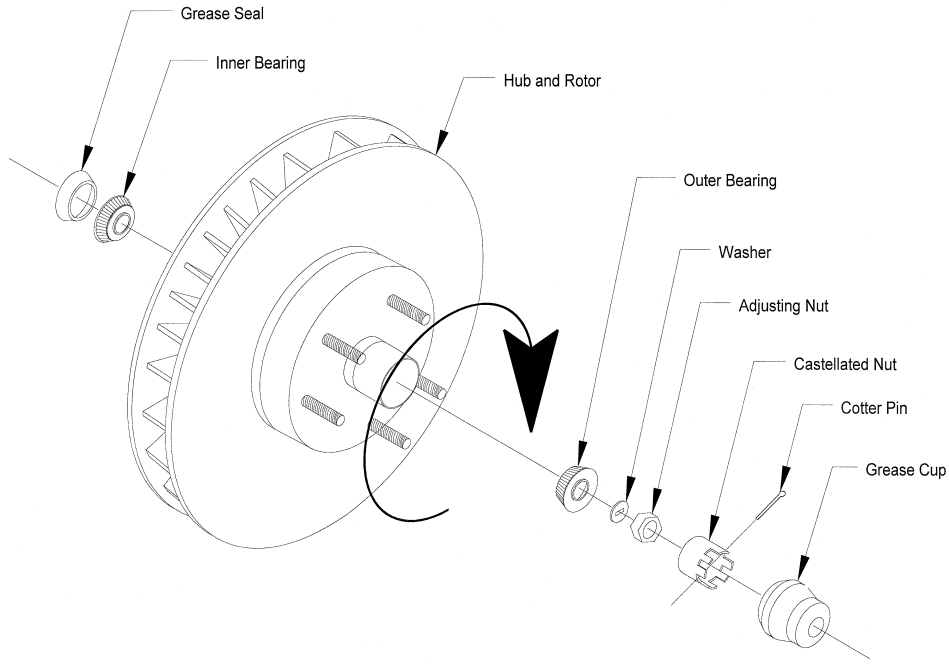
RIGHT WHEEL ASSEMBLY

FIG. 1—Exploded view of a right front wheel assembly.

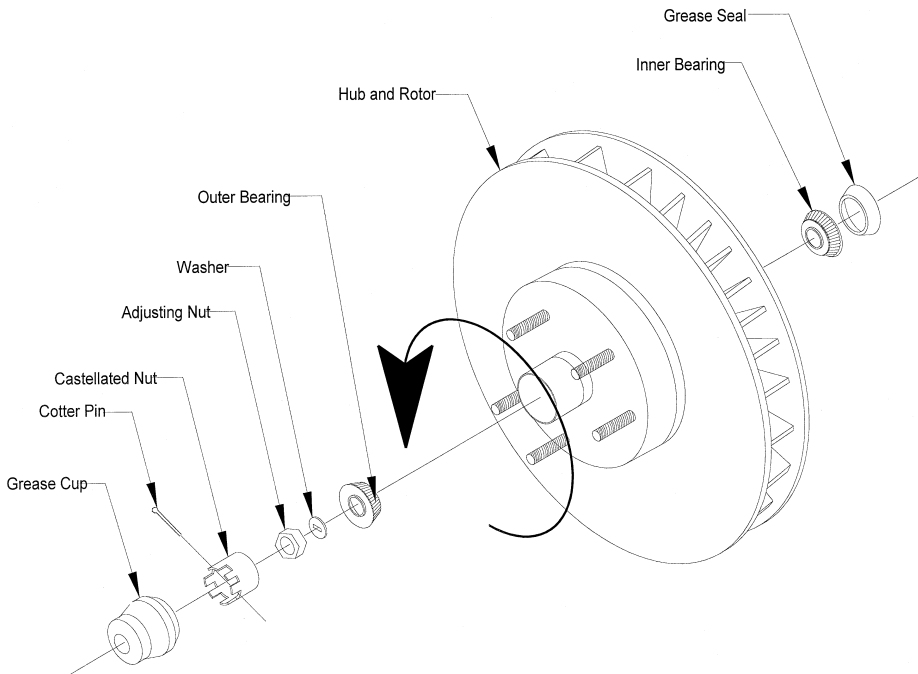
LEFT WHEEL ASSEMBLY

Looking at Fig. 2, the left side of the vehicle, we see the tire now rotates in the counter-clockwise direction when the vehicle is moving in the forward direction. The adjustment nut being threaded onto the spindle still rotates in the clockwise direction. This is where the problem begins. If the cotter pin has not been installed, the adjusting nut may eventually work itself loose and the tire and wheel assembly will start to move outward on the spindle. As it does so the wheel assembly pushes against the adjusting nut. Because of the difference in the direction of rotation of the tire and wheel assembly and the threads on the spindle, the adjusting nut will begin to unthread itself from the spindle as the wheel assembly pushes against it. If unchecked, the nut will eventually drop off of the end of the spindle into the grease cup, and the wheel and tire assembly will be moved outward, away from the car and off of the

FIG. 2—Exploded view of a left front wheel assembly.
