CORROSION PROBLEMS IN Ti/KClO<sub>4</sub> LOADED DEVICES WHEN SUBJECTED TO HUMIDITY ENVIRONMENTS\*

T.M. MASSIS, J.T. HEALEY, D.H. HUSKISSON and W.G. PERKINS  
Sandia National Laboratories, Albuquerque, NM 87185\*\*

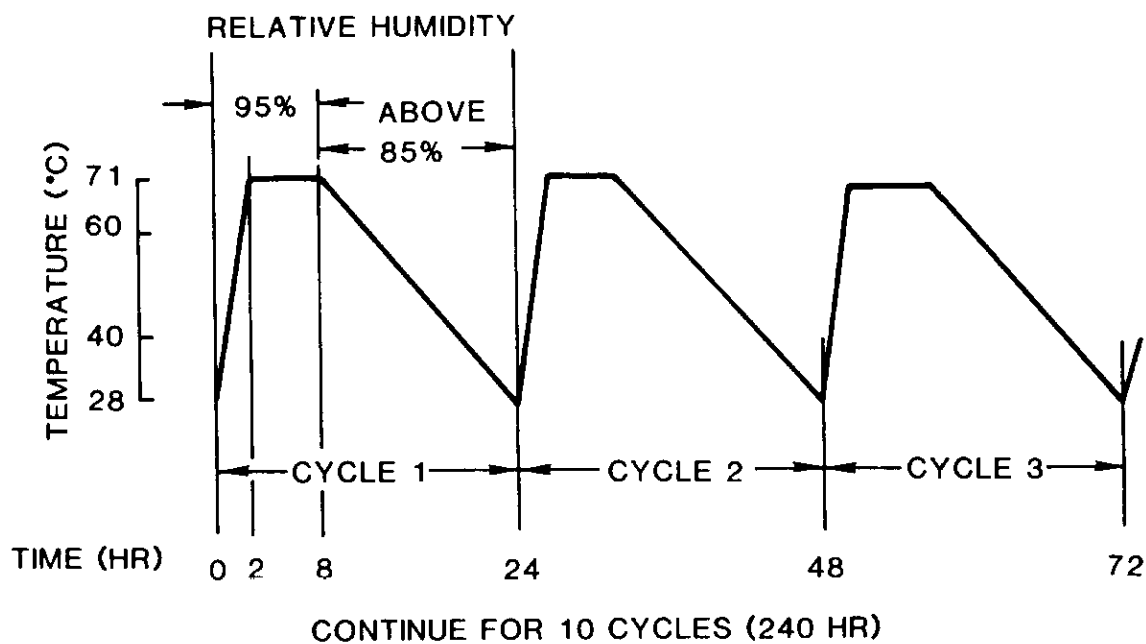
The original design applications of the piston motor, including the ones examined for corrosion, did not require the use of the component in a high humidity environment. However, a recent application of this device required a severe humidity test cycle as shown in Figure 8. Measurement of the bridgewire resistance after humidity testing revealed values significantly above the  $1.0 \pm 0.1$  ohm specification for the circuit. In many cases, an open circuit was indicated

Fig. 8. The humidity cycle used for the piston motor
