THE DECONTAMINATION OF A DISUSED GAS WORKS SITE

A PARKER, K W PEARCE

S F FENNER and M S WRIGHT

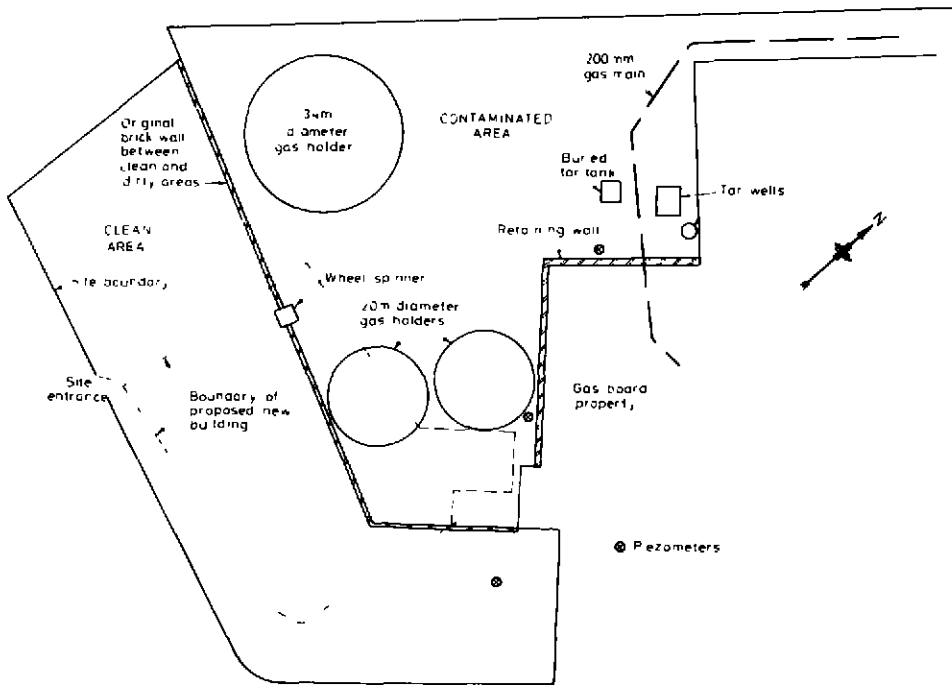
Fig 1 Plan of gas works site

The site is a level, irregularly shaped piece of land approximately 130 m by 100 m, divided into two roughly equal sections by a brick wall (Fig 1).

As can be seen in Fig 1, the retail store was to be built mainly on the "clean" area although it extended partly into the "dirty" area originally occupied by the gas works. The car park was to occupy the remainder of the "dirty" area. As a consequence of preliminary chemical and geotechnical investigation it was decided to remove all the material beneath the designated building area down to the underlying clay and to replace this with crushed rock and compacted sub-base, so that the development would take place on uncontaminated material having known geotechnical characteristics
