APPROACH TO A LEAK ON AN LNG TANK BOTTOM

Z. MERATLA

Summary

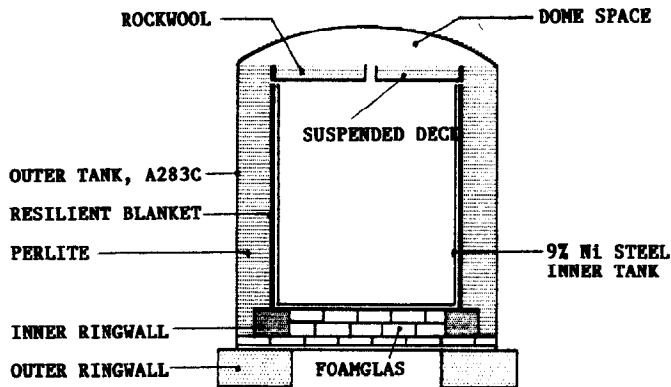
A failure in the carbon steel outer tank bottom results in the release of boil-off gas only. The latter circulates from the tank dome space, along the annular space, to the leaking point, for tanks with a suspended deck. Figure 1 illustrates the tank design referred to in this paper. A failure in the primary container bottom results in LNG liquid leakage into the tank bottom insulation. Depending on the size of the leak, the outer tank bottom may be breached when exposed to the cryogenic liquid at -161°C and LNG may be released into the foundations.

Fig. 1. The 48,000 m³ LNG tank configuration.
