How is it possible? Why didn't we do anything?
A case history!

H.J. Pasman^{a,*}, R. Grollier Baron^b

Abstract

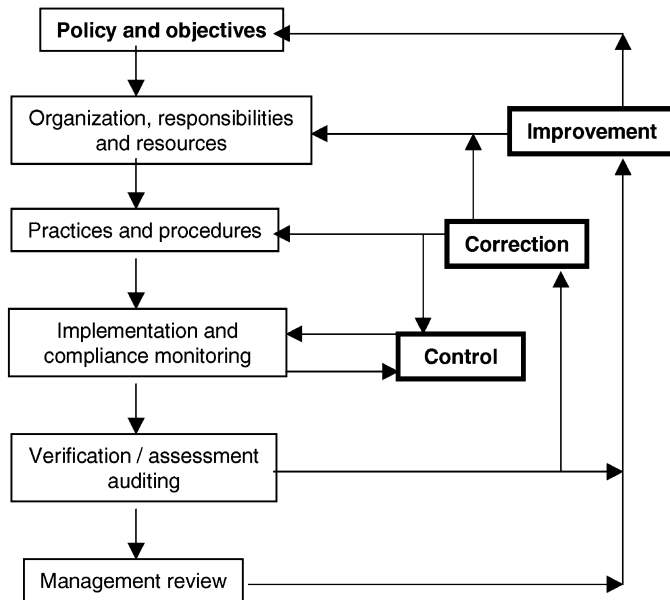
Also, there was no continual improvement scheme as in a quality assurance scheme with possible improvement feedback loops on, for example, a daily, annual or 5-year interval basis, as shown in Fig. 2 as control, correction and improvement loops, respectively.

Fig. 2. Typical structure of key elements in a Safety Management System, also shown are the improvement feedback loops. Source [1]: EPSC Safety Management Systems.
