# Environmental stress-corrosion cracking of fiberglass: Lessons learned from failures in the chemical industry

T.J. Myers<sup>a,\*</sup>, H.K. Kytömaa<sup>a</sup>, T.R. Smith<sup>b</sup>

<sup>a</sup> Exponent Inc., 21 Strathmore Road, Natick, MA 01760, USA

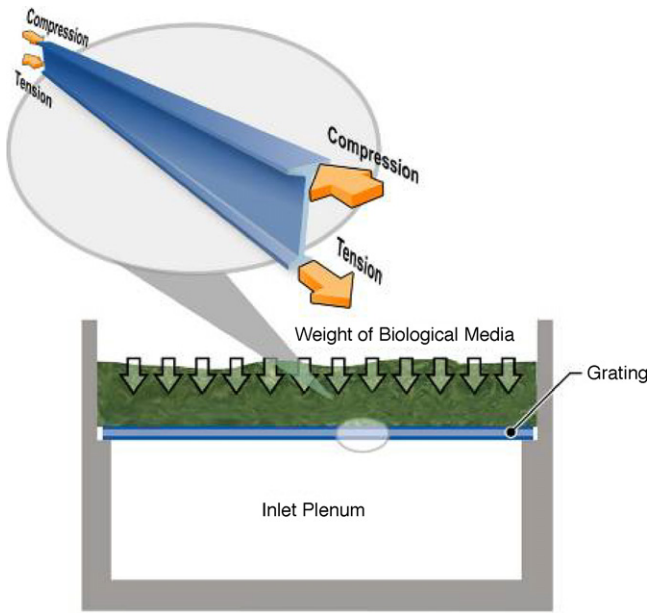
Chambers containing biological media converted dilute sulfur containing gases in a plant's exhaust stream to sulfuric acid ( $\text{H}_2\text{SO}_4$ ). A schematic of a chamber is shown in Fig. 3. Process gases traveled up through the filtration media, which was supported by a grating constructed from FRP I-beams. The I-beams, which were approximately 7 ft long and 2 in. tall, were subjected to bending stresses as shown in Fig. 3 due to the weight of the media. Water was sprayed into the top of the chamber resulting in an aqueous stream of about 1 wt.%  $\text{H}_2\text{SO}_4$  trickling over the I-beams. Within 3–4 months of startup, all chambers put into service had failed.

Fig. 3. Schematic of biological media chambers. Process gases flow up through the biological media. An aqueous stream containing H<sub>2</sub>SO<sub>4</sub> drains down over the beams. FRP I-beam gratings support the biological media.

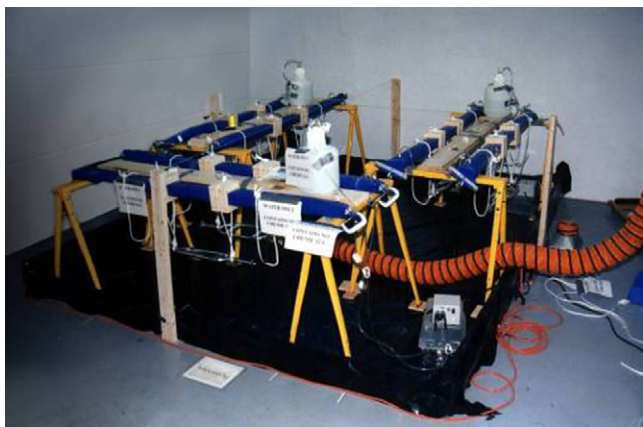
Fig. 7. Apparatus used to test beam pairs under load in various aqueous environments. Six sets of beam pairs were enclosed in flexible hose and weights were hung from the beams to load beam pairs in a four point bending configuration. Aqueous solutions were circulated through the flexible hose with peristaltic pumps.

The manufacturer of the beams claimed that ESCC occurred not because of the lack of a corrosion barrier on the bottom of the tension flange, but because the presence of dilute  $\text{CS}_2$  in the process streams caused the resin layer to swell, allowing acid to attack the structural fiberglass. While some resins are not compatible with concentrated  $\text{CS}_2$ , the resin manufacturer confirmed that the specific resin used in the beams would be suitable for the application because it would not be adversely affected by the presence of  $\text{CS}_2$  at the low concentrations present in the chambers. The average  $\text{CS}_2$  concentration was less than 1 ppm in the aqueous phase and approximately 180 ppm in the vapor phase. To confirm that the dilute  $\text{CS}_2$  played no role in the failures, beam pairs (two attached beams) were tested under two loads in aqueous solutions containing  $\text{CS}_2$  alone,  $\text{CS}_2$  and  $\text{H}_2\text{SO}_4$  combined, and  $\text{H}_2\text{SO}_4$  alone at concentrations representative of the chambers. The apparatus used in the testing is shown in Fig. 7.

of 11,000 psi and exposed to  $\text{H}_2\text{SO}_4$  failed in 4.5 days regardless of whether  $\text{CS}_2$  was present. Similarly beams loaded with a lower mid-span stress of 8400 psi and exposed to  $\text{H}_2\text{SO}_4$  failed in 9.5–10 days regardless of whether or not  $\text{CS}_2$  was present. The tests demonstrate that ESCC occurs more rapidly in beams under greater loads even though the loads were significantly below the beams' ultimate strength. By comparison the beams in the chamber were designed to support a load corresponding to a stress of 10,500 psi and were reported to have a failure stress of 100,000 psi. Beams that were only exposed to  $\text{CS}_2$  did not fail during 52 days of testing and showed no signs of deterioration. These tests confirmed that the presence of  $\text{CS}_2$  was not necessary to cause the beams to fail and that the beams would fail due to exposure to  $\text{H}_2\text{SO}_4$  alone under load due to the lack of a corrosion barrier on the bottom of the tension flange. Furthermore, the presence of dilute  $\text{CS}_2$  did not accelerate the failures refuting the beam manufacturer's claim that  $\text{CS}_2$  swelling the resin had allowed the ESCC to occur.
