Failure Analysis of an Ammonia Refrigerant Condenser Tube

N.G. Muralidharan, R. Kaul, K.V. Kasiviswanathan, T. Jayakumar, and B. Raj

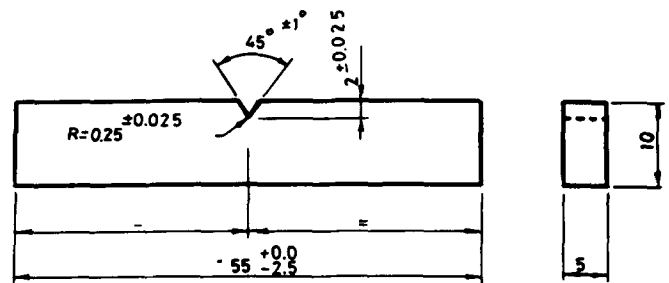
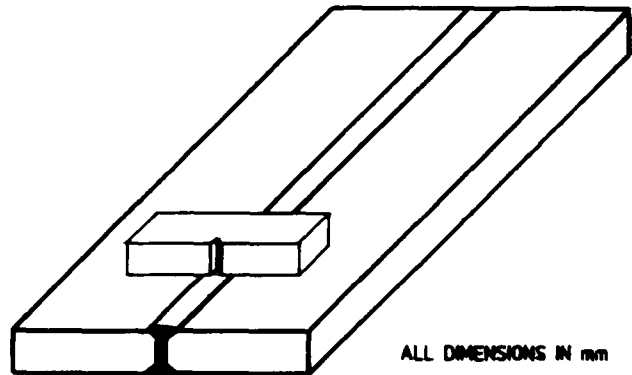
mens are given in Fig. 12 (Ref 3, 4). The tests were performed on a Tinius-Olsen model 358 J (Tinius-Olsen Testing Machine Co., Inc., Willow Grove, PA) impact machine with DYNATUP (GRC Instruments, Santa Barbara, CA) instrumentation, as per ASTM E 23 (Ref 3). The results of impact tests carried out on subsize Charpy specimens at different temperatures are presented in Fig. 13. Transition temperatures for subsize Charpy specimens from base metal and weld metal (using 0.25 J/mm² ligament area criterion, equivalent to 10 J for subsize specimens) were calculated as 210 and 247 K, respectively.

Fig. 12 (a) Dimension of subsize Charpy V-notch specimen used for testing. (b) Orientation of subsize Charpy V-notch weld specimen with respect to weld length
