Evaluation of the In-Service Performance Behavior of Honeycomb Composite Sandwich Structures

J.E. Shafizadeh, J.C. Seferis, E.F. Chesmar, and R. Geyer

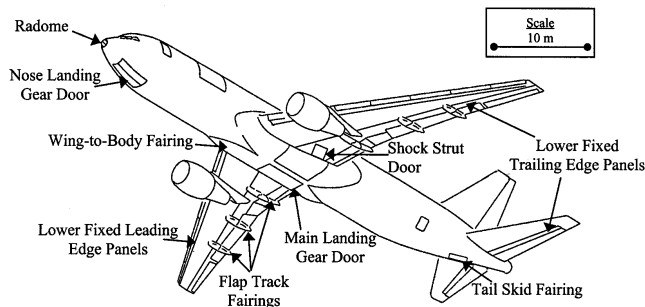
Fig. 1 Bottom view of Boeing 767 showing location of honeycomb composite structures

Figures 1 and 2 show the exterior honeycomb composite structures of a 767. Most of the thermographic inspections were performed on the lower surfaces of the aircraft. The composites on the lower surfaces of the aircraft represent approximately 66 wt% of the exterior honeycomb composites on the airframe of the 767. A limited number of inspections were performed on the upper wing surfaces, and little ingressed water was observed. However, it should be noted that ingressed water was most easily detected on the lower surfaces of the aircraft.

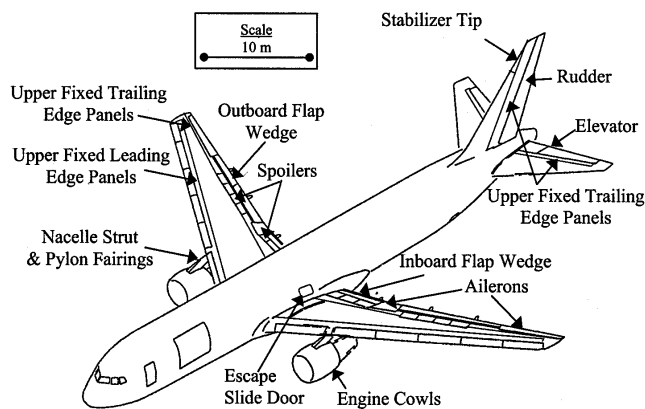
Fig. 2 Top view of Boeing 767 showing location of honeycomb composite structures
