# In Situ Repair Welding of Steam Turbine Shroud for Replacing a Cracked Blade

S.K. Albert, C.R. Das, V. Ramasubbu, A.K. Bhaduri, S.K. Ray, and Baldev Raj

A root-cracked blade in a high-pressure steam turbine of a nuclear power plant had to be replaced with a new blade by cutting the shroud to remove the cracked blade. This necessitated in situ welding of a new shroud piece with the existing shroud after the blade replacement. The in situ welding of the shroud, a 12%Cr martensitic stainless steel with tempered martensite microstructure, was carried out using gas-tungsten arc welding and 316L austenitic stainless steel filler metal followed by localized postweld heat treatment at 873 K for 1 h using a specially designed electrical resistance-heating furnace. Mock-up trials were carried out to ensure that sound welds could be made under the constraints present during the in situ repair welding operation. In situ metallography of the repair weld after postweld heat treatment confirmed the adequate tempering of the martensitic structure in the heat-affected zone. Metallurgical investigations carried out in the laboratory on a shroud test-piece that had been welded using the same proc

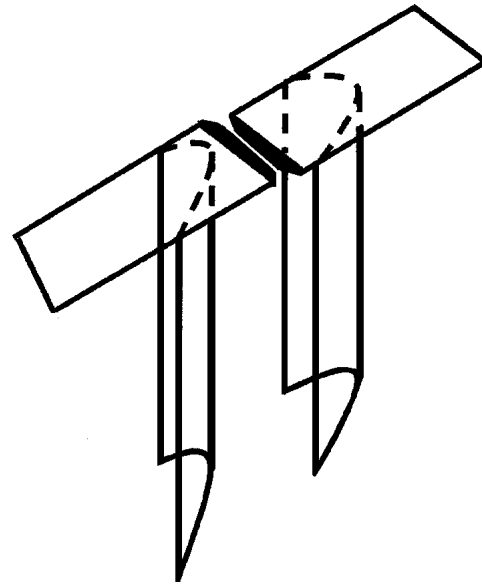
**Fig. 4** Schematic representation of the mock-up assembly of the III-stage HP turbine blades and shroud piece

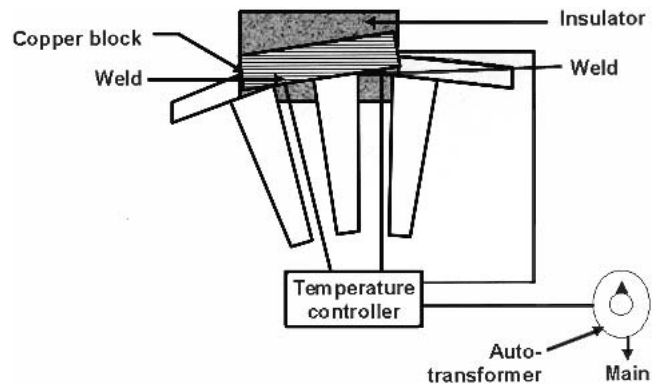
**Fig. 6** Schematic diagram showing the set-up used for localized PWHT by electrical resistance heating

The repair-welded joints of the turbine shroud were subjected to local PWHT at 873 K for 1 h soon after the completion of welding. The localized PWHT was carried out using a specially designed electrical resistance-heating furnace by which both of the weldments could be heat-treated simultaneously. This furnace was provided with an on-off controller and a solid-state relay capable of controlling the temperature with an accuracy of  $\pm 2$  K, while the power supply was provided from an autotransformer for controlling the heating and cooling rates. The heat from the furnace was transferred to the weldments on the shroud through a copper block, which has a flat top surface (on which the heater is placed) and a curved bottom surface, with the dimensions and shape matching those of the shroud piece (on which it was seated during PWHT). The use of the copper block ensured good thermal contact with the shroud for efficient heat transfer during heat treatment. A

K-type thermocouple was welded to the underside of the shroud, and its output was fed to the controller for both monitoring and controlling the PWHT temperature. A schematic diagram of the localized PWHT set-up is given in Fig. 6.

During the PWHT, the weldments were slowly heated to 873 K over 5 h, and after holding at this temperature for 1 h, the furnace was switched off and the weldments were allowed to slowly cool down to 573 K. Subsequently, the furnace was removed and the joint was allowed to cool in air. Heating was done slowly to minimize the chances for the failure of the heating elements by overheating and to improve the heat transfer from the elements to the weldments. Figure 7 shows the actual heating and cooling cycle achieved during the in situ PWHT of the repair-welded shroud, along with the heating and cooling cycle achieved during PWHT of the welded shroud material used in subsequent laboratory investigations.
