Correlation Between Molten Vanadium Salts and the Structural Degradation of HK-Type Steel Superheater Tubes

F.C. Nunes, L.H. de Almeida, and A.F. Ribeiro

(Submitted December 5, 2005; in revised form December 20, 2005)

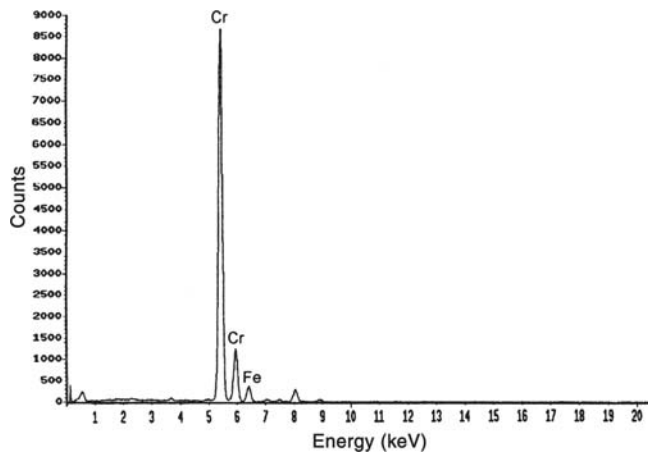
Fig. 6 EDS analysis of the chromium carbide particles

TEM was used to observe and identify the phases present near the external surface in more detail. Figure 5 shows massive chromium carbide particles in the austenitic matrix (shown by the arrows). The EDS analysis of these particles is presented in Fig. 6. On the other hand, EDS from the matrix (Fig. 7) also displayed strong peaks of iron, chromium, and nickel, as expected.

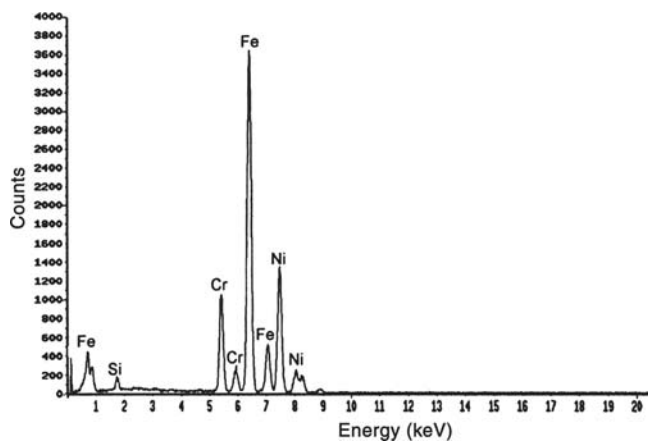
Fig. 7 EDS analysis of the matrix presenting strong peaks of Cr and Ni (main alloying elements, as expected)
