Metallurgical Analysis of Ball Bearing Seized During Operation

Abhay K. Jha, M. Swathi Kiranmayee, P. Ramesh Narayanan, K. Sreekumar, and P.P. Sinha

Keywords aerospace, failure analysis, metallography

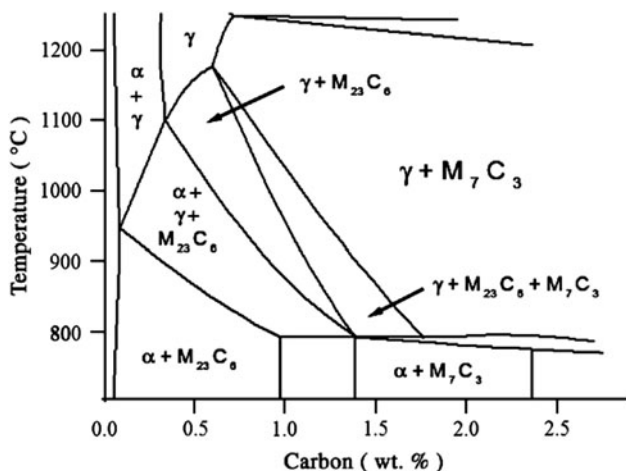
Fig. 15 17% Cr Isoleth, Fe-Cr-C phase diagram

Sample of 3-mm diameter and 0.5-mm thick disc made out of C_s was subjected to DSC from RT to 800 °C with heating rate of 10 °C per min and 800-950 °C, with heating rate of 5 °C/min. Slower heating rate at elevated temperature was chosen taking into consideration 17 wt.% Cr Isopleth, Fe-Cr-C phase diagram (Fig. 15). Heating rate was kept as low as 5 °C per min during temperature range of 800-950 °C. DSC curve (Fig. 16) confirmed endothermic phase transformation (Ferrite → Austenite) at the temperature of 840 °C, which was in good agreement with Fe-Cr-C phase diagram.
