# Assessment of wear on the cones of modular stainless steel Exeter hip stems

R. P. S. CHAPLIN\*, A. J. C. LEE, R. M. HOOPER

Department of Engineering, University of Exeter, Exeter, EX4 4QF, UK

The wear on the stem cones of retrieved Exeter Universal hip stems has been assessed using scanning electron microscopy (SEM), energy-dispersive X-ray analysis (EDX) and surface profilometry. The *in-service* life of these prosthetic stems varied, up to a maximum of 7 years. A combination of SEM, EDX and visual assessment indicates that the stem cones have not suffered from any corrosion. SEM scans indicate that damage to stem cones (excluding extraction and post-removal damage) can be categorised into insertion marks and fretting marks. In some cases there are signs of material being deposited on the cone surface. Surface profilometry suggests that the levels of debris generation at the cone/internal head interface are very low relative to those that are likely to be associated with head articulation against the acetabular cup. A total of 20 stem cones underwent SEM scans. From these, 10 subsequently have undergone surface profilometry along with the corresponding internal head surfaces.

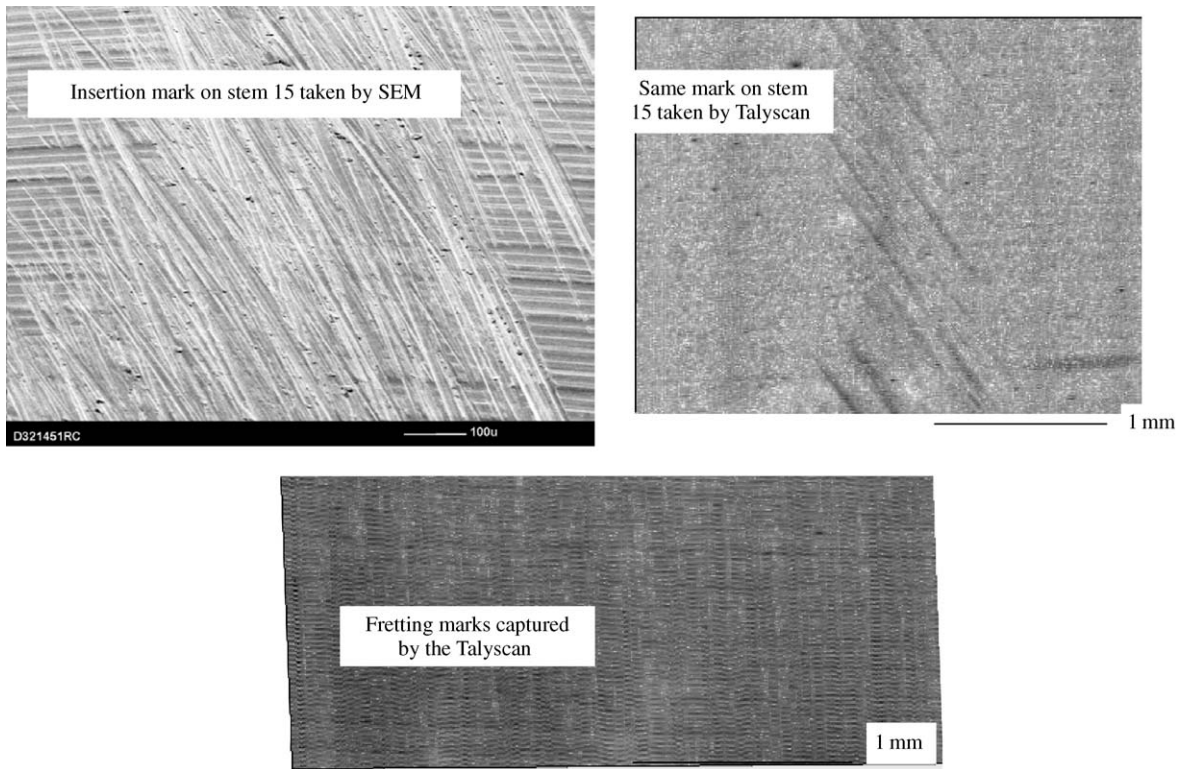
Figure 16 Comparison of images taken by SEM and Talyscan.

The Talyscan 150 and associated software can be used to generate surface images of moderate resolution (measurements taken every 5–10  $\mu\text{m}$ ), which can be tilted or rotated through any angle. Fig. 16 shows how the images produced using SEM and the Talyscan 150 can be matched together to form complimentary images. Because of its lower resolution, the Talyscan 150 cannot easily be used to measure specific features noted by SEM, for example, individual insertion marks.

$2 \text{mm}^2$  area. Although the resolution of Talyscan images is not as high as SEM images, Fig. 16 shows the fretting patterns as captured by the Talyscan measurements.

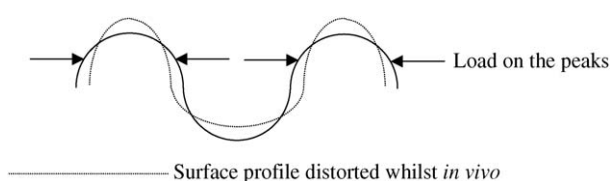
Figure 17 Showing a possible distortion of a surface whilst *in vivo*.

shown indicate that the pre-use values for  $S_p$  and  $S_v$  were probably greater than the reference values. The values for material loss shown in column 6 are thus likely to be significant overestimates.
