Microscopy of failure mechanisms in filament-wound pipe

M. L. C. JONES, D. HULL

Department of Metallurgy and Materials Science, University of Liverpool, P.O. Box 147, Liverpool, UK

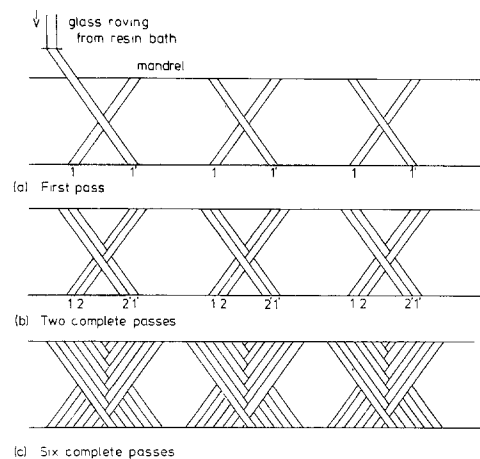
Figure 7 Schematic representation to show the development of cross-over points in this type of filament wound pipe.

The relatively crack-free band in the centre of Fig. 5 extended round the circumference of the pipe and was repeated at regular intervals along the length. This crack-free zone coincided with the cross-over points in the pipe. These points are

formed in helical wound pipes as illustrated in Fig. 7. The overlapping of the rovings at the cross-over points results in a local change in the fibre volume fraction. Regions of good packing alternate with regions containing pockets of resin with low fibre content as illustrated in Fig. 8.
