Stress corrosion cracking of GRP pultruded rods in acid environments

B.NOBLE^{*}, S. J. HARRIS^{*}, M. J. OWEN[†]

*Department of Metallurgy and Materials Science and [†]Department of Mechanical Engineering, University of Nottingham, Nottingham, UK

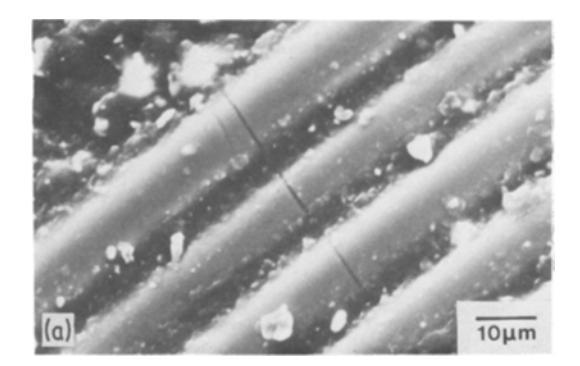
In order to study the nature of crack initiation, a series of samples were subjected to a stress of 207 MN m^{-2} in an environment of 0.01 N hydrochloric acid for times of 2, 4, 8, 16, 32 and 64 h. Transverse cracks were initiated at several points and these could be observed visually on the surfaces of the 32 and 64 h specimens (Fig. 3). Incipient cracks could also be found on the 16 h specimen by scanning electron microscopy. The 16 and 64 h specimens were subjected to a detailed microscopic examination. Fig. 4a shows after 16 h the characteristic appearance of the surface of the rods with prominent fibres and incipient cracks extending across 3 or 4 fibres. Axial sectioning (Fig. 4b) confirmed that these cracks did not extend to subsurface fibres or into the adjacent resin. Transverse sections showed the absence of axial splitting at this stage of the tests.

Figure 3 Transverse cracking on the surface of a GRP pultruded rod subjected to a stress of 207 MN m⁻² in an environment of 0.01 N hydrochloric acid for a time of 64 h. Magnification \times 3.

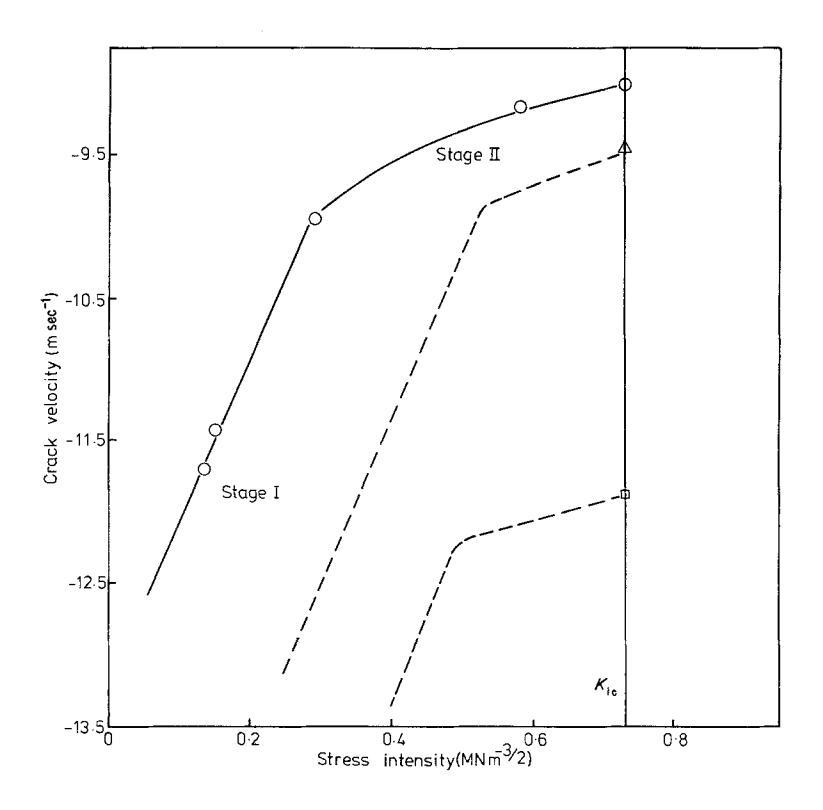
levels used in 5 NHCl. For the same crack length the stress intensity values are in the range 0.14 to $0.73 \text{ MN m}^{-3/2}$. Fig. 19 shows the resulting plot of log (average crack velocity) against stress intensity. The feature controlling the form of the curve will be the slow growth of the crack through the initial part of each glass fibre that has fractured at this stage of the test. Reducing the acid concentration from 5 to 0.5 to 0.001 N will displace the plot to higher stress intensity values as shown schematically in Fig. 19.

Figure 19 Plot of crack velocity against stress intensity in various acid environments: \circ 5 N HCl; \diamond 0.55 N HCl; \Box 0.001 N HCl. _______ represents the experimental plot and _______ represents the schematic plot.
