## Failure analysis of turbine blade in atomic power plant

### Abstract

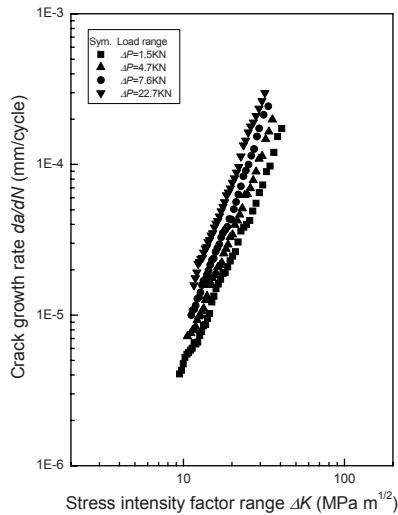
Fig. 5. Relation between stress intensity factor range and crack growth rate.

stress intensity factor. When the crack growth rate increased with the increase of the load range for the same stress intensity factor, the material was considerably affected by the load range. Fig. 6 shows the fatigue fracture surface within the range of each stress intensity factor for 7.6kN of the same load range by using a scanning probe microscope. A typical ductile striation is not shown in the figure; instead, a small crack is repetitively formed in the direction of depth of fracture appearance perpendicular to the crack growth direction.

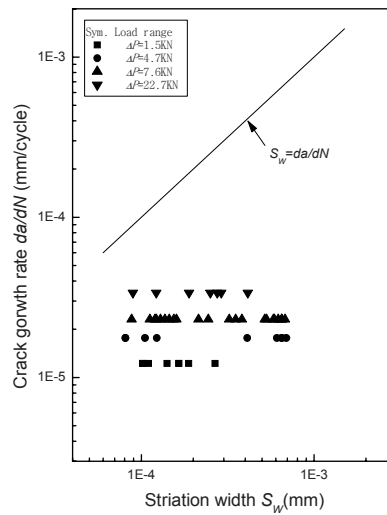
Fig. 7. Relation between 3-dimensional striation width and crack growth rate at  $\Delta K = 15MPa\sqrt{m}$ .

Fig. 7 shows the correlation between the range of the stress intensity factor and the intervals of small cracks for each load range, and the correlation with crack growth rate as a symbol and solid line, respectively. The intervals of small cracks to the same range of stress intensity factor show a difference from  $\times 133$  up to  $\times 16666$  compared with the crack growth rate, so it was found that small cracks were intermittently formed along the crack growth. There

fore, it seems that it is not reasonable to perform fracture surface analysis by using the interval of small cracks.

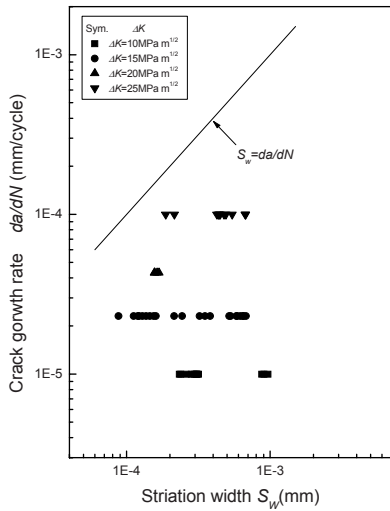
Fig. 10. Relation between 3-dimensional striation width and crack growth rate at  $\Delta P = 7.6kN$ .

Fig. 10 shows the interval of striation observed by an atomic force microscope and the crack growth rate, in the range of the stress intensity factor. The interval of striation was quietly distributed, irrespective of the range of the stress intensity factory and the load range. Such results might be interpreted as suggesting that ductile striation randomly relies on the crystal direc-

tion, while brittle striation is more sensitive to the load direction than the crystal direction. Thus striation was formed toward the crack growth direction, but the number was so small and the distribution was irregular. In addition, the interval of striation was as small as one-tenth the crack growth rate. Therefore, the scale of the load applied to a low pressure turbine blade cannot be estimated by the interval of striation measured by an atomic force microscope. To solve the above-stated problem, Fig. 11, which shows the surface roughness calculated, was used. It was assumed that the surface roughness curve gained by observing 250 areas toward the crack growth direction for each range of the stress intensity factor, 10, 15, 20, 25  $MPa\sqrt{m}$ , by the atomic force microscope would be a roughness curve. In the figure, a solid line shows the data of the root mean square roughness,  $Rq$  for the length from the pin hole regressed by the method of least squares, while the dotted line shows the distribution of the root mean square roughness calculated from a CT test specimen under fatigue.
