Comparison of thermal fatigue behaviour of ASTM A 213 grade T-92 base and weld tubes[†]

Abstract

Keywords: Thermal fatigue; T-92 tube; Transverse and Circumferential cracks; Failure analysis

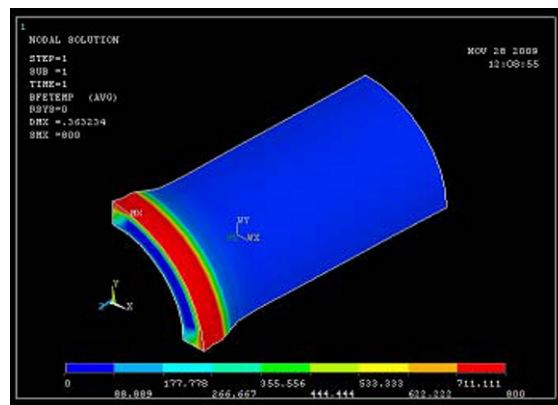
Fig. 9. Temperature contour plot on tube while heating at 800° C in the center.

Temperature and strain plots were used for finding the temperature and strain distribution on the heated tube. For the three-dimensional modeling, very fine mesh was chosen in order to achieve good results. The temperature distribution plot is shown in Fig. 9. A comparison of the experimental and analyzed results showed that the tube was normal before heating; after the thermal fatigue process, the tube’s heated zone showed bulging in both conditions, as shown in Figs. 9 and 11, respectively. In this study, we arrested the linear expansion of

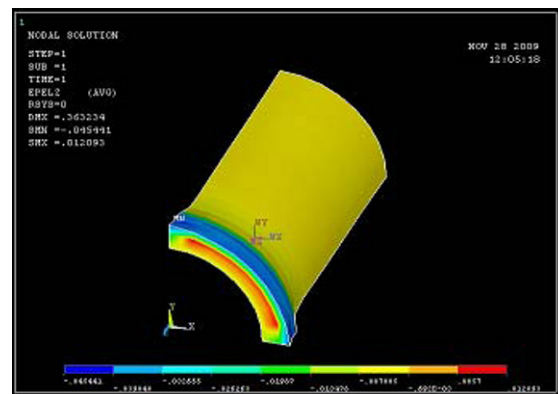
Fig. 10. Strain contour plot on tube after heating at 800° C in the center.

the tube by applying constrained condition to avoid the possibility of linear expansion during thermal fatigue. Thus, both tubes were shown to be bulged in the experimental and FEM analysis.

This indicates that the developed model showed similar characteristics with the experimental model. The strain distribution plot is shown in Fig. 10.

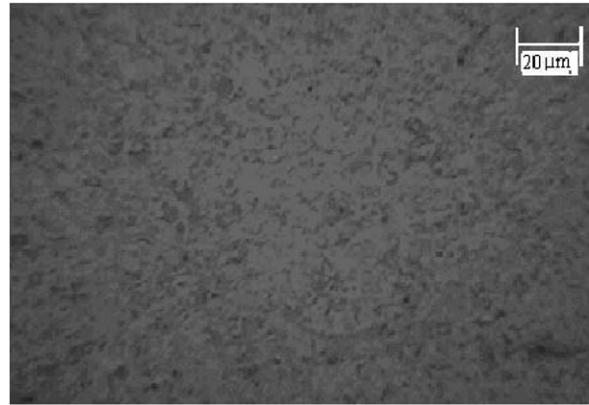
Fig. 18. Microstructure of base in defect-free region.

The microstructures of defect-free surfaces of the failed base tube are shown in Fig. 18.

Fig. 18 shows the optical microstructure of T-92 failed base tube taken in the defect-free surface. The microstructure of T-92 failed base tube showed a larger grain size. The dark-colored grains seen in the microstructure are tempered martensite. The tempered martensite provides the alloy high-creep strength by precipitation hardening. Formed carbides and

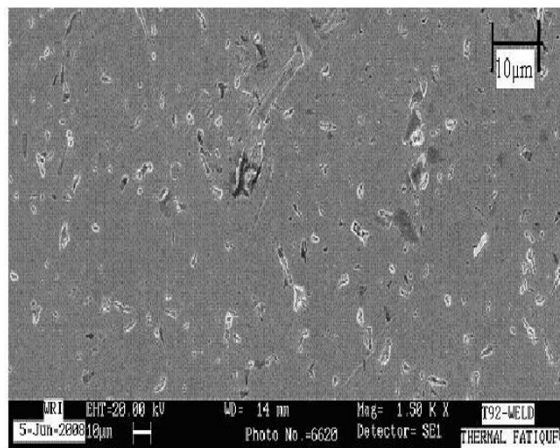
Fig. 24. Unaffected weld tube structure.

Fig. 24 shows the microstructure taken in the unaffected region of the failed weld tube. The defects present in the failed weld tube are shown in Figs. 25(a and b). Figs. 25(a and b) clearly show that the cracks developed from the outer surface of the tube, which then traveled towards the inner surface. Similarly, it traveled in the circumference of tube's heated region. When compared to the base cracks, the cracks obtained in the weld were larger. Crack formation was observed inside the cracked surface at higher magnification. Upon further magnification, grain boundary cracks were clearly seen, as shown in Fig. 25. Figures 26 (a and b) show the position of the crack width was initially high; the crack growth rate increased as it moved towards the inner surface due to the temperature difference and rate of cooling.

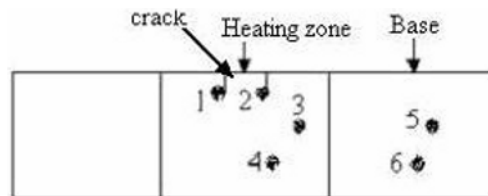
Fig. 27. Hardness locations taken in the failed base tube.

Hardness measurements were taken on the base and welded tube materials before being subjected to thermal fatigue. After failure occurred, hardness was determined according to the Vickers hardness test. The hardness location taken in the base and welded tube specimens are shown in Figs. 27 and 28. The load applied was 10 kg. The hardness values taken from the base and welded tube materials are tabulated in Tables 4 and 5.
