# A metallographic and fractographic study of outside-in cracking caused by power ramp tests

S. Shimada <sup>a,\*</sup>, E. Etoh <sup>a</sup>, H. Hayashi <sup>b</sup>, Y. Tukuta <sup>b</sup>

<sup>a</sup> Global Nuclear Fuel Japan Co., Ltd., 2163, Narita-cho, Oarai-machi, Higashi Ibaraki-gun, Ibaraki-ken 311-1313, Japan

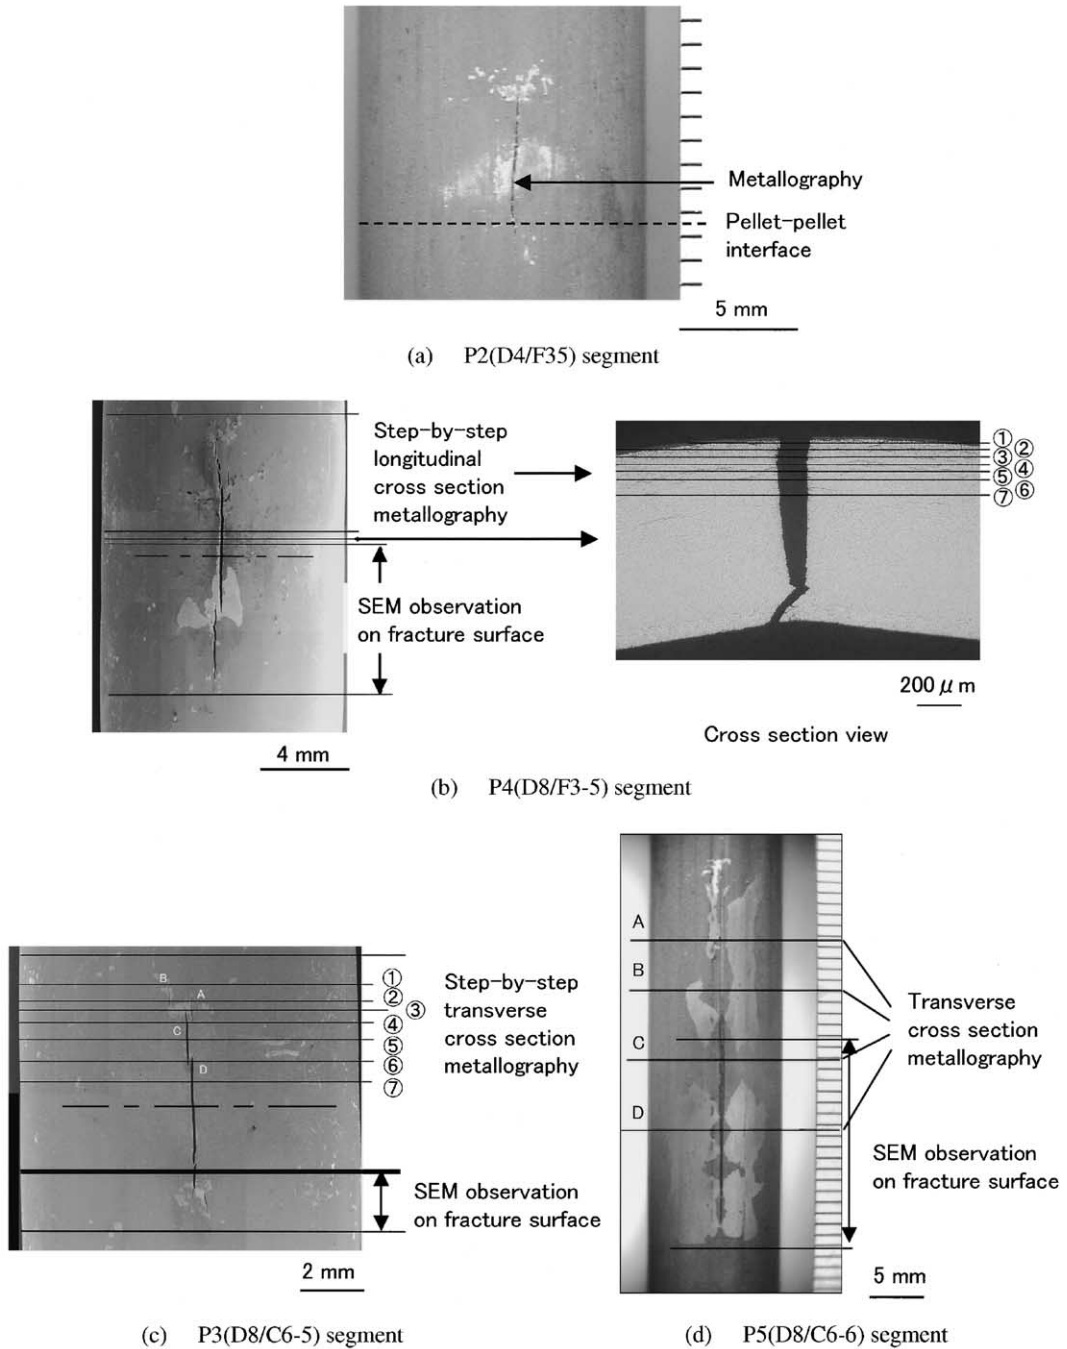
The rods with splits on outer surfaces, P2, P3, P4 and P5, were carefully inspected with emphasis placed on hydride distributions in cladding tubes and fracture surface characteristics. An ordinary inspection was also made for P1 rod which failed by PCI/SCC. Metallographic transverse views and a SEM image of inner surface of P1 are given in Fig. 2 and they reveal a typical PCI/SCC failure mode. As for the rods that failed with splits, periscopic, metallographic and fractographic observations were made for the PIE schemes designated in Fig. 3.

As explained in Fig. 3, transverse and longitudinal cross-section metallography was done step-by-step on D8/C6-5 and D8/F3-5 segments, respectively. The depth polished in every view step is tabulated in Table 2.

Fig. 3. PIE schemes for failed segment rods with splits.

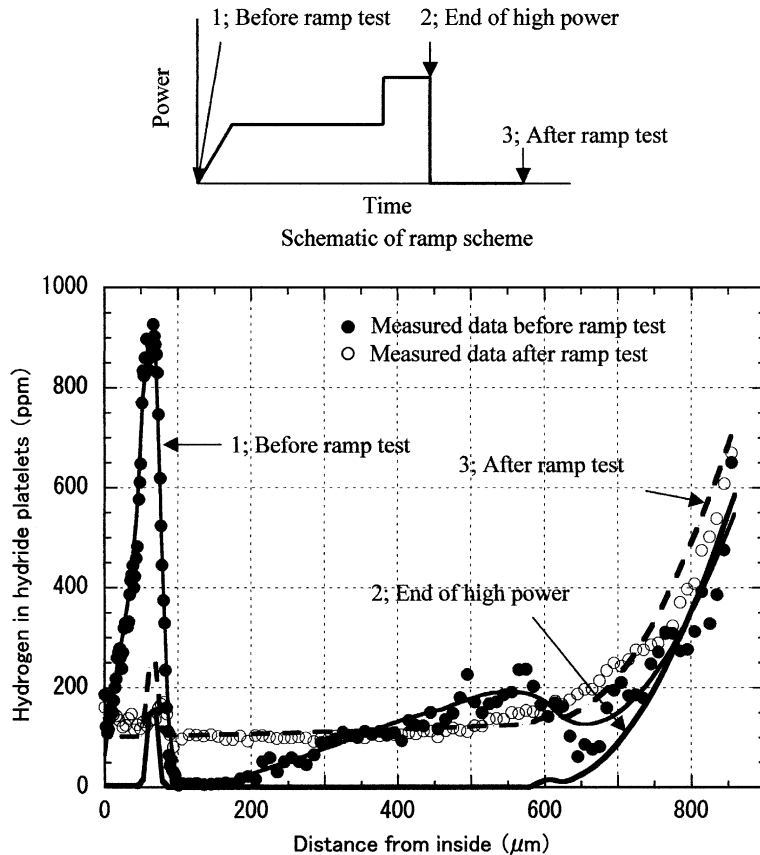
distribution in the cladding tube suggests that it would be difficult for hydrogen in the tube to take charge of the hydride precipitation at the crack front in most of the propagation region. A hydrogen content profile along the tube wall during a ramp test analyzed by using PIE results is shown in Fig. 20. The initial hydrogen content distribution before ramp test rod was measured by using the metallographic pictures of the claddings that experienced just base exposure (Fig. 17), and the final hydrogen content distribution of the ramp-tested rod, by Fig. 5, for example. Using the measured initial distribution profile, the analysis was conducted so that the final hydrogen content profile fit the measured data. The calculation results are plotted in Fig. 20 as well as measured data profiles. The analysis reveals the hydrogen content is too low for the hydrogen in cladding to precipitate in most of the propagation region at high temperature, even if hydrogen solubility, affected by stress concentration at the crack tip, is taken into ac-

Fig. 20. Calculated hydride profiles along radial direction during ramp test (Average hydrogen content: 180 ppm).
