Preliminary results of post-irradiation examinations on LiSoR-2 test section

Y. Dai ^{*}, H. Glasbrenner, V. Boutellier, R. Bruetsch, X. Jia, F. Groeschel

Paul Scherrer Institut, 5232 Villigen PSI, Switzerland

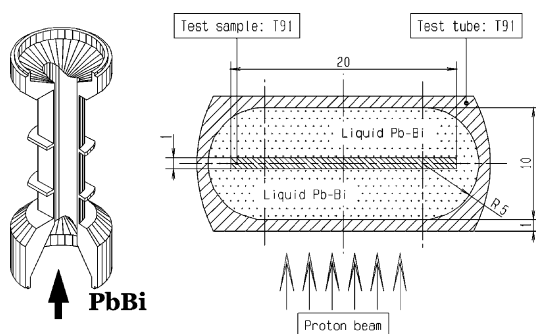
Fig. 1. Sketches showing the tube of the LiSoR test section and the cross-section of the tube including the test specimen. The dimensions are in millimeters.

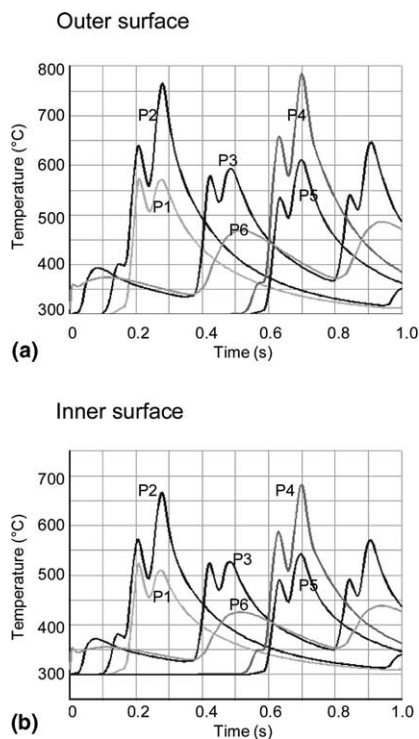
after the irradiation using the ANSYS code are shown in Fig. 2(a) and (b) which indicate that: (1) the temperatures at different positions are very different whereby the maximum temperature in each case is reached just after the turning point of the beam; (2) the temperature at one position oscillates at a frequency of 1.17 Hz; (3) the maximum temperature at the outer surface of the tube is about 780 °C, and the corresponding temperature at the inner surface is about 670 °C [7]. The temperature gradient of 110 °C cross the wall (1 mm thick) introduces a thermal stress of about 170 MPa, which is much higher than the yield stress of T91 at these temperatures. Therefore, the material in the irradiated zone of the tube should be subjected to thermal fatigue deformation during irradiation. For the tensile specimen, the temperature was lower due to cooling from both surfaces by flowing LBE. However, the heat deposition in the specimen was about 1.5 times of that in the wall of the tube [6]. This resulted in a maximum temperature at the middle of the specimen of about 620 and 580 °C at the surfaces. The 40 °C temperature difference across the 0.5 mm thickness gave a thermal stress of about 120 MPa. This thermal stress was in superposition with the stress of 200 MPa applied mechanically and resulted in also thermal fatigue deformation similar to that in the tube.

Fig. 2. Plots showing (a) outer and (b) inner surface temperatures at six positions in the irradiation zone of the tube.
