Preliminary observations of hot spot for HT-7 long pulse discharges

M. Su, Y. Yang *, The HT-7 Team

Institute of Plasma Physics, Academy of Sciences, Division 6, P.O. Box 1126, Hefei 230031, PR China

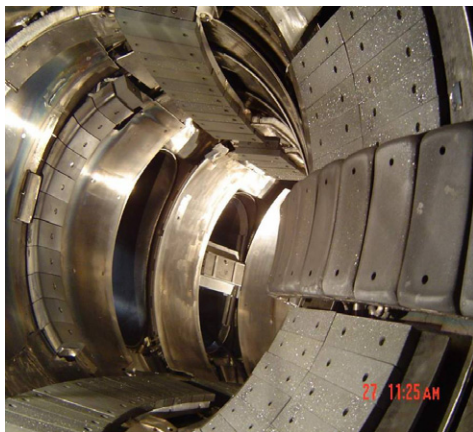
Fig. 1. This photo shows the relative position of limiters inside HT-7 chamber. The circular belts on the top and at the bottom of the photo are the upper and bottom TL. The extruded part to the left between the upper TL and bottom TL is one of the PL. The horizontal array of a few tiles in the middle of the right hand side is the BL (It should be pointed out that part of the TL was removed for the present situation.).
