# Description of gasket failure in a 7 cell PEMFC stack<sup>☆</sup>

Attila Husar<sup>a,\*</sup>, Maria Serra<sup>a</sup>, Cristian Kunusch<sup>b</sup>

<sup>a</sup> Institut de Robòtica i Informàtica Industrial, Parc Tecnològic de Barcelona, Edifici U, C. Llorens i Artigas, 4-6, 2a Planta, 08028 Barcelona, Spain

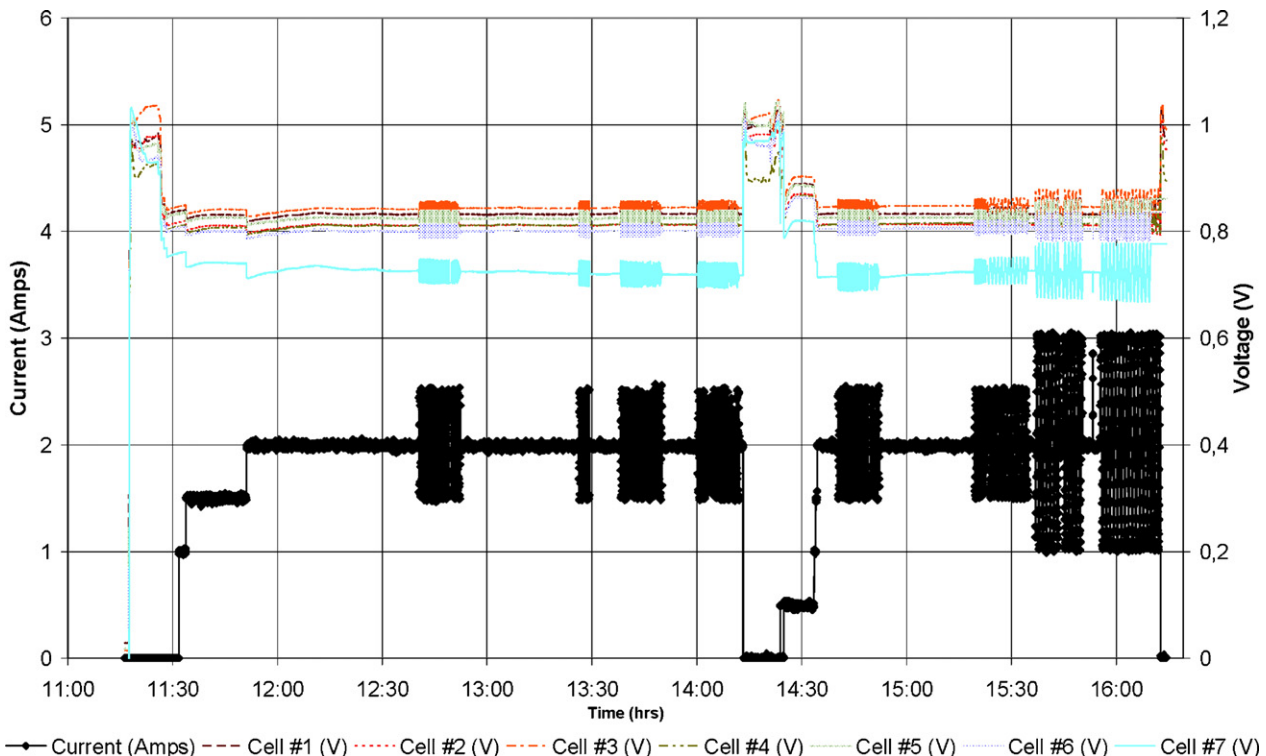
The stability of the stack over time with respect to individual cell voltage is shown in Fig. 2. As can be seen in this figure the stack was stable under these conditions. The variation in the cell voltage can be attributed to changes in the current due to impedance spectroscopy tests performed on the stack. Cell #7 of the stack had consistently showed a poor performance when compared to the other cells in the stack. However, this issue will not be analyzed in this work as it is unrelated to the ultimate failure of the stack.

Fig. 2. Normal voltage current response of the 7 cell stack a few days before failing,  $H_2/O_2$ , 1.02 Stoichiometry for anode and cathode,  $60^\circ\text{C}$  stack temperature, no humidification and a gas pressure of  $4.50\text{ bar}_a$  ( $50\text{ psi}_g$ ) for both the anode and cathode.
