# Behaviour of a rupture of the 21 June 2000 earthquake in South Iceland as revealed in an asphalted car park

Jacques Angelier\*, Françoise Bergerat

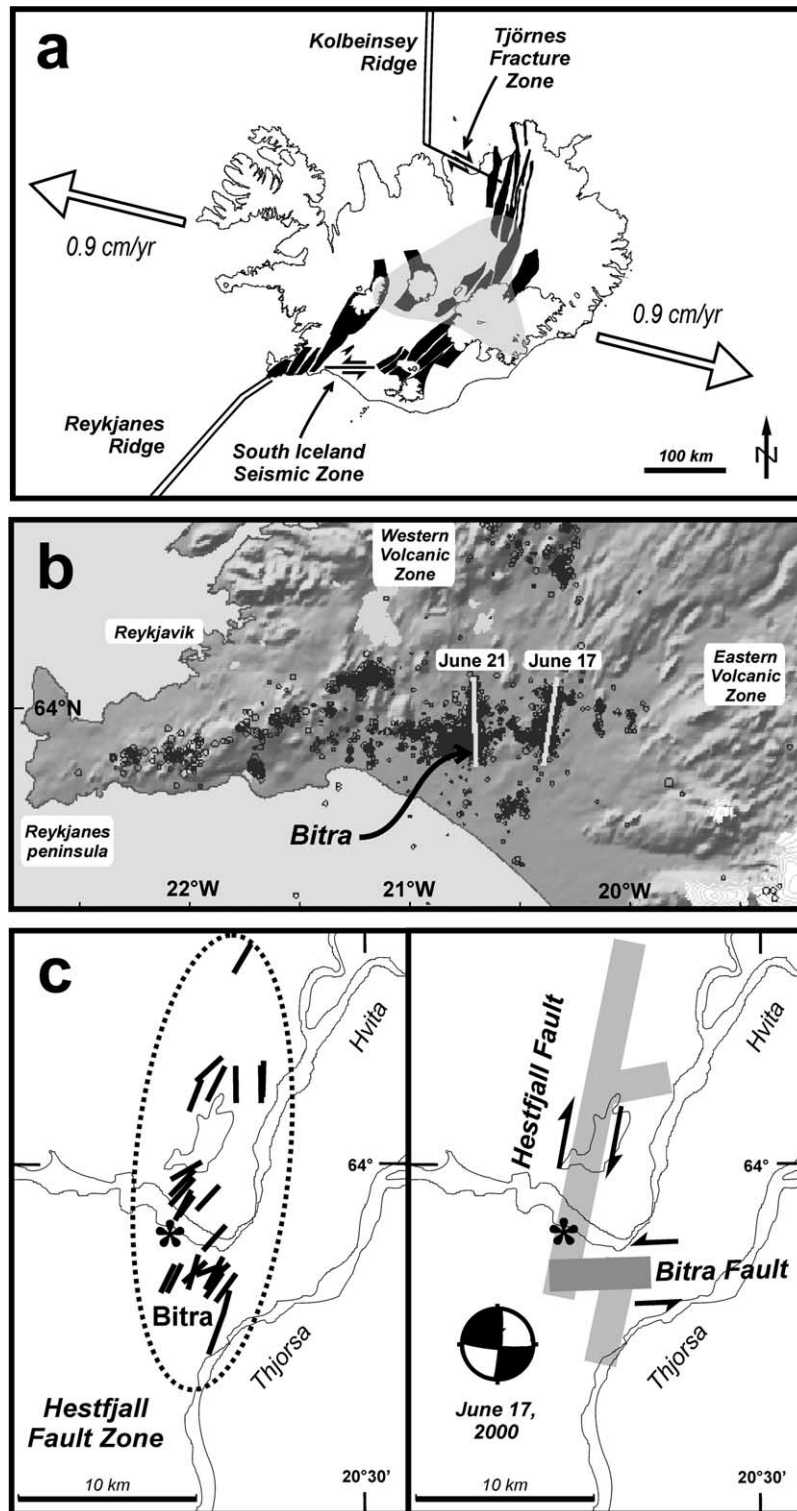
Fig. 1. The South Iceland Seismic Zone and the 17 and 21 June 2000 earthquakes. (a) Geodynamic setting of Iceland. Mid-Atlantic ridge as double line, Icelandic rift zones in black (left white when covered by glaciers), apex of thermal anomaly in light grey, plate divergence indicated by open arrows. (b) Main fault traces and aftershocks of the 17 and 21 June 2000 earthquakes (modified after Stefánsson et al., 2000). Location of the area studied (Bitra) indicated. White lines refer to alignments of earthquake epicentres, not to surface traces. (c) Surface traces (thick black lines) of the 21 June 2000 earthquake, after the National Energy Authority of Iceland (Orkustofnun), 2000. Epicentre as asterisk. Main faults in grey (Bitra Fault in dark grey). Earthquake mechanism added as 'beachball' stereoplots.

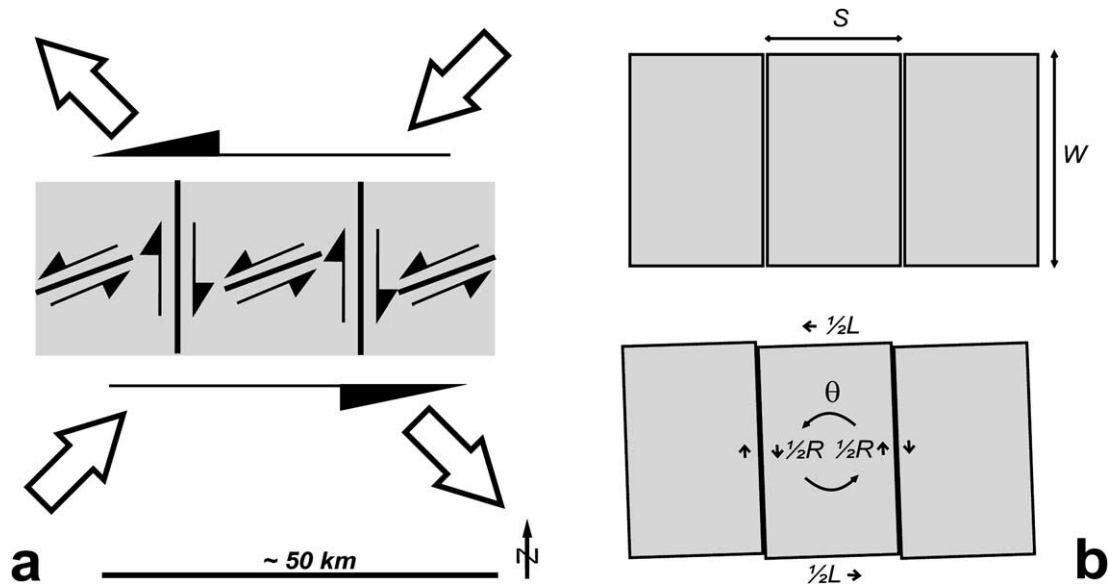
Fig. 9. Fault pattern and mechanisms of the South Iceland Seismic Zone. (a) Distribution of strike-slip movements and far-field stress. Deformed South Iceland Seismic Zone in light grey pattern. Pairs of large open arrows indicate the directions of compression (convergent arrows) and extension (divergent arrows). Couples of black arrows indicate the direction and sense of shear. (b) Determination of the relationships between the width,  $W$ , of the deformed zone, the spacing,  $S$ , between the N–S right-lateral faults, the anticlockwise rotation angle,  $\theta$ , of the blocks, the amount of right-lateral slip,  $R$ , on N–S faults and the amount of left-lateral slip,  $L$ , along the deformation zone.

Our reconstruction reveals co-seismic left-lateral slip of about 0.5 m along a N80°E-trending fault. The orientation and sense of motion may seem surprising in light of the general behaviour of the 21 June 2000 rupture trace, which trends N–S and reveals right-lateral strike-slip. At Bitra, the nearly E–W main fault trace shown in Fig. 3b is actually a conjugate segment of the main rupture trace (Fig. 1c), which explains both its different orientation and its opposite sense of motion (Fig. 9a).

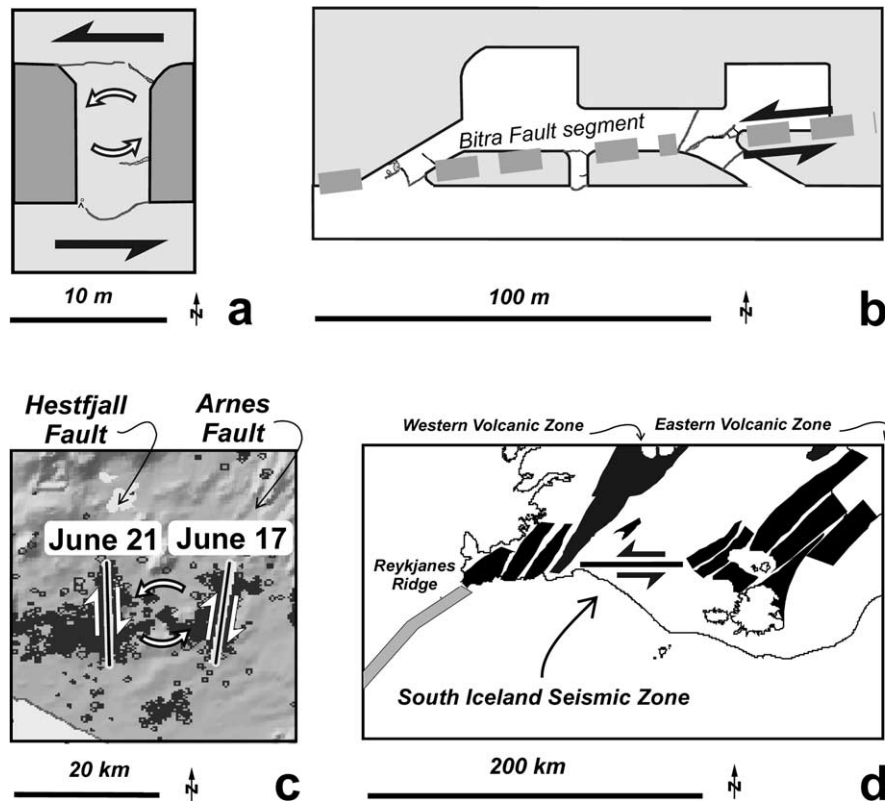
Fig. 10. The multiscale pattern of deformation in the South Iceland Seismic Zone. (a) Anticlockwise rotation of asphalted access road, about 10 m long, related to left-lateral shear (see Fig. 6). (b) Left-lateral motion of the Bitra Fault segment (several hundred metres long). (b) Right-lateral displacement on two major N–S faults of the South Iceland Seismic Zone, approximately 20 km long, and inferred anticlockwise block rotation (see Fig. 9). (c) Left-lateral motion of the South Iceland Seismic Zone, approximately 100 km long.
