The Application of Thermal Sprayed Coatings for Pig Iron Ingot Molds

H.-J. Kim and Y.-G. Kweon

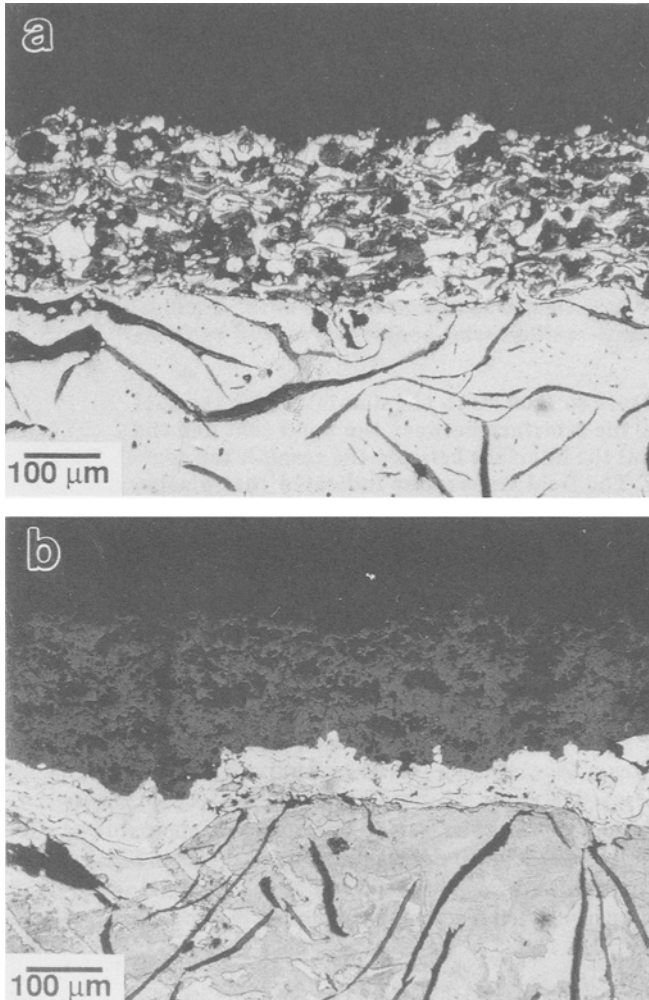
Metco 5P-II and Sulzer F4 (PT-M1100) equipment (Sulzer Metco, Westbury, NY) was used for flame and plasma spraying, respectively. The substrate was a gray cast iron (FC20) used for mold materials. The coating thickness was approximately 300 µm; cross-sectional microstructures are shown in Fig. 1. All the coatings were supplied by a commercial thermal spraying job shop using their recommended process parameters.

Fig. 1 Typical cross-sectional microstructures of coated specimens. (a) One-layered coating (flame spray) and (b) two-layered coating (plasma spray)
